Tow coupling safety alert

Axle-stop/retention devices - important warning

Holland FW31 series fifth wheels - warning

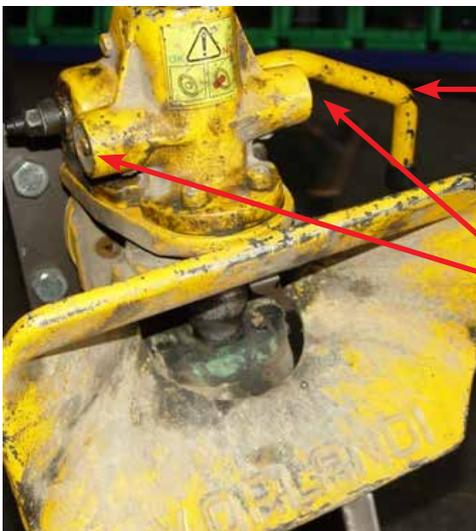
Release handle must exhibit strong resistance when raising the drop pin

Both locking plungers to be fully engaged without any physical assistance

Lock plunger to be fully engaged (seated) into recess

When inspecting a pin type coupling for condition and performance ensure that:

- there is no material present in and around the lower drop pin bush and the outlet hole beneath which could prevent full engagement of the drop pin
- the release handle has a strong downward force or resistance when raising the drop pin to connect/disconnect a trailer
- any form of locking mechanism engages fully without any physical assistance.

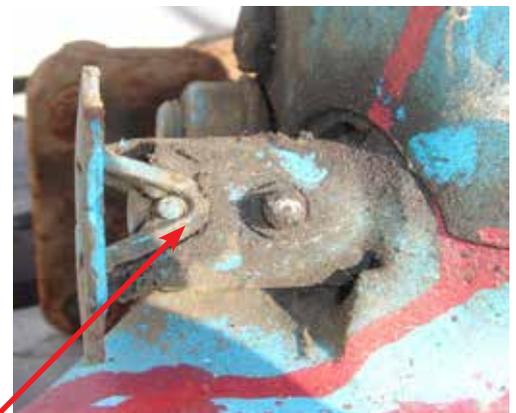
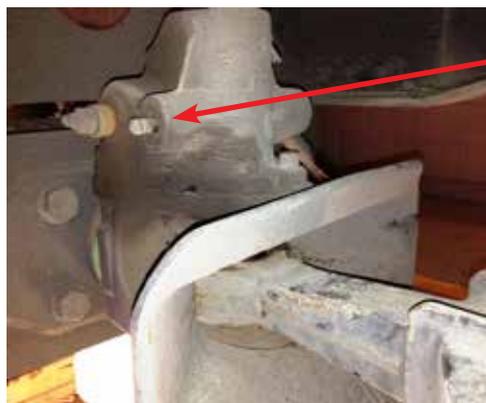
Investigation into the cause of the detachment identified that there was evidence that the tow drop pin had not fully engaged due to debris packed in the lower bush. It was also noted that the outlet hole beneath the bush was blocked due to stones and other material. This appears to be a particular issue with logging trucks where the trailer is placed on the back of the truck when empty (piggy-backed). This can lead to dirt and other foreign material settling on wet and oiled surfaces and becoming compacted preventing full engagement of the drop pin. Two other cases have been identified where the release handle had insufficient force to hold the drop pin in place, or the lock plungers were not fully engaged.

Locking plunger not engaged

This outlet hole must be completely clear of any stones or dirt etc

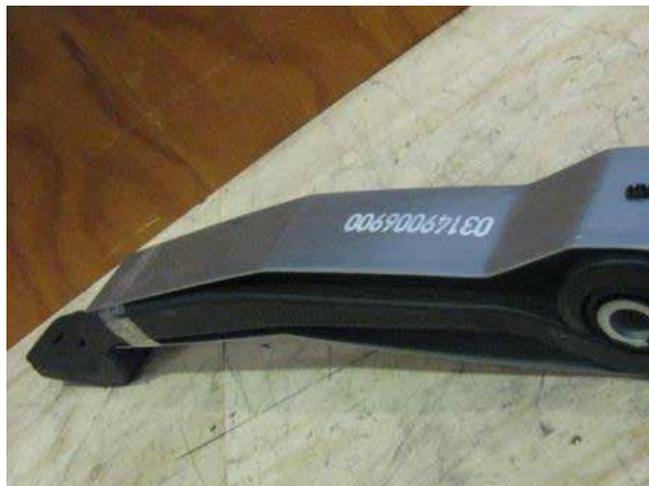
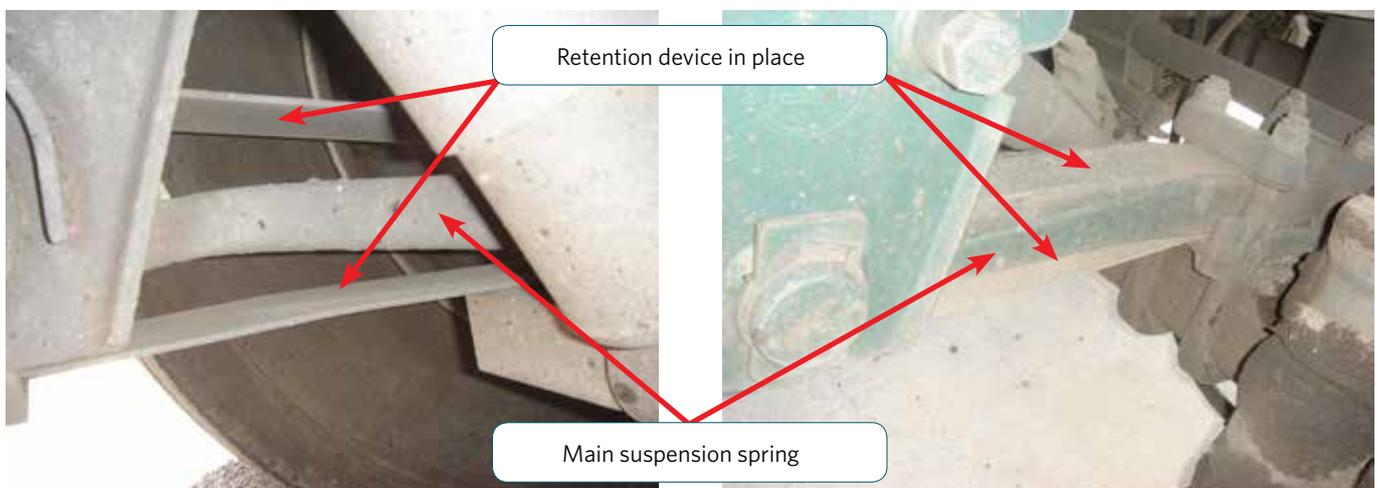
Example of a new arm complete with bush and safety retention device

The VIRM requires a defective suspension component, such as an axle stop, to be rejected at CoF. A cracked, broken or missing axle stop would fall into this category. Vehicle Inspectors must ensure that these safety devices are thoroughly inspected as the consequences of failing to identify a fault may be catastrophic, as the example below clearly illustrates.

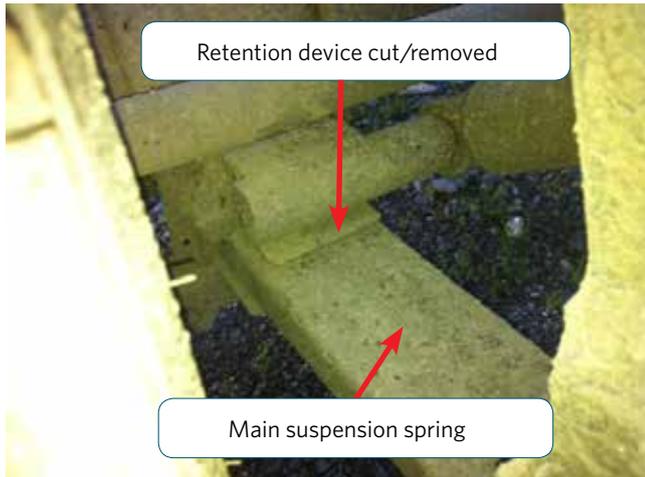
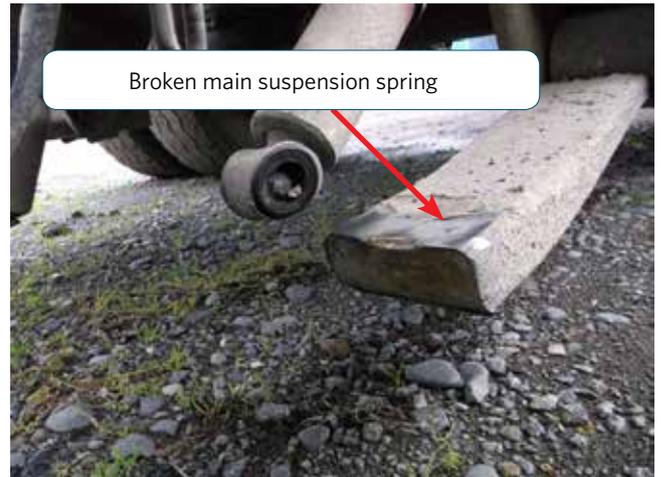
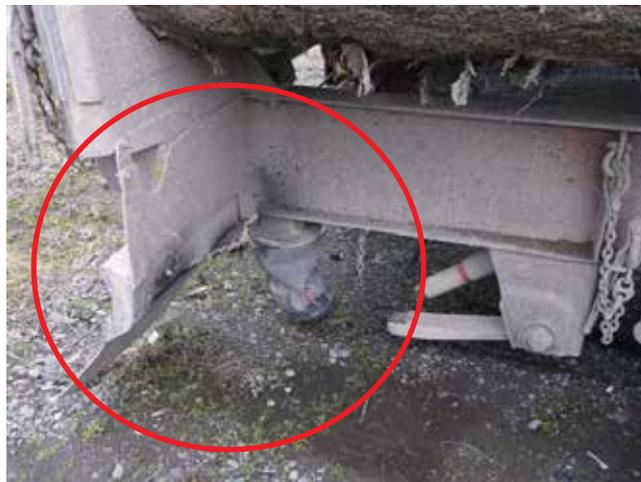
There have been a number of accidents involving truck and trailer units where the trailer has lost an axle due to a broken main leaf spring. Axle stop devices which would have retained the axle were either defective or missing.

A dramatic example of what can happen if the retention devices are not in place:

The only item left holding the axle in place when the arm failed on the right-hand side was the shock absorber. Once this failed the brake had no retardation effect on the trailer and the axle is free to move out the back of the trailer.

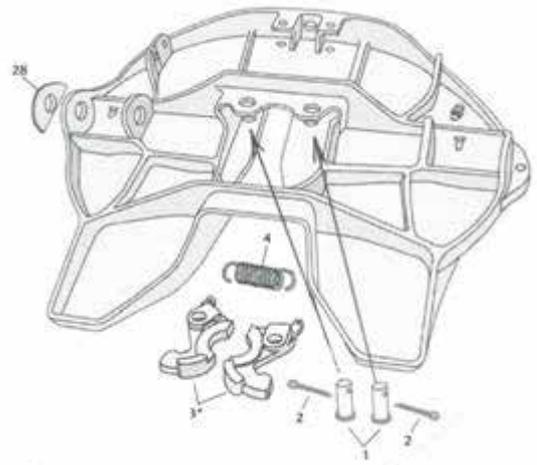
There have been problems with some of these (and potentially with other makes) where the headed pivot pins for the locking jaws may move upwards through the main body of the fifth wheel and eventually foul on the kingpin mounting bolt heads.

There is a risk of semi-trailer disconnection because the alignment of the jaws can be affected.

The original type pins are secured with ¼" split pins but some may have been replaced with pins with circlips and grease nipples. When you are inspecting fifth wheels please look underneath and ensure that all these pins (marked '1' in the picture), if visible, are all sitting in the correct position with their fixings (cotters, circlips, etc.) intact.
