TAKATA AIRBAGS RECALL

VIRM amendment 1 December 2016

A new **VIRM: In-service certification** amendment will come into force on 1 December 2016. It's a significant amendment that includes:

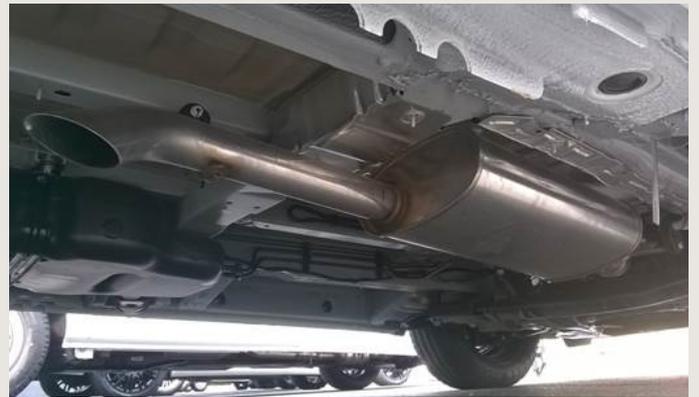
Some Mercedes-Benz Vito 111 vans are fitted with an original equipment short exhaust system that does not extend outside the perimeter of the passenger compartment, (see photo below).

Land Transport Rule: Vehicle Equipment 2004 requires that an exhaust system must be designed, constructed, positioned and maintained in a way that minimises the risk of heat or fumes emitted from the system harming the motor vehicle's occupants.

Mercedes-Benz has confirmed that their short exhaust system fitment is compliant with this requirement. Accordingly, a Mercedes Vito vehicle fitted with this exhaust system can be issued with a WoF or CoF, provided it meets other VIRM requirements (eg is in good working order and without leaks).

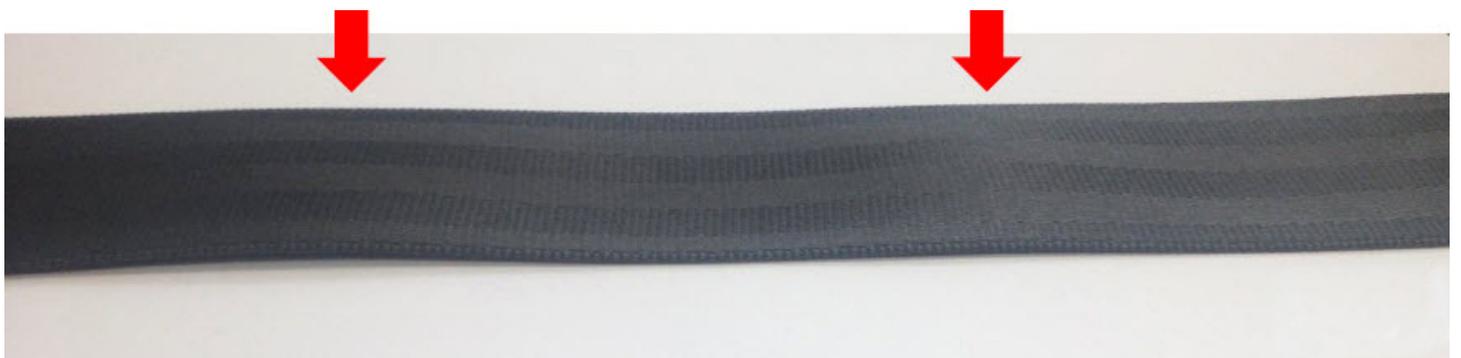
Seat belts applied to some Hyundai *iMax* and *iLoad* vehicles are applied with mono type seat belt webbing.

Mono type webbing can help reduce occupant injury to the chest area during a vehicle accident. With normal use this type of webbing can develop ripples in the centre of webbing when laid on a flat surface (see image below). Under **section 7-5 Seatbelts and seatbelt anchorages**, reason for rejection 5(d): *stretching (eg the belt has unusual web patterns or the webbing is deformed, will not lie flat, or is curled or rippled)* - you would have to fail the seatbelt.

That's not the case with these seatbelts though, which have gone through independent testing using crash test dummies that found:

- the test dummy was retained during impact
- no separation or fragmentation of any component.

As long as the seatbelt meets the other requirements you can pass these particular seatbelts that show rippling.

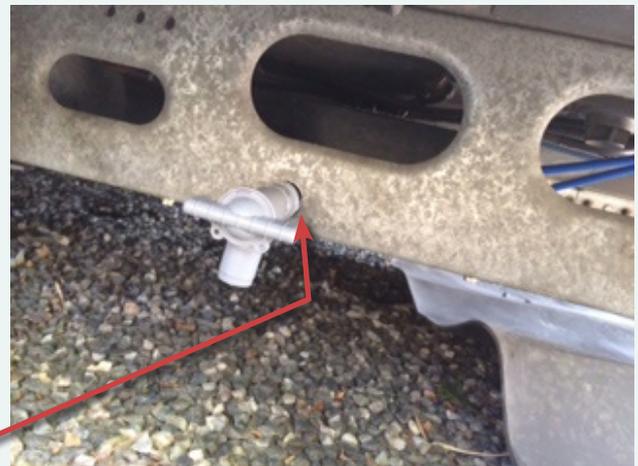
Modern caravans often use a specially-designed frame to keep their overall weight to a minimum. If a hole is drilled into them, the increased stress can cause cracks to develop around the hole.

During inspections, carefully check for signs of cracking around any holes that may have been added to fit aftermarket equipment, such as the plumbing fitting shown in the photo.

Hole has been drilled to allow for the plumbing fitting

The sooner cracks are spotted, the less costly the repairs will be.
