**Extract taken from:** Border inspection of imported used vehicles > Reference materials > Examples of major structural damage and corrosion > Under-body damage: crushing of floor pan stiffening members

## 5-1 Under-body damage: crushing of floor pan stiffening members

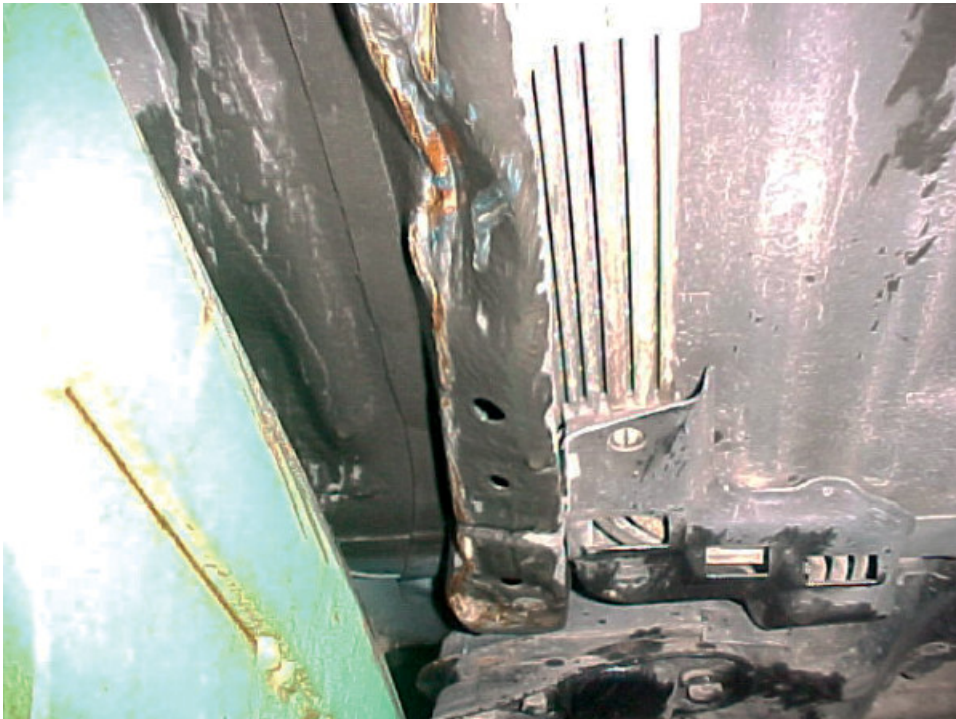
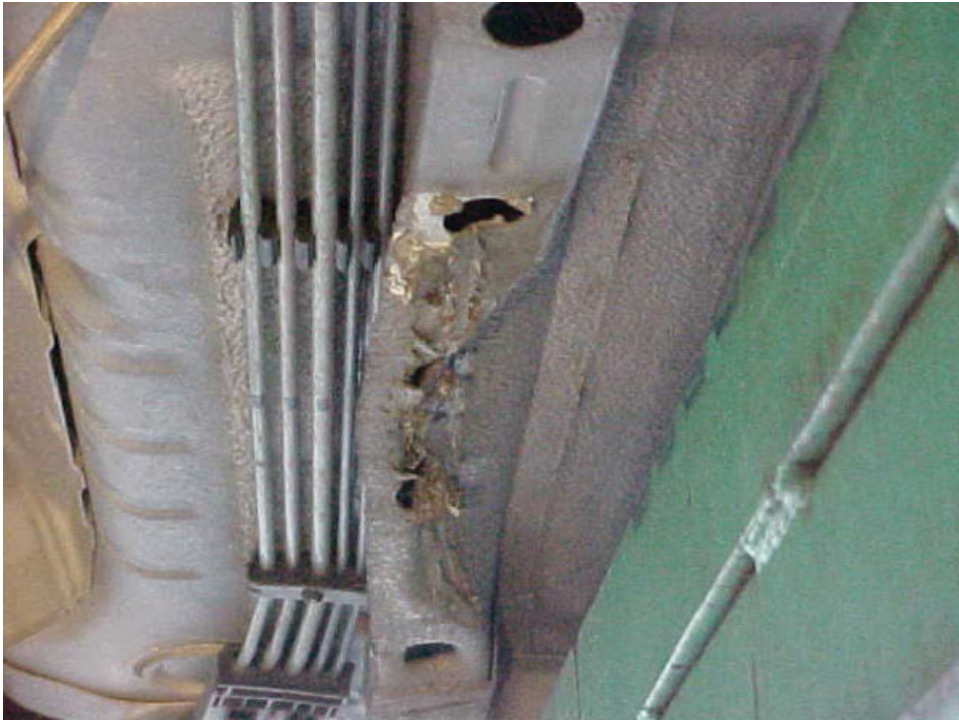
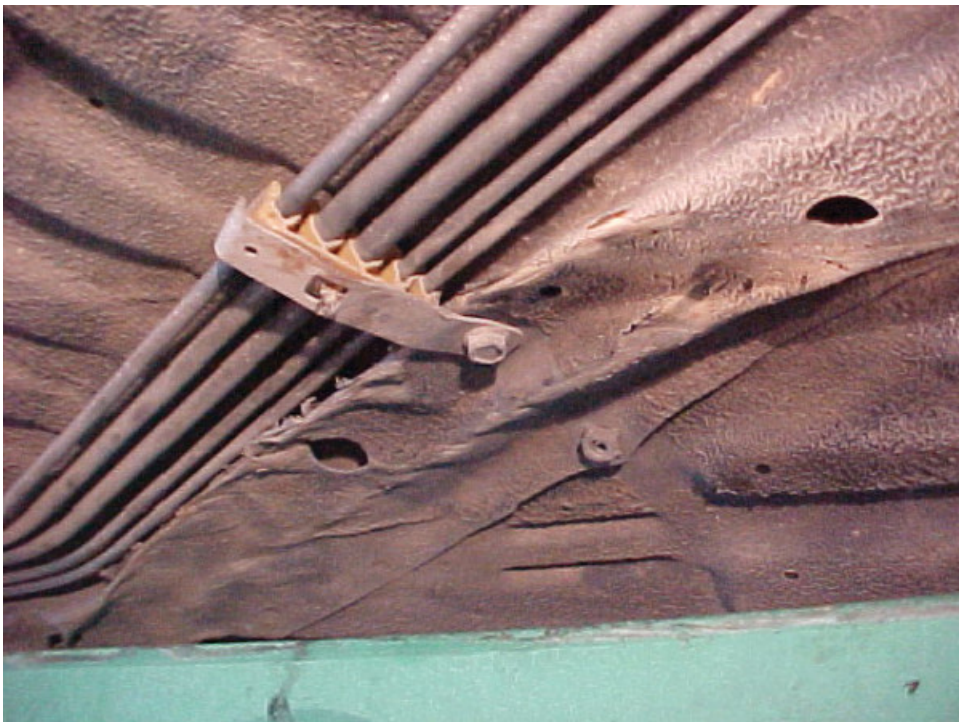
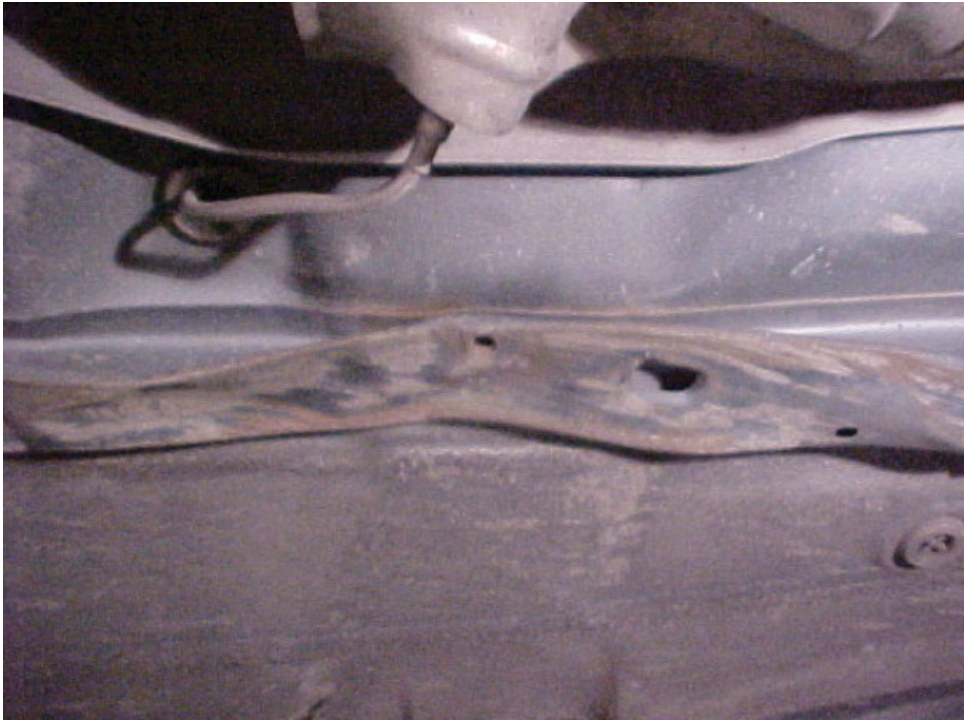
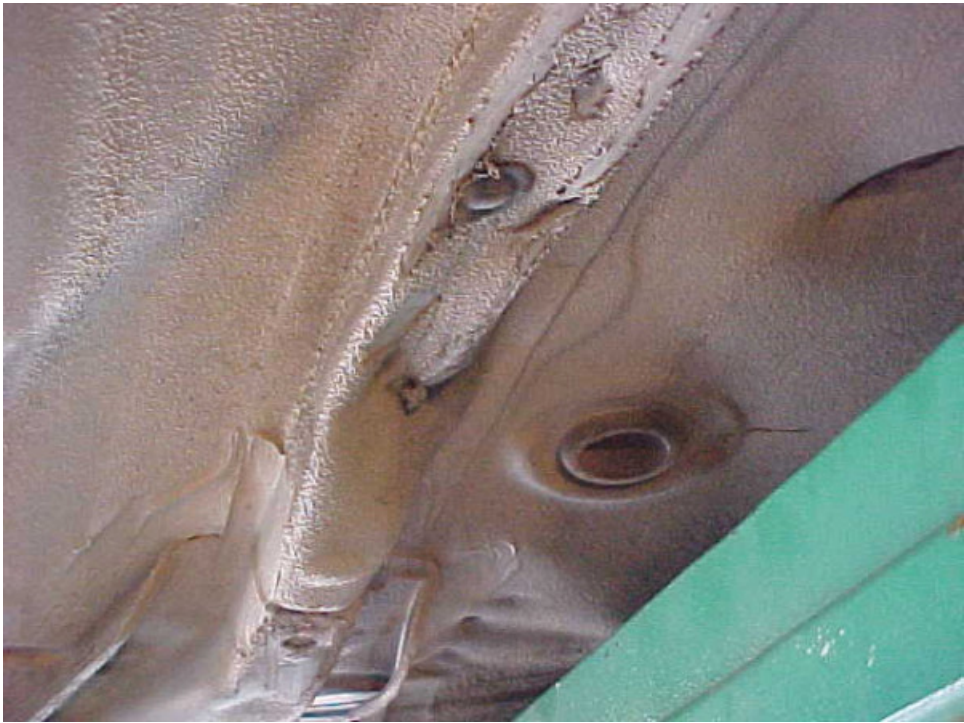
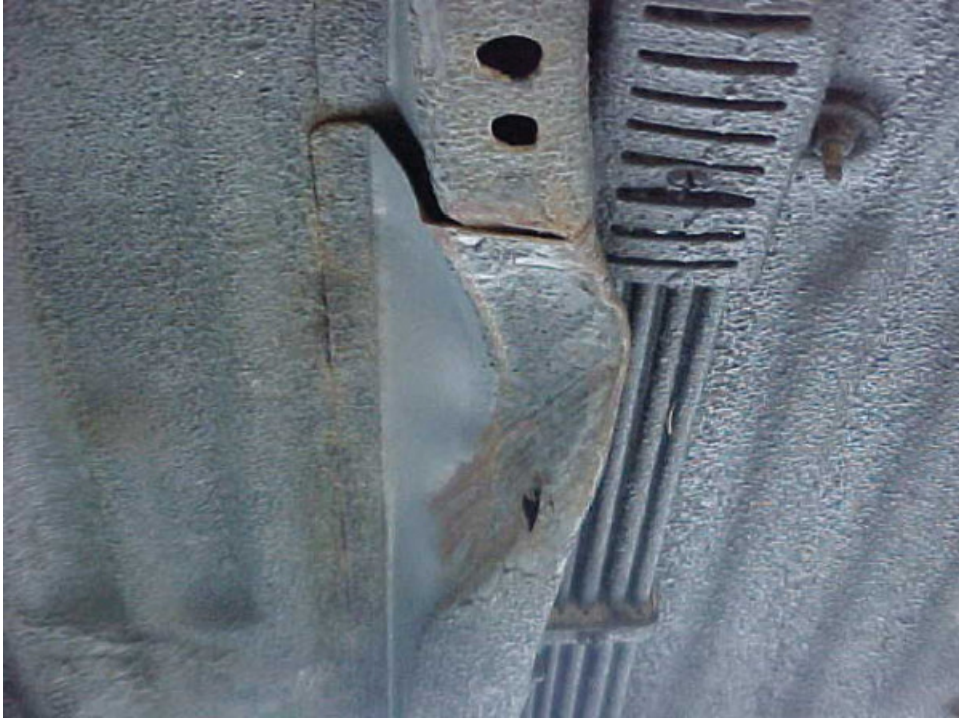
The damage in these images **must be flagged for damage.**

Where it's determined that the damage is non-structural, and there's no other damage requiring an LT308, the repair certifier will issue an LT307.
