Extract taken from: Border inspection of imported used vehicles > Reference materials > Examples of major structural damage and corrosion > Distortion to longitudinal rails: front and rear crush zones

5-7 Distortion to longitudinal rails: front and rear crush zones

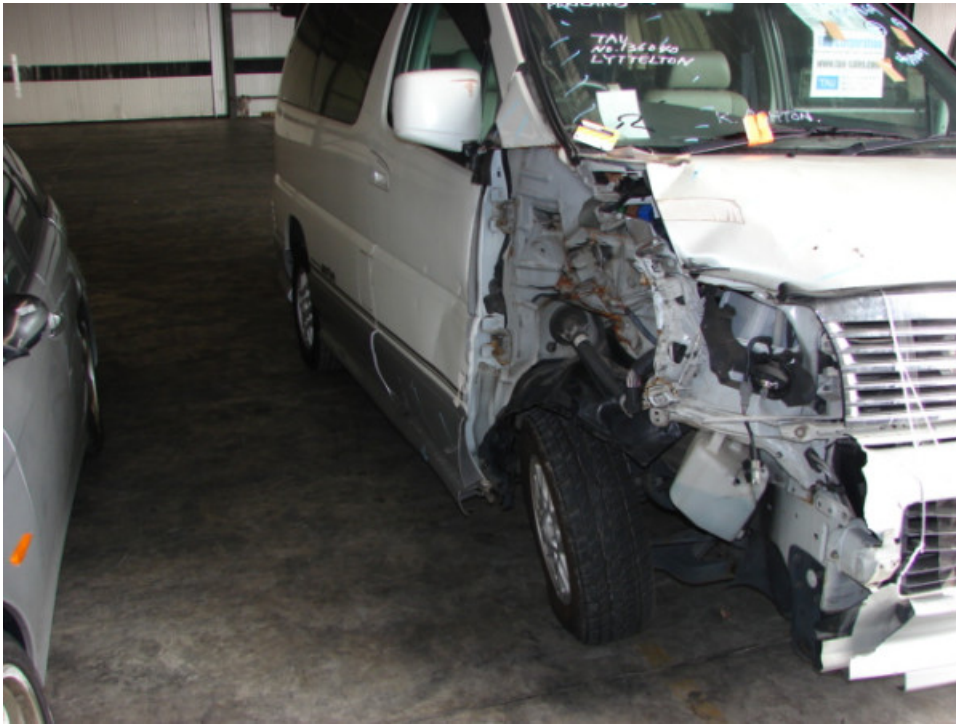
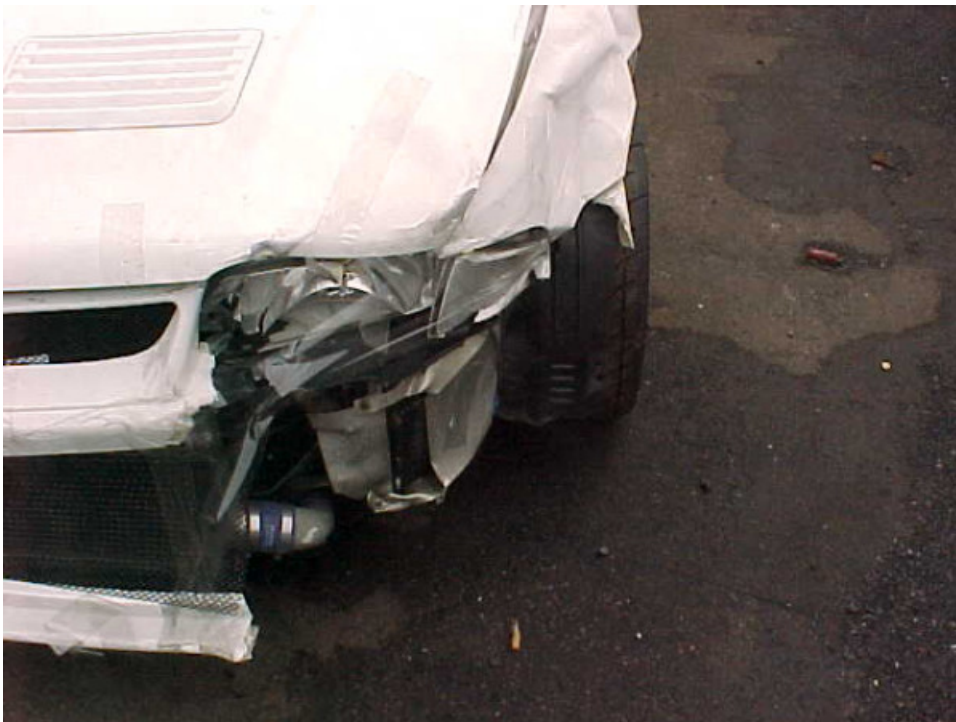
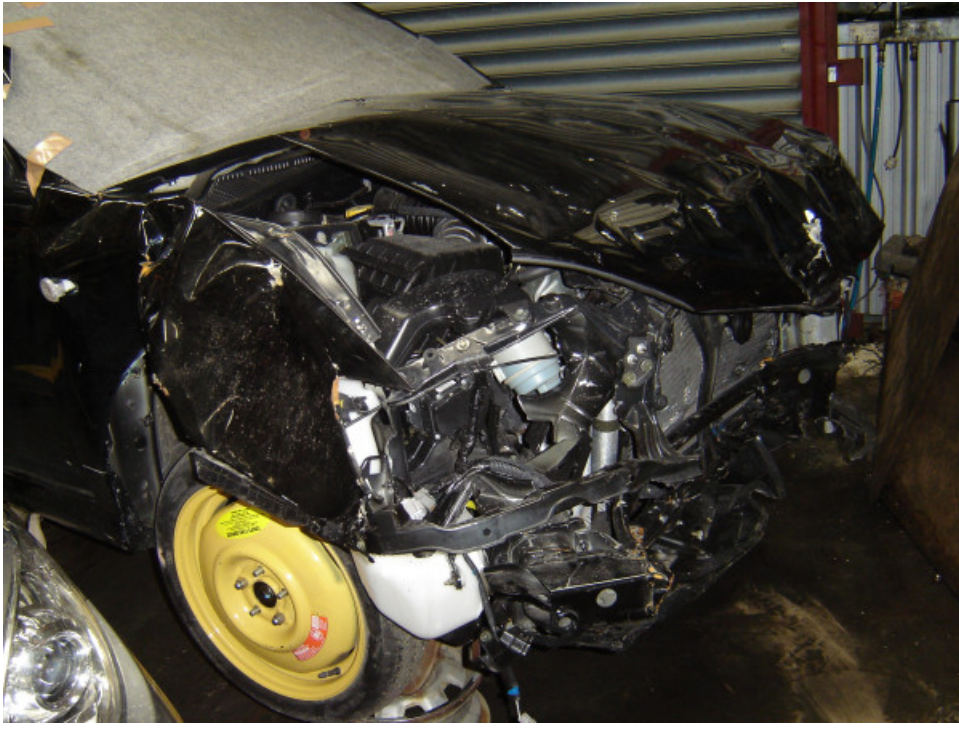
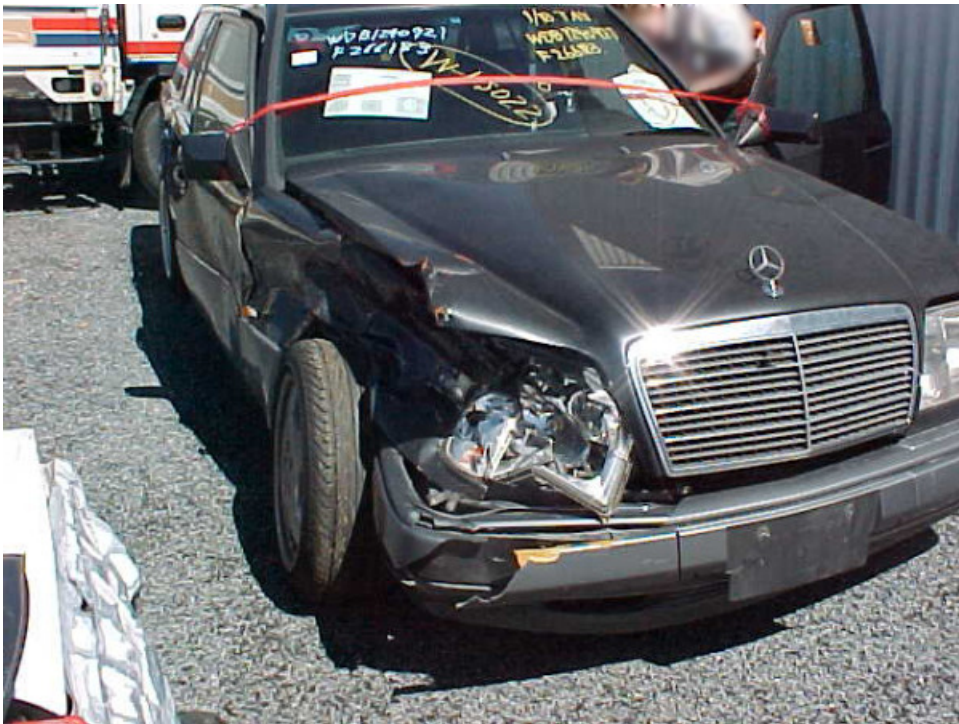
Distortion to longitudinal rails: front and rear crush zones
