Extract taken from: Entry certification > Reference materials > Examples of major structural damage and corrosion > Corrosion which has resulted in perforation or flaking of the metal: Nissan Terrano and Mistral

## 71-10 Corrosion which has resulted in perforation or flaking of the metal: Nissan Terrano and Mistral

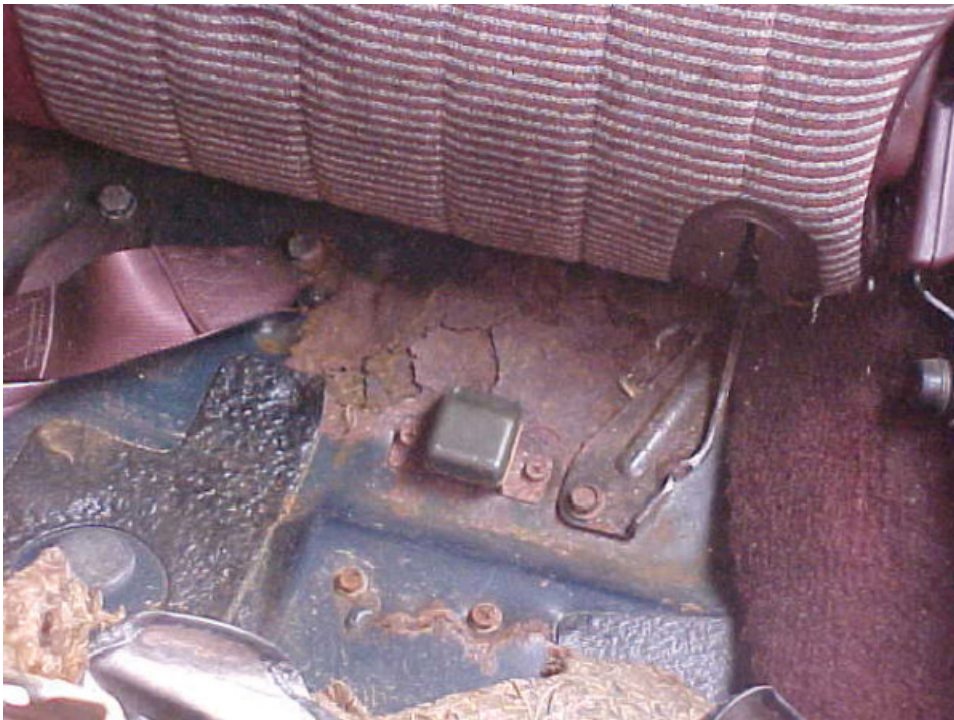
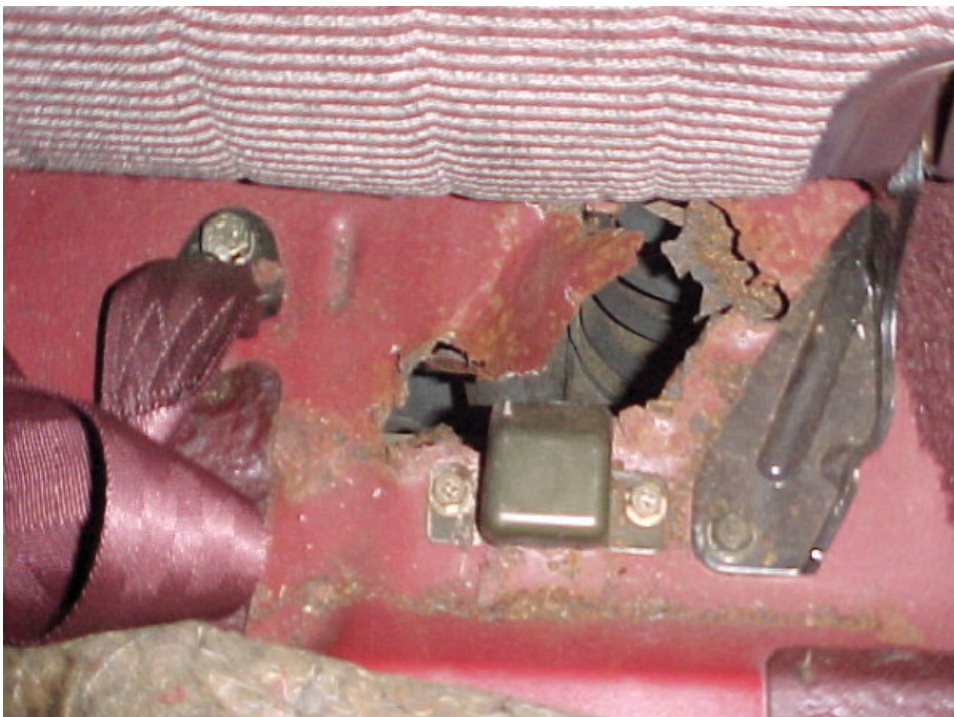
When inspecting Nissan Terranos or Mistrals always check for corrosion of the floor under the rear seat (examples are shown in the first three photos below).
