Extract taken from: Border inspection of imported used vehicles > Reference materials > Examples of major structural damage and corrosion > Corrosion which has resulted in perforation or flaking of the metal: Nissan Terrano and Mistral

5-10 Corrosion which has resulted in perforation or flaking of the metal: Nissan Terrano and Mistral

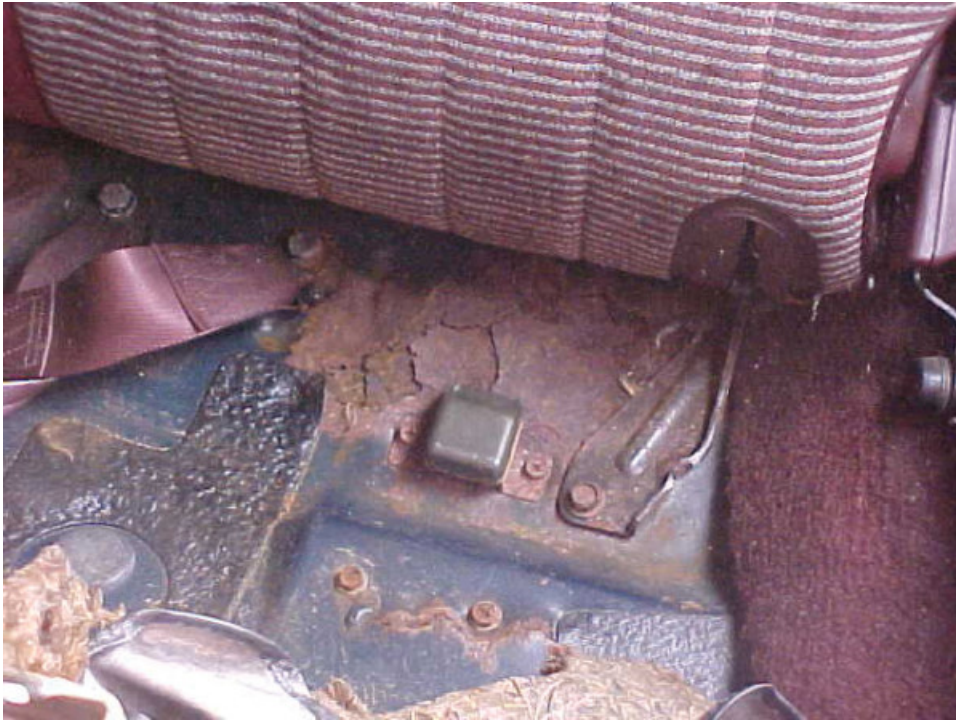
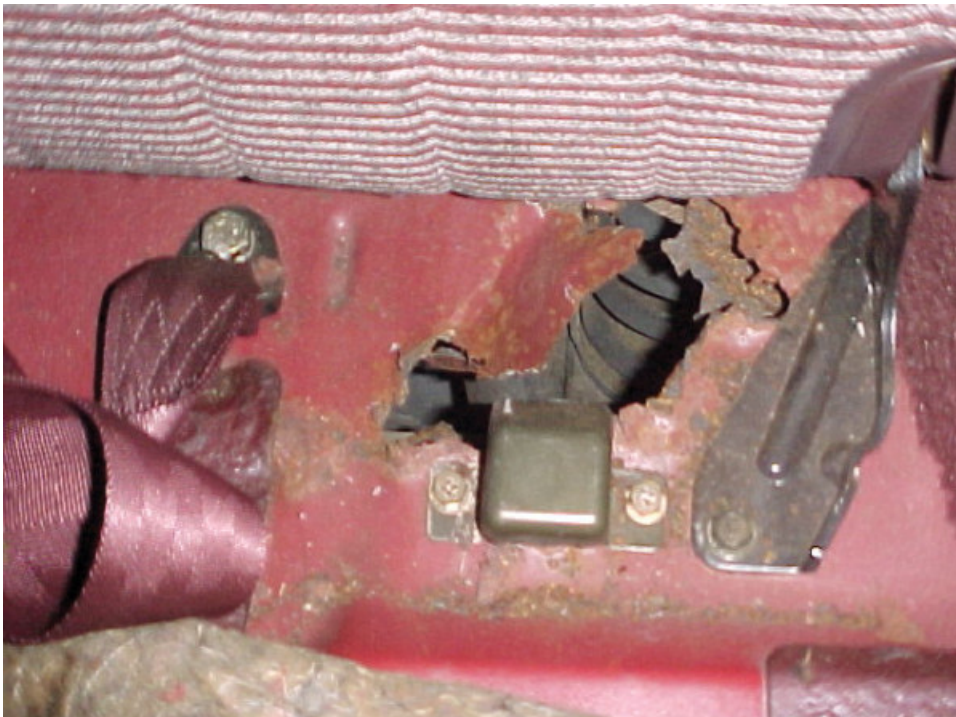
When inspecting Nissan Terranos or Mistrals always check for corrosion of the floor under the rear seat (examples are shown in the first three photos below).
