Extract taken from: Border inspection of imported used vehicles > Reference materials > Examples of major structural damage and corrosion > Corrosion which has resulted in perforation or flaking of the metal: Nissan Terrano and Mistral

5-10 Corrosion which has resulted in perforation or flaking of the metal: Nissan Terrano and Mistral

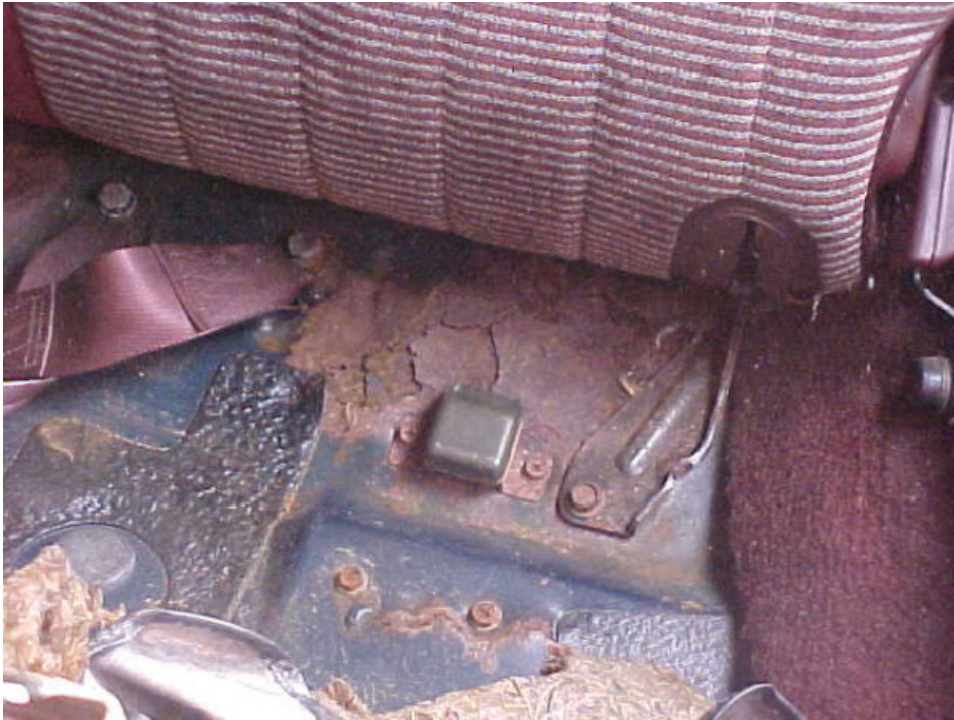
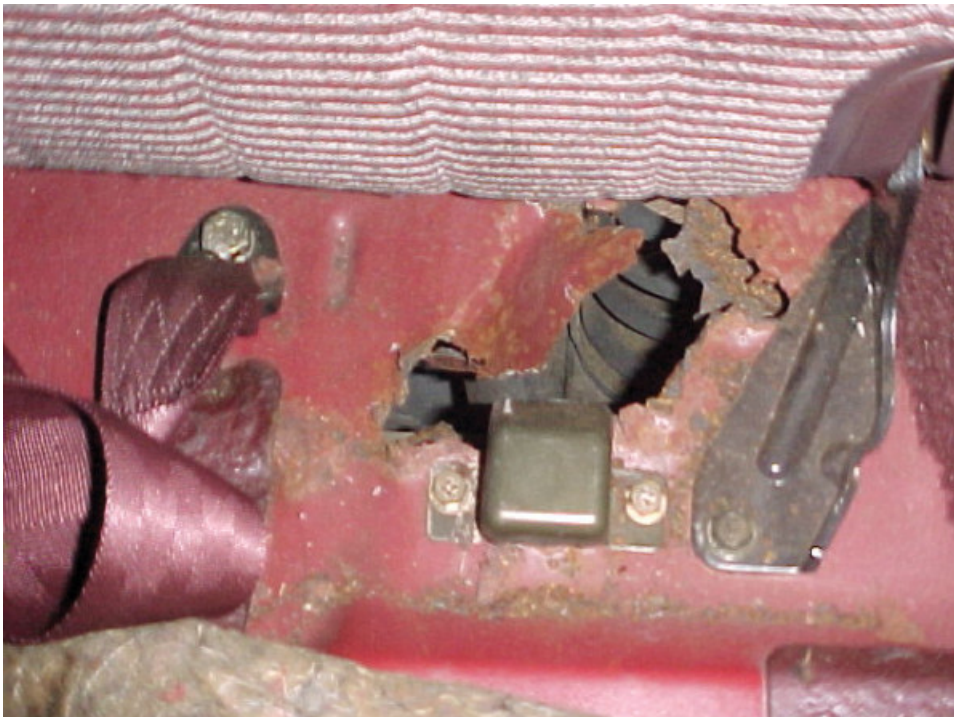
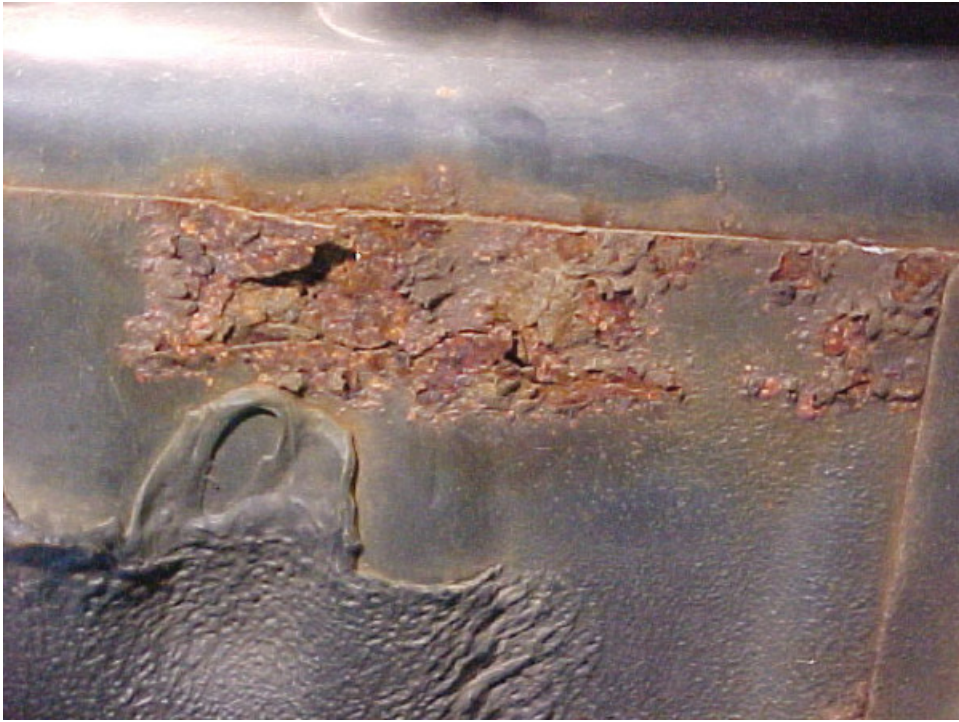
When inspecting Nissan Terranos or Mistrals always check for corrosion of the floor under the rear seat (examples are shown in the first three photos below).
