# WoF news

VEHICLE CERTIFICATION UNIT

May 2006 Issue 9

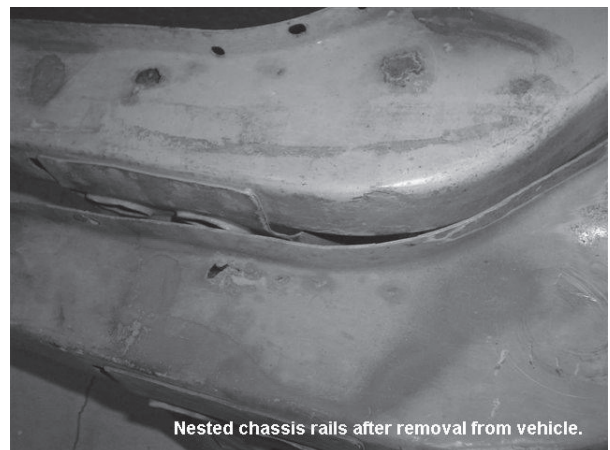
...keep an eye out for rusted chassis rails in 1997–99 VT Commodores. The AA is reporting an increase in this condition.

Below is a photo of rails from a couple of vehicles that had been removed as part of the repair. The perforation corrosion is quite obvious.
