# VIRM: In-service certification (WoF only) amendment

# 1 October 2023 amendment preview

September 2023

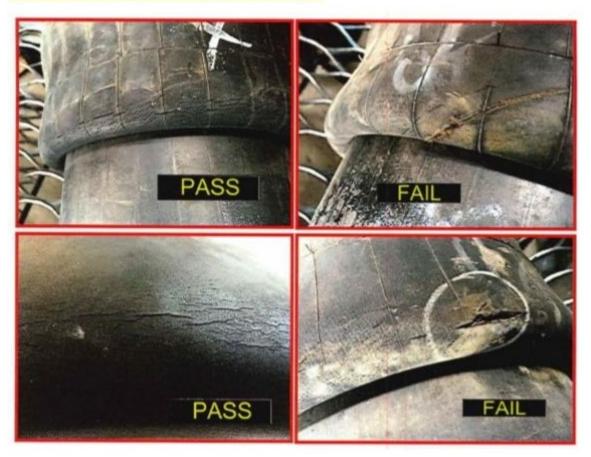
Figure 9-1-2. Sample air bag bellows images

- 8. A **lock stop** is loose, damaged or missing.
- 9. Air bag bellows has obvious external damage protruding or worn cords (Figure 9-1-2).

Note: Assessment to be conducted:

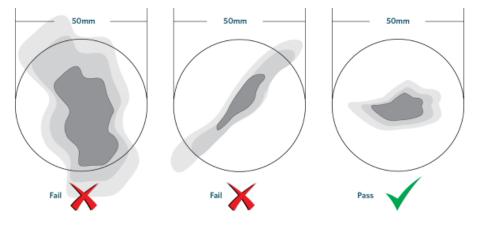
Figure 3-1-1. Corrosion or wood rotting damage 50mm diameter limit

- b) cracking (Note 3 1) (Figure 3-1-3), or
  - c) fracture, or
  - d) corrosion or wood rotting damage (Note 1 1) that is individually larger than 50mm in diameter (Figure 3-1-1), or

Corrosion or wood rotting damage is where the a metal or wooden structure has been eaten away, which is evident by and could be seen as bubbling, or pitting of the steel or by water damage, delamination or swelling of a wooden surface. The outward signs of such corrosion damage is typically displayed by the lifting, bubbling or discolouring of painted surfaces or bubbling of paint. In extreme cases, the area affected by the corrosion damage will fall out and leave a hole

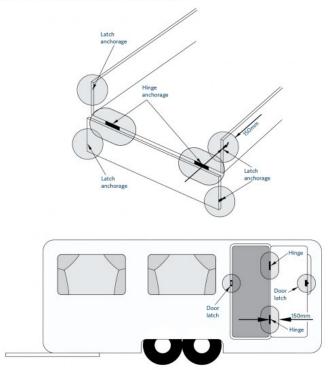
Figure 3-1-4. Hinge and latch anchorages

- 3. There is corrosion or wood rotting damage within 150mm of the hinge of a hinged panel (Figure 3-1-4).
- 4. There is corrosion or wood rotting damage within 150mm of the latch of a hinged panel (Figure 3-1-4).

No <del>corrosion</del> structural damage is allowed within 150mm of a circle around the outside of <del>hinge or latch components</del> a hinge, latch or load anchorage component.
