# VIRM: In-service certification (WoF only) amendment

## 1 April 2024 amendment preview

March 2024

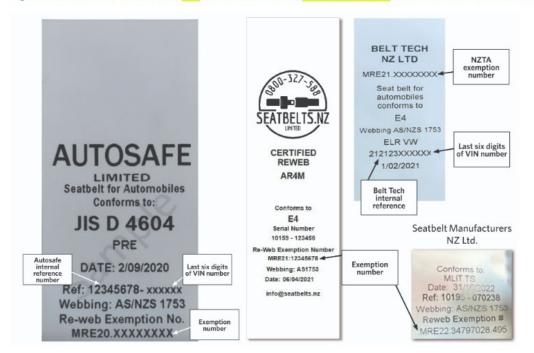
Figure 16-1-1. Sample Autosafe Ltd, Seatbelts NZ Ltd, Belt Tech NZ Ltd and Seatbelt Manufacturers NZ Ltd labels

To be compliant a re-webbed seatbelt **must** have a label with an exemption number (Figure 16-1-1) and either an exemption letter (paper copy in the vehicle) or be confirmed on the websites below.
