Extract taken from: Entry certification > Reference materials > Examples of major structural damage and corrosion > Under-body damage: crushing of floor pan stiffening members

71-1 Under-body damage: crushing of floor pan stiffening members

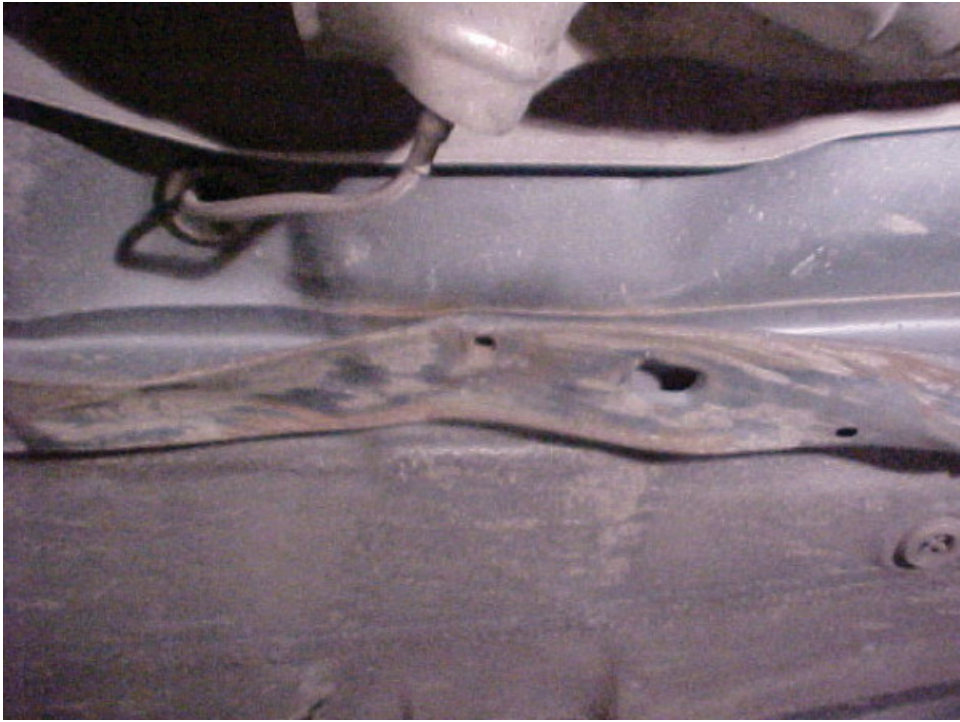
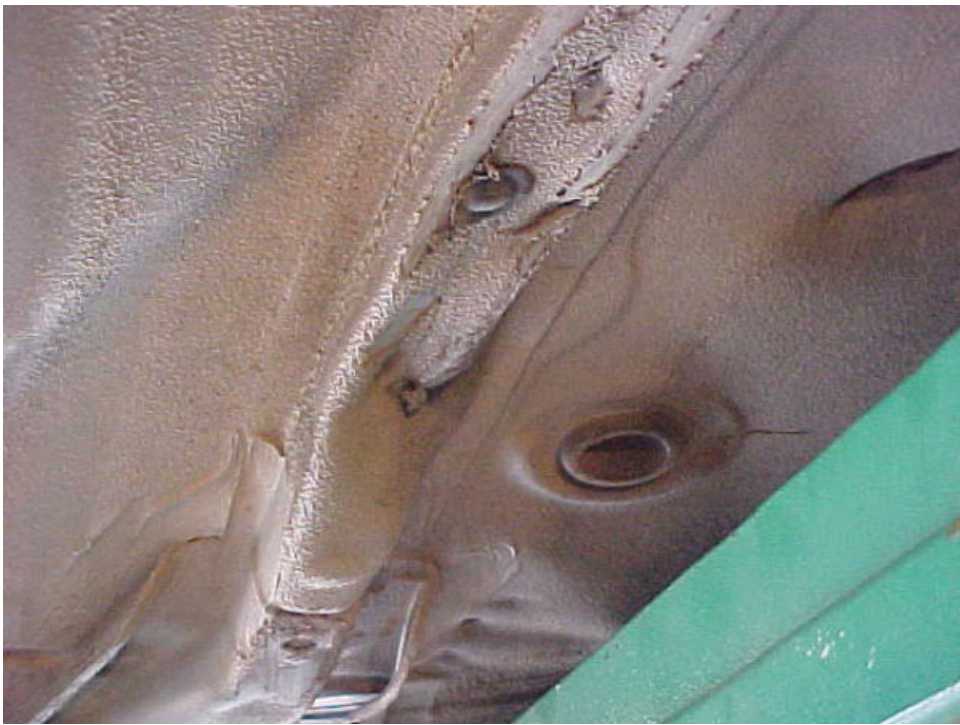
The damage in these images **must be flagged for damage.**

Where it's determined that the damage is non-structural, and there's no other damage requiring an LT308, the repair certifier will issue an LT307.
