**Extract taken from:** Entry certification > Reference materials > Examples of major structural damage and corrosion > Under-body damage: crushing of floor pan stiffening members

## 71-1 Under-body damage: crushing of floor pan stiffening members

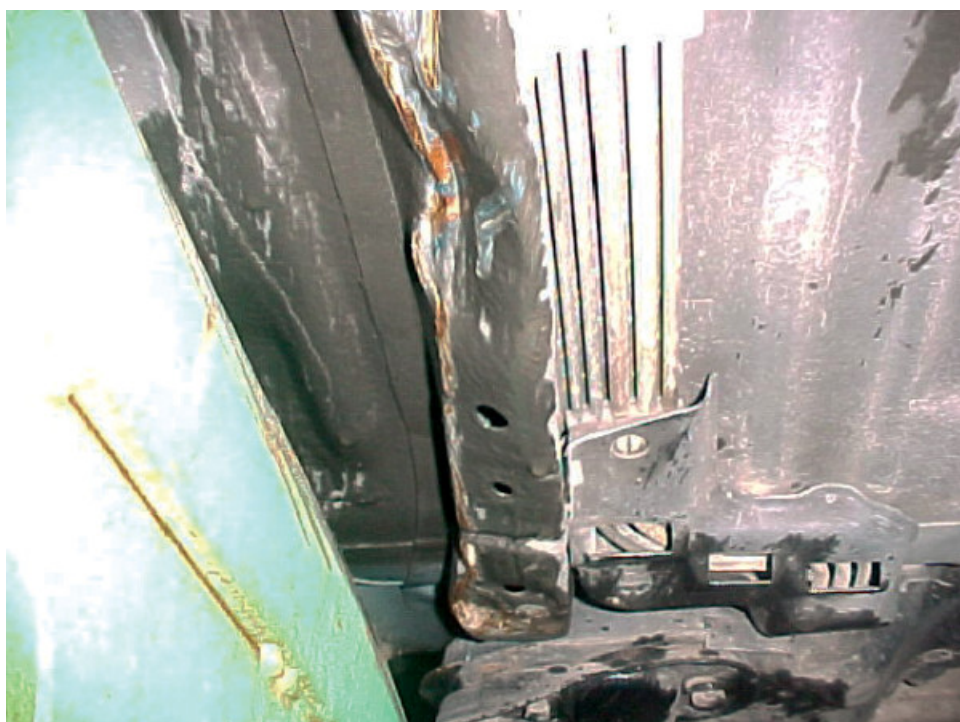
The damage in these images **must be flagged for damage.**

Where it's determined that the damage is non-structural, and there's no other damage requiring an LT308, the repair certifier will issue an LT307.
