**Extract taken from:** Entry certification > Reference materials > Examples of major structural damage and corrosion > Under-body damage: crushing of floor pan stiffening members

## 71-1 Under-body damage: crushing of floor pan stiffening members

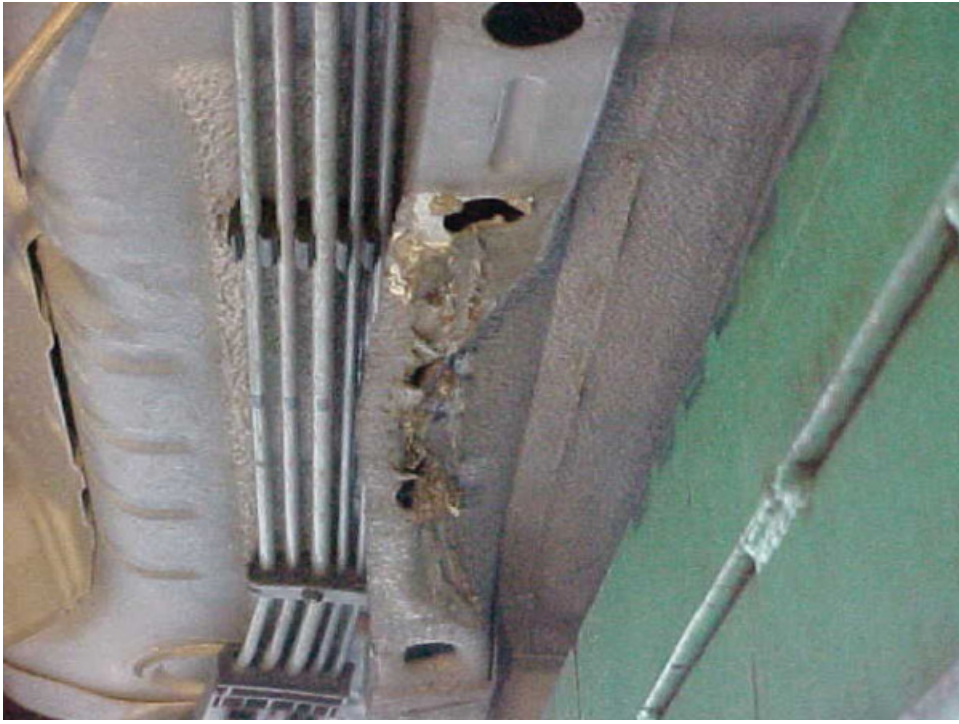
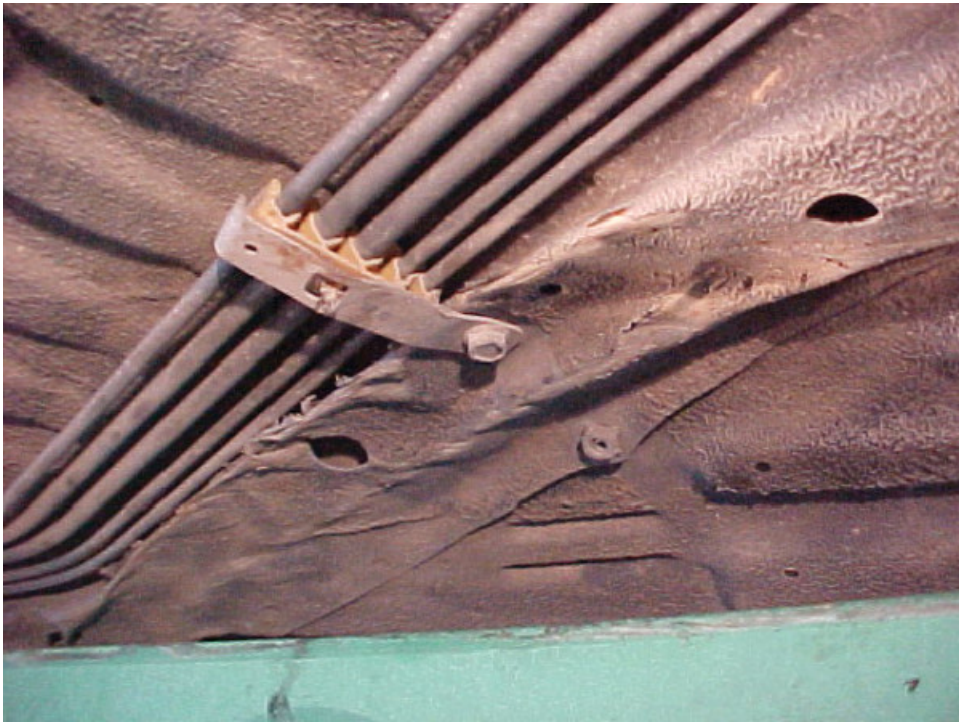
The damage in these images **must be flagged for damage.**

Where it's determined that the damage is non-structural, and there's no other damage requiring an LT308, the repair certifier will issue an LT307.
