Extract taken from: Border inspection of imported used vehicles > Reference materials > Examples of major structural damage and corrosion > Under-body damage: crushing of floor pan stiffening members

5-1 Under-body damage: crushing of floor pan stiffening members

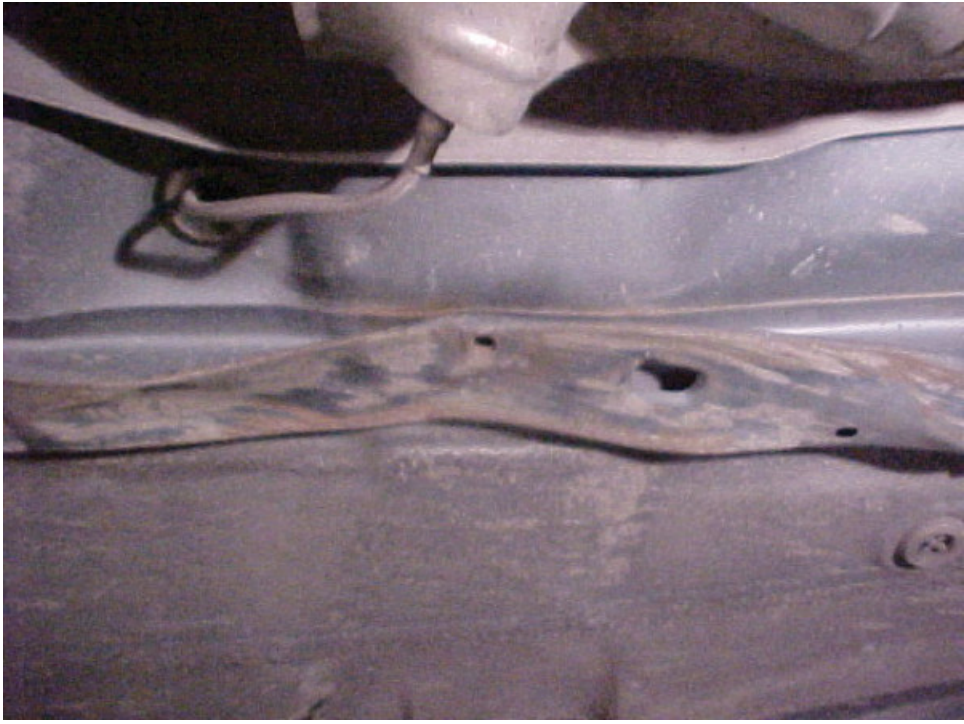
The damage in these images **must be flagged for damage.**

Where it's determined that the damage is non-structural, and there's no other damage requiring an LT308, the repair certifier will issue an LT307.
