Extract taken from: Border inspection of imported used vehicles > Reference materials > Examples of major structural damage and corrosion > Distortion to longitudinal rails: front and rear crush zones

5-7 Distortion to longitudinal rails: front and rear crush zones

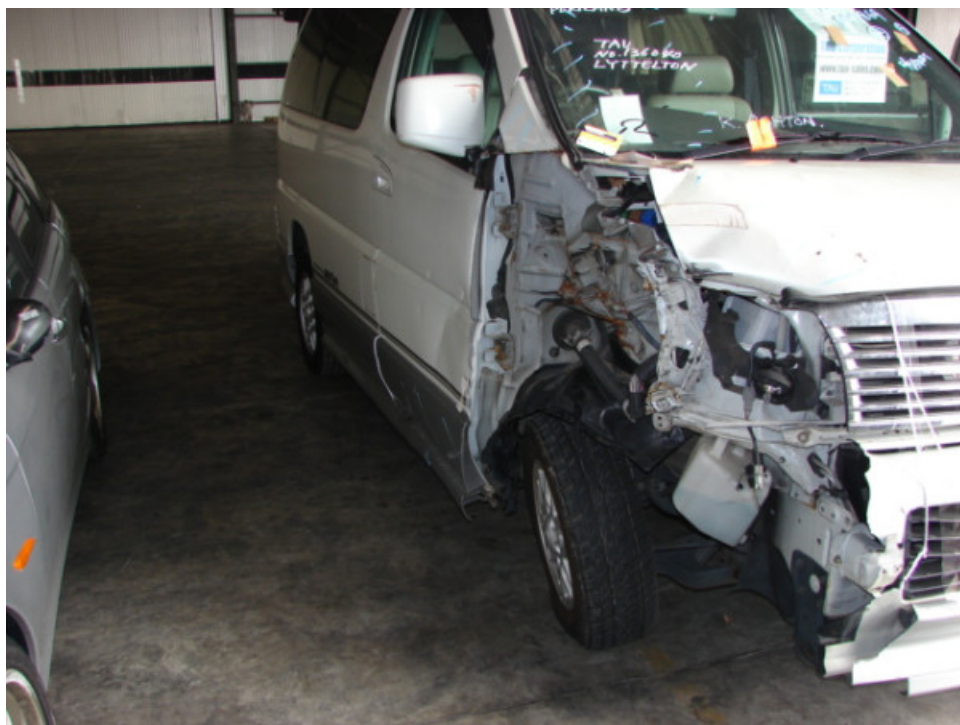
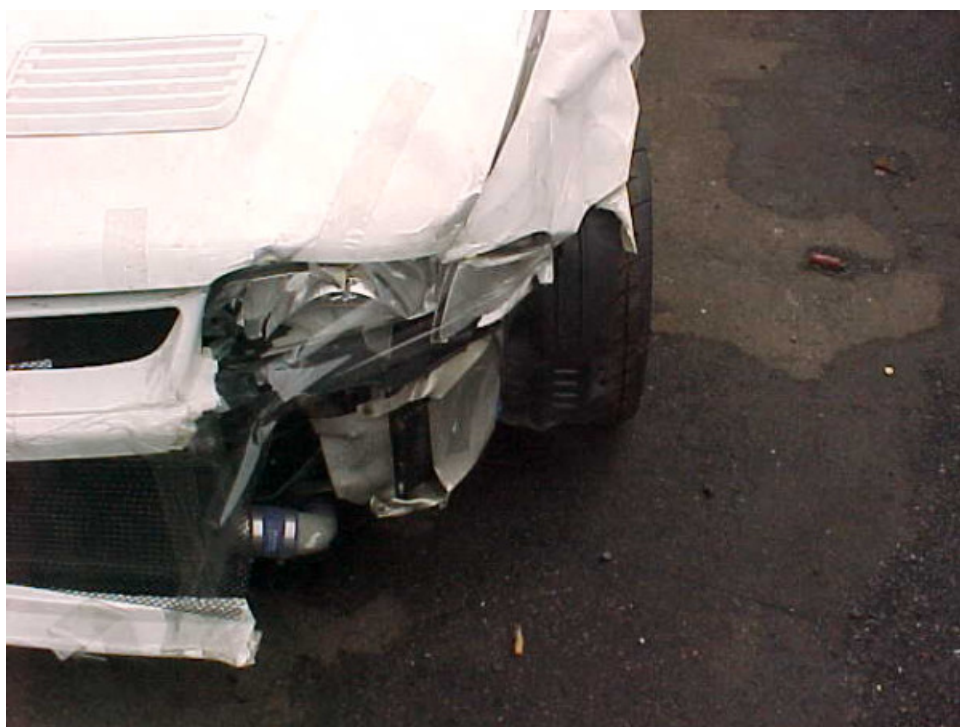
Distortion to longitudinal rails: front and rear crush zones
