Extract taken from: In-service certification (WoF and CoF) > General trailers > Vehicle structure

3 Vehicle structure

3-1 Structure

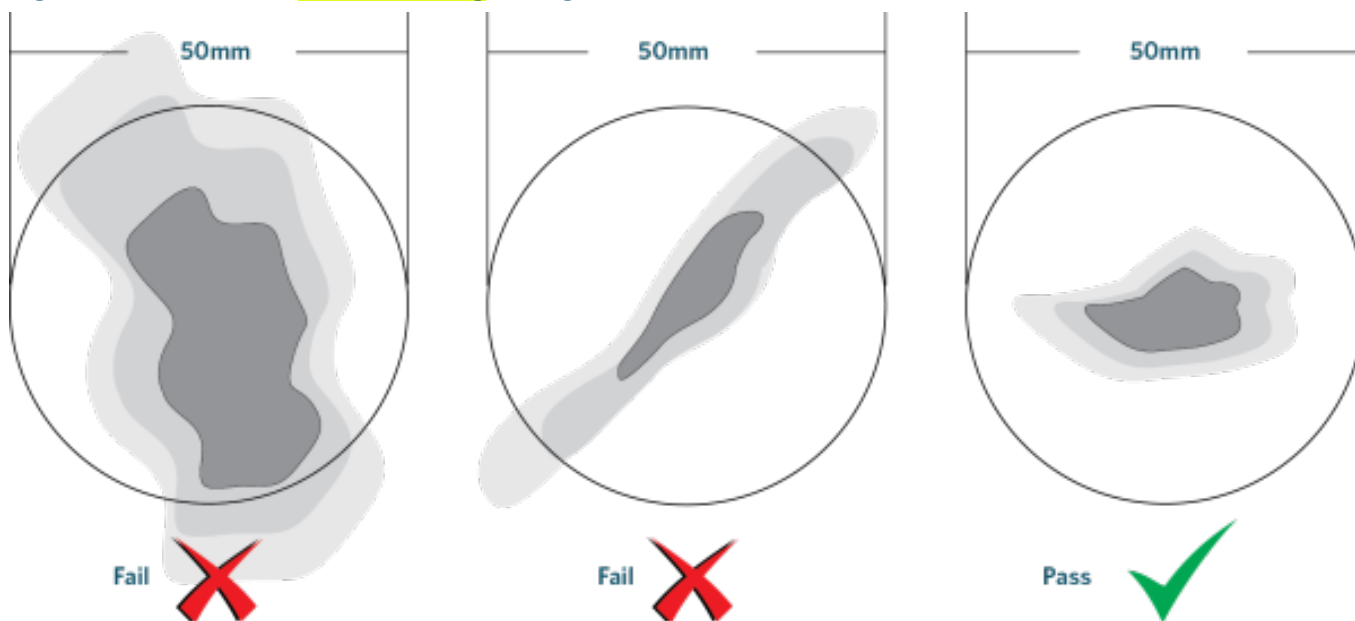
Figure 3-1-1. Corrosion or wood rotting damage 50mm diameter limit

- b) cracking (Note 3) (Figure 3-1-3), or
 - c) fracture, or
 - d) corrosion **or wood rotting** damage (Note 1) that is individually larger than 50mm in diameter (Figure 3-1-1), or

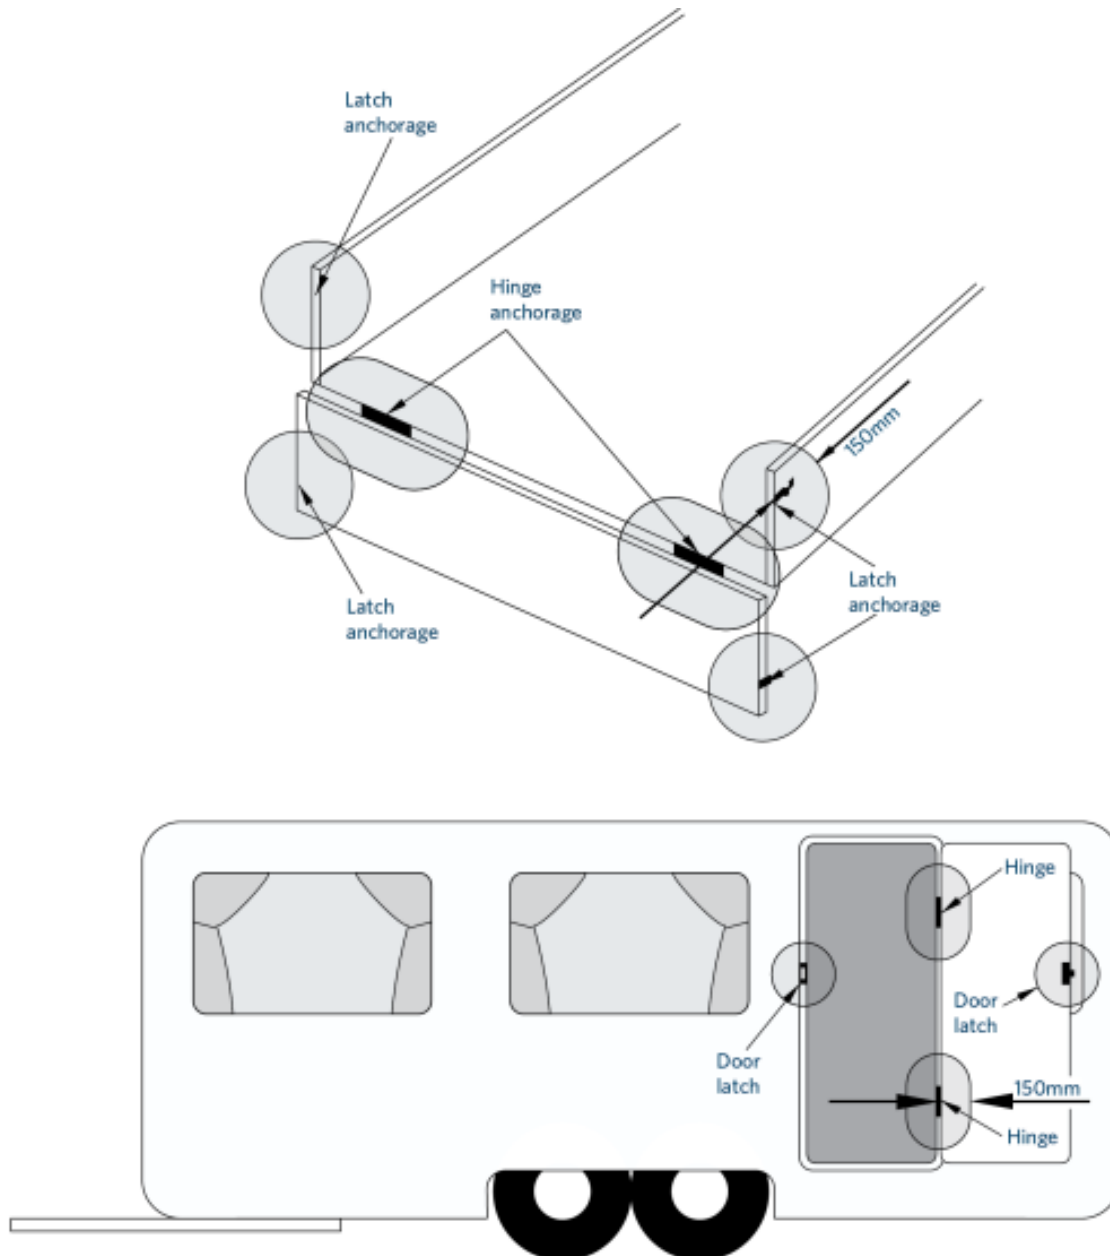
Figure 3-1-4. Hinge and latch anchorages

3. There is corrosion **or wood rotting** damage within 150mm of the hinge of a hinged panel (Figure 3-1-4).
4. There is corrosion **or wood rotting** damage within 150mm of the latch of a hinged panel (Figure 3-1-4).

No structural damage is allowed within 150mm of a circle around the outside of a hinge, latch or load anchorage component.

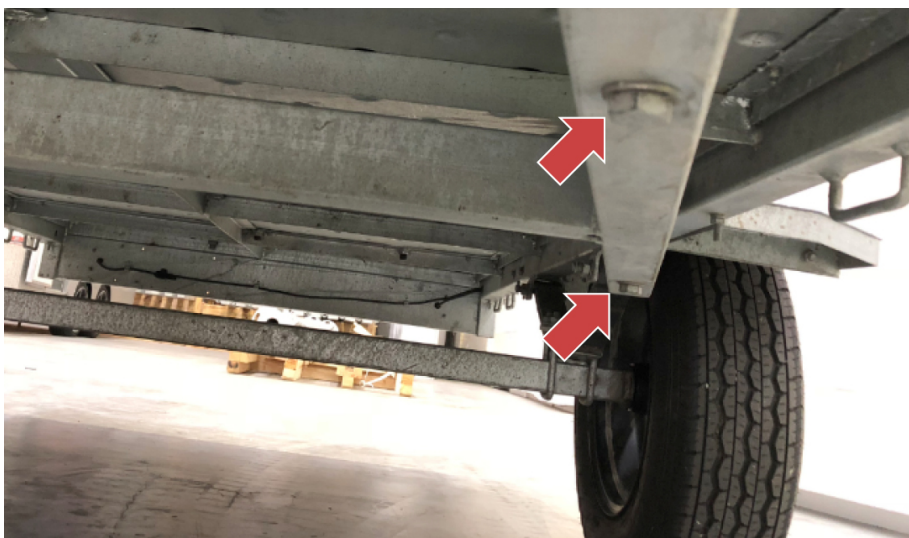
Bolted through drawbar attachment to trailer

5. A hinged panel does not remain secure in a closed or locked position.
6. The trailer is an unrepaired Trailpro 8x4 Tradesman (model number TP5) or a Trailpro 8x5 Tandem (model number TP8), with a bolt-through drawbar attachment (these trailers are subject to safety recall) (Note 4). See Figure 3-1-5 for advice on identifying these trailers. See Figure 3-1-6 and Figure 3-1-7 for advice on identifying repaired Trailpro trailers.

The identification tag may be missing, faded, damaged or obscured. All Trailpro models have drawbars that are **bolted rather than welded** to the trailer. The TP5 has a single axle and a tray size of 8'x4' (2.4m x 1.2m). The TP8 is a tandem axle model with a tray size of 8'x5' (2.4m x 1.5m).

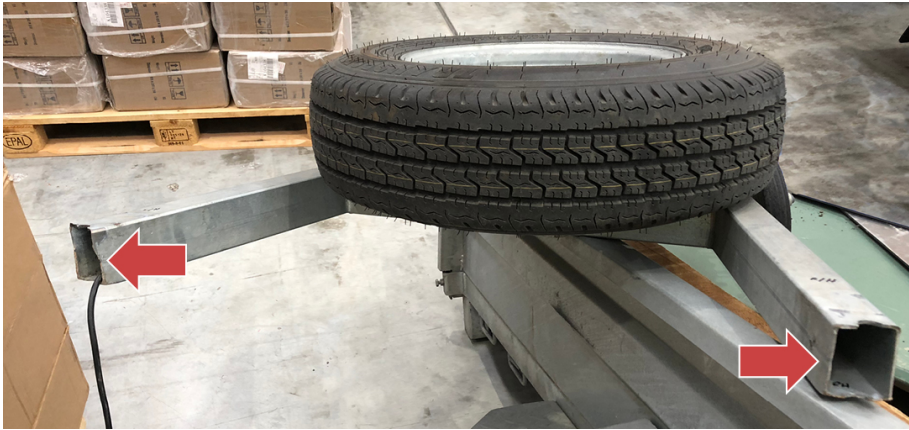
Broken drawbar (sitting on trailer)

There is a safety risk with the Trailpro brand of light trailers which were sold through Bunnings NZ between 1 January 2006 and 12 October 2018. Bunnings is now recalling all Trailpro trailers, other than Trailpro 8x4 Tradesman (TP5) or 8x5 Tandem (TP8) models that have undergone Bunnings-approved repairs as part of an earlier recall. These can be identified by the serial number on the identification plate ending with an “R” (see Figure 3-1-6). A TP5 or TP8 trailer with a serial number ending with an “R” may be issued a WoF if it passes all other checks. More information can be found in the [safety recall notice](#) on the Transport Agency website.
