Extract taken from: Entry certification > Reference materials > Examples of major structural damage and corrosion

71 Examples of major structural damage and corrosion

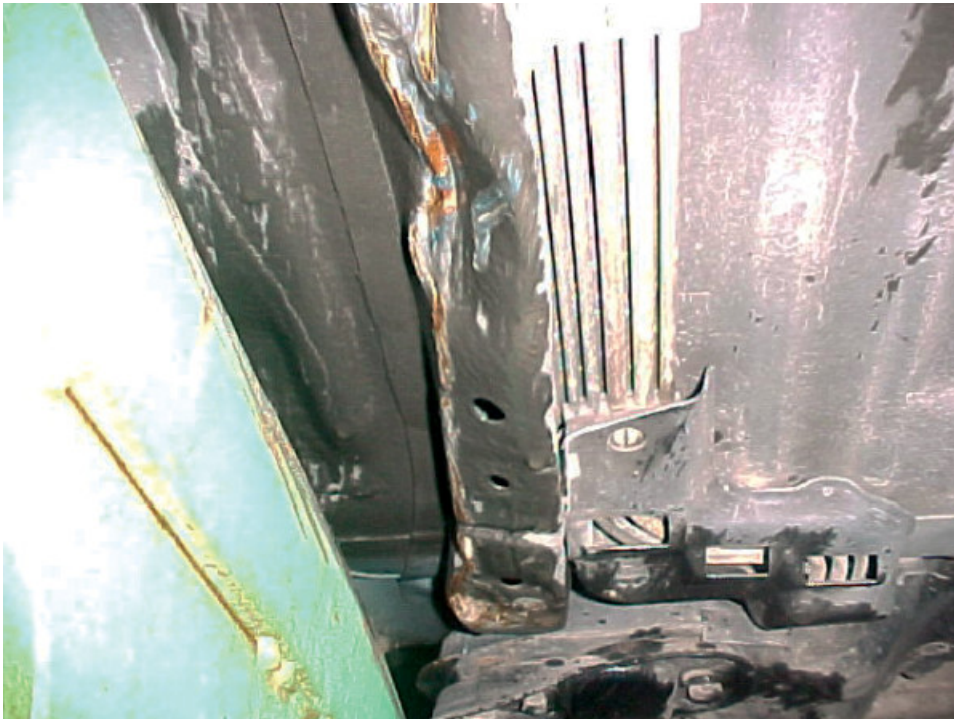
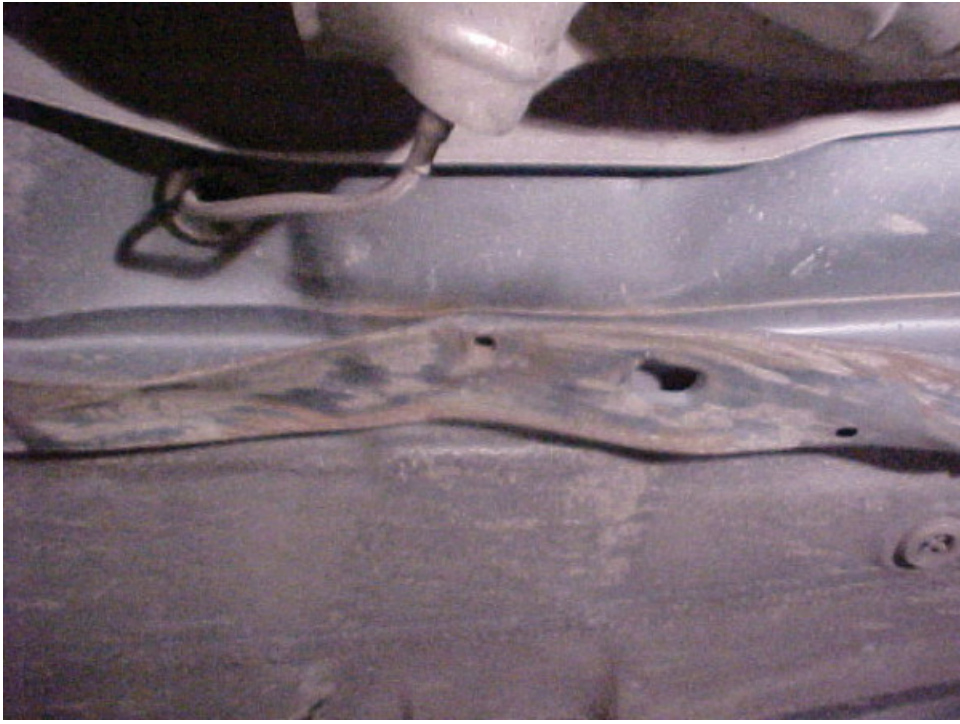
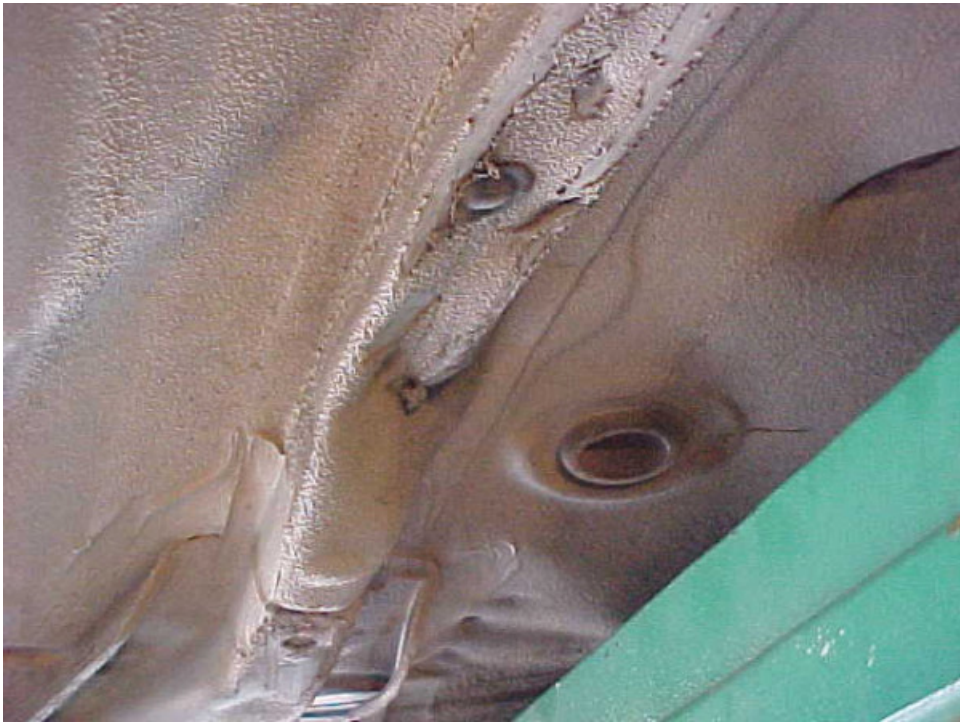
71-1 Under-body damage: crushing of floor pan stiffening members

The damage in these images **must be flagged for damage.**

Where it's determined that the damage is non-structural, and there's no other damage requiring an LT308, the repair certifier will issue an LT307.

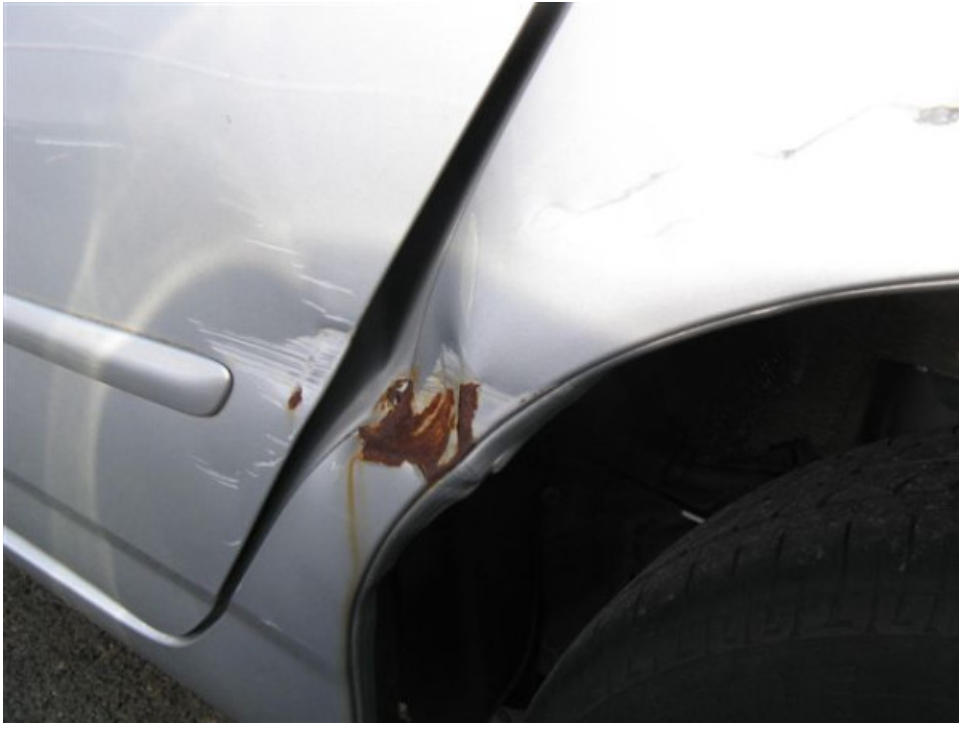
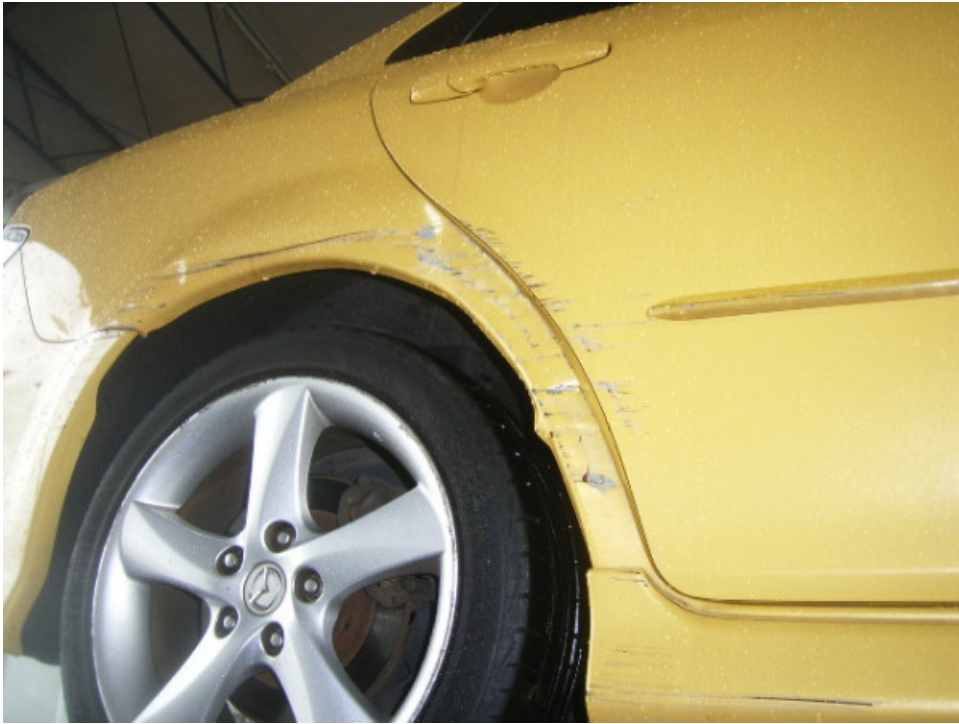
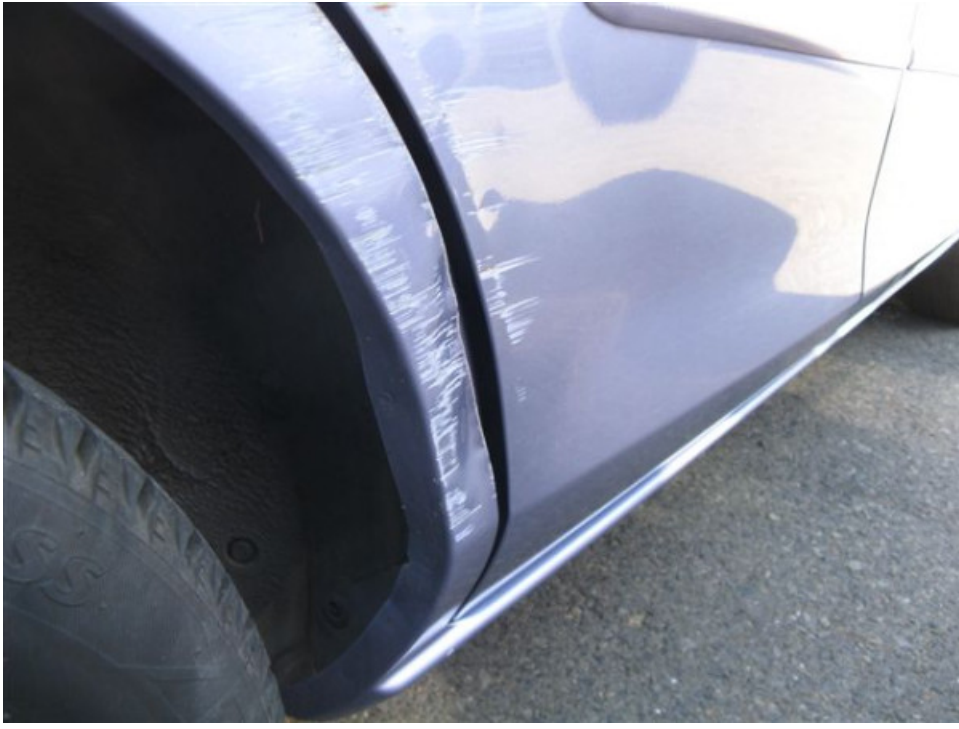
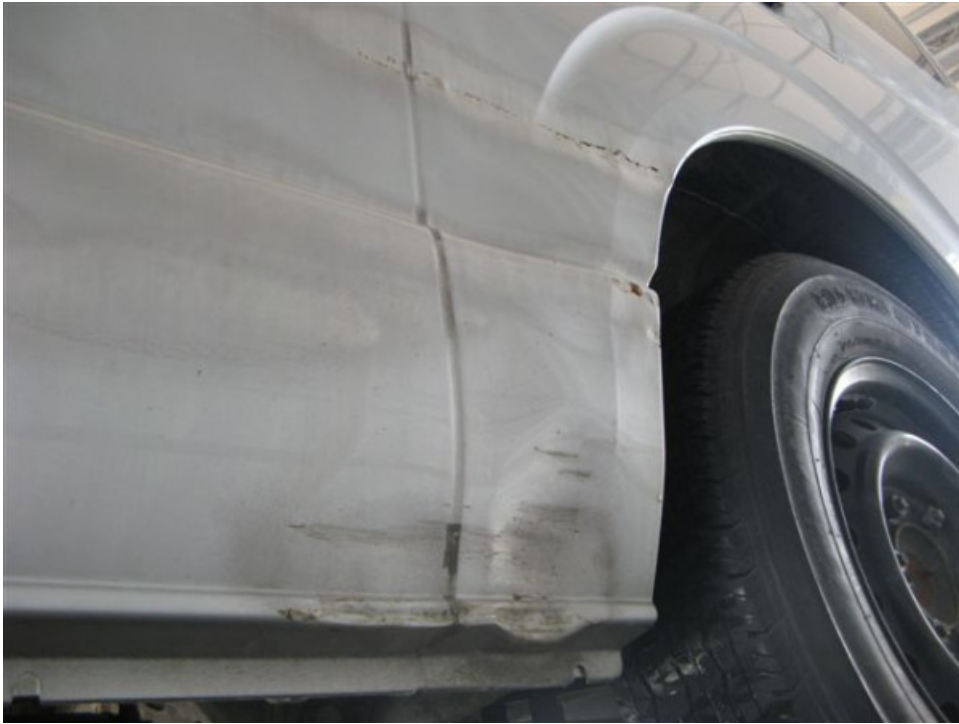
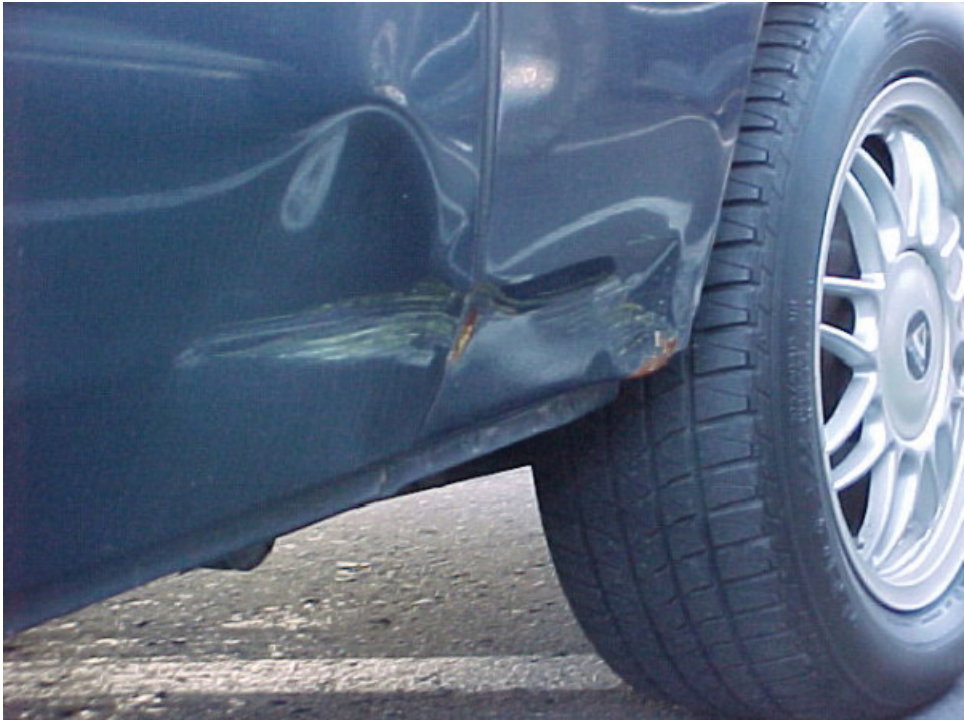
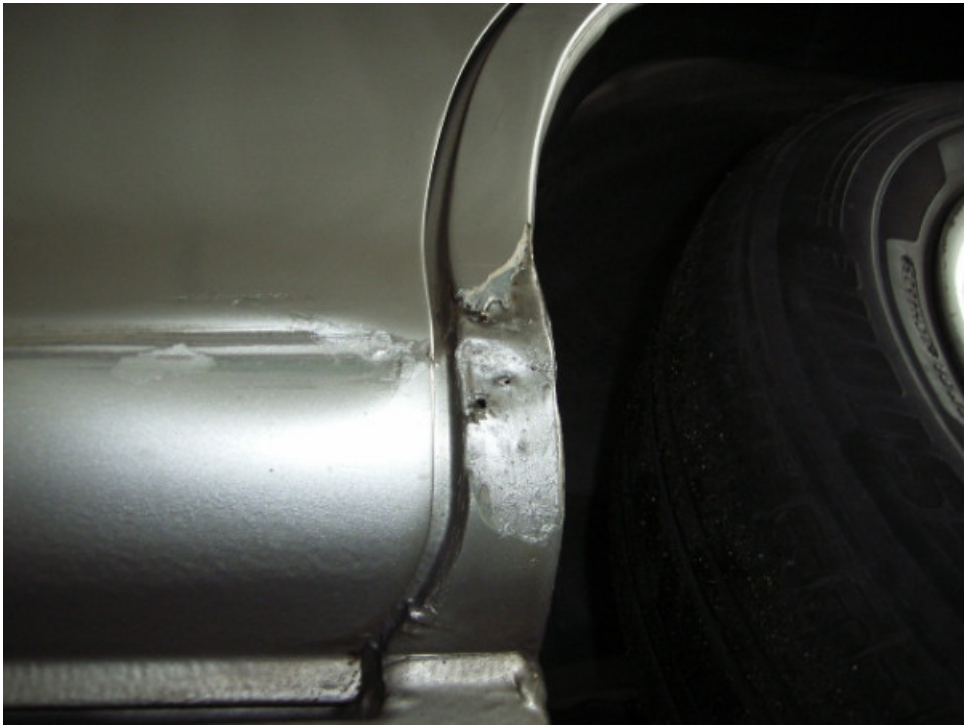
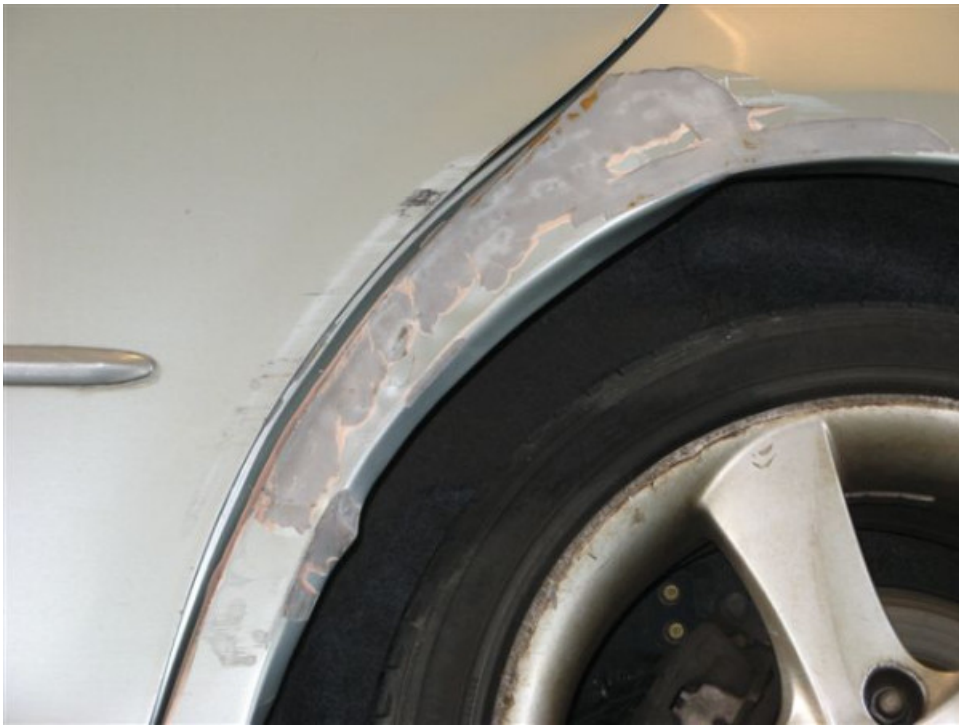
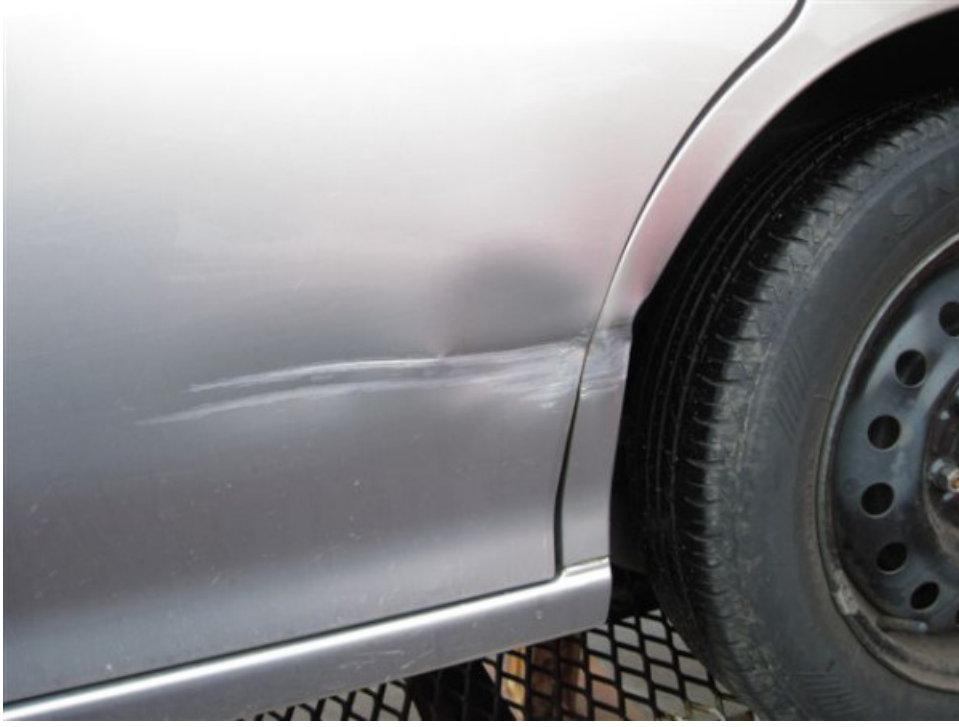
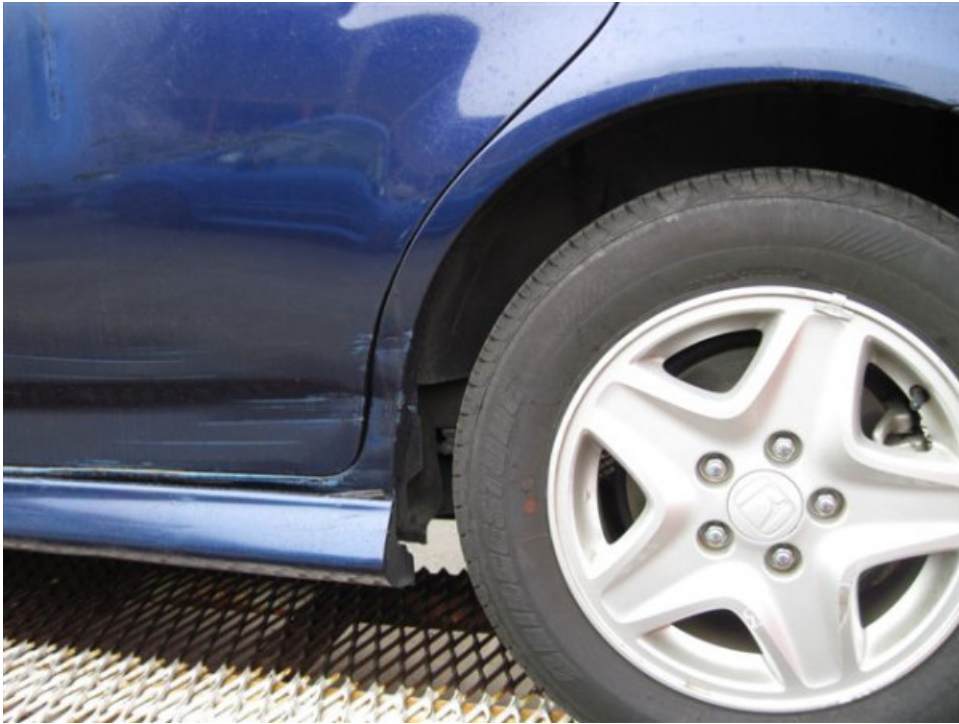
71-6 Dogleg flag

Look for discrepancies in the door gap.

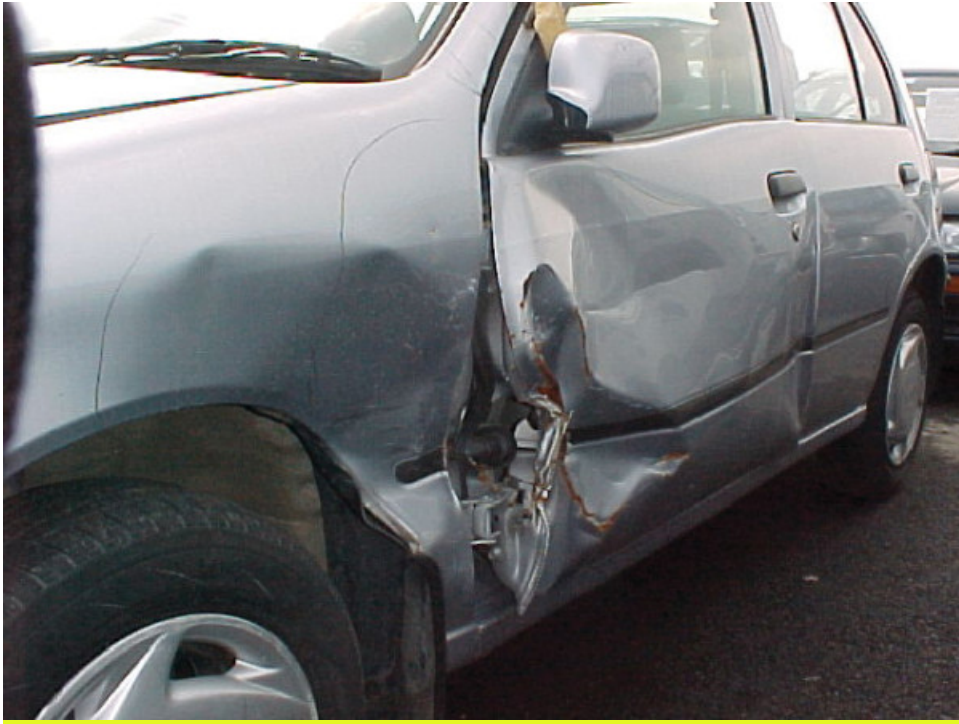
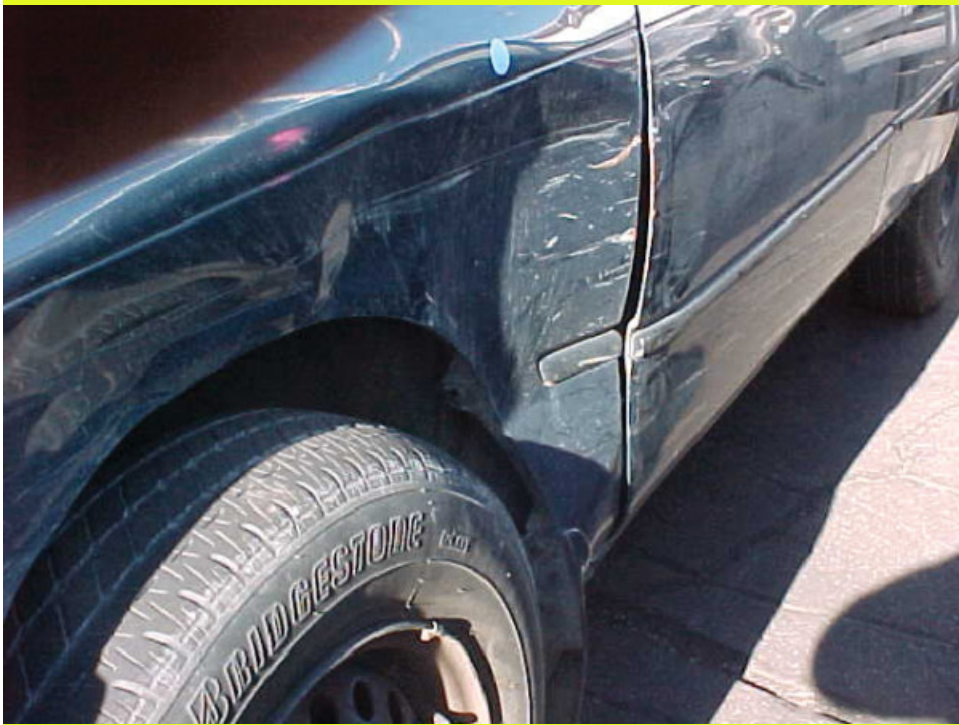
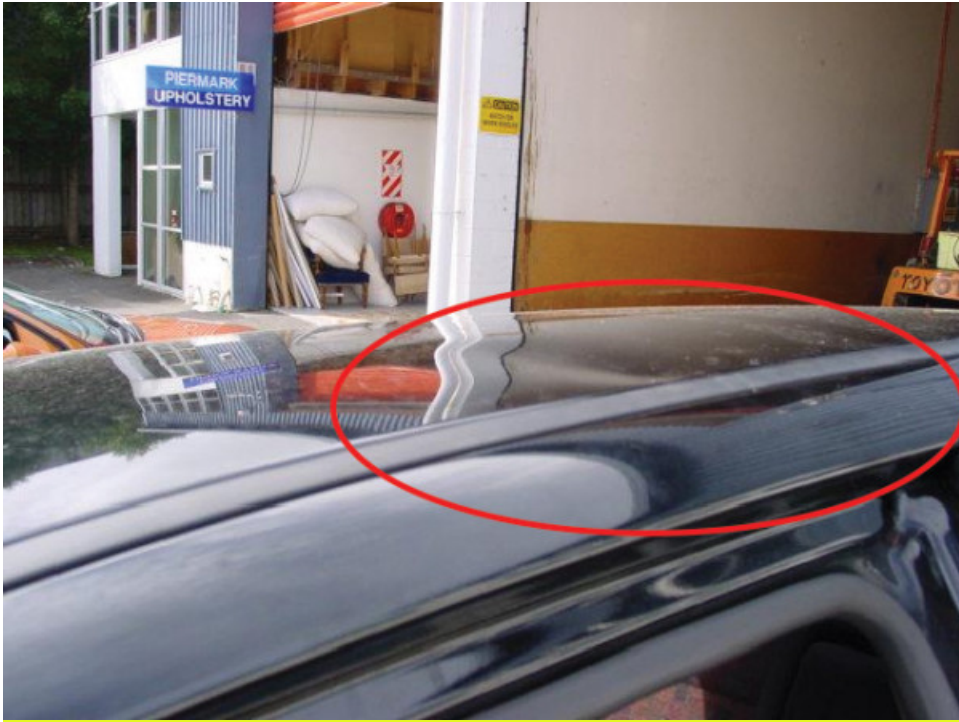
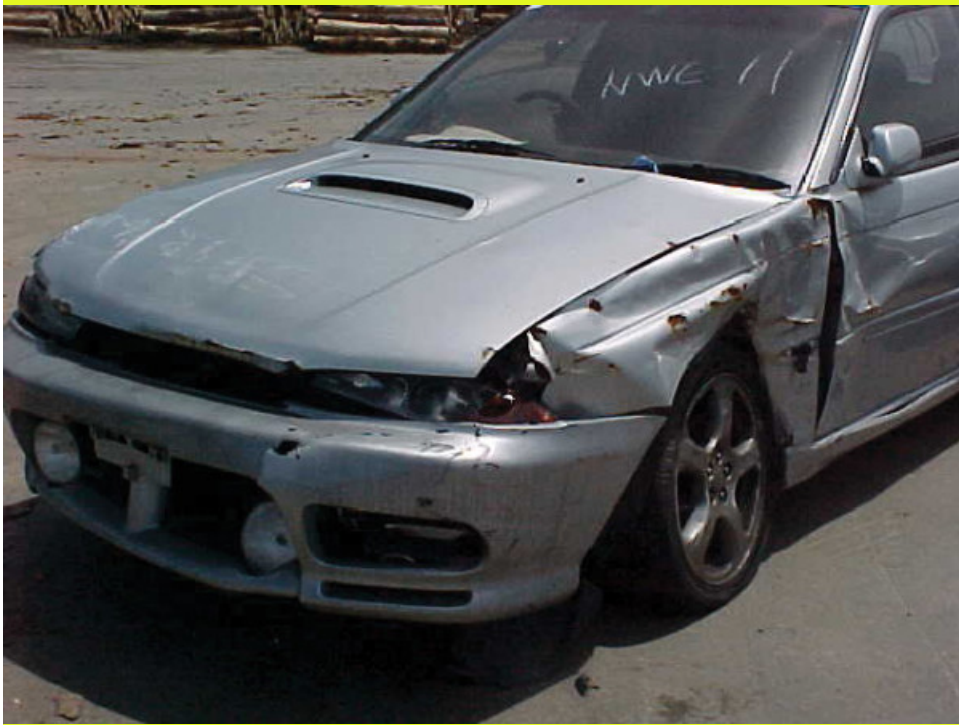
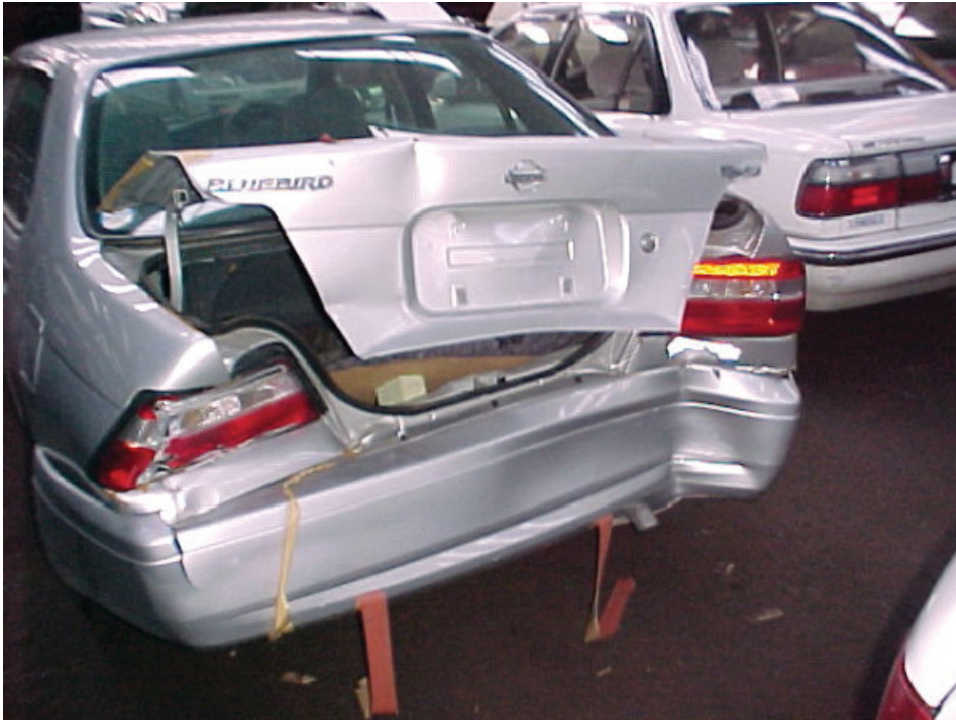
71-9 Damage to the vehicle's outer body panels: seam or joint integrity

Damage to the vehicle's outer body panels which affect the integrity of any of the seams or joints installed by the vehicle manufacturer (and may have also caused secondary damage - further inspection may be required)

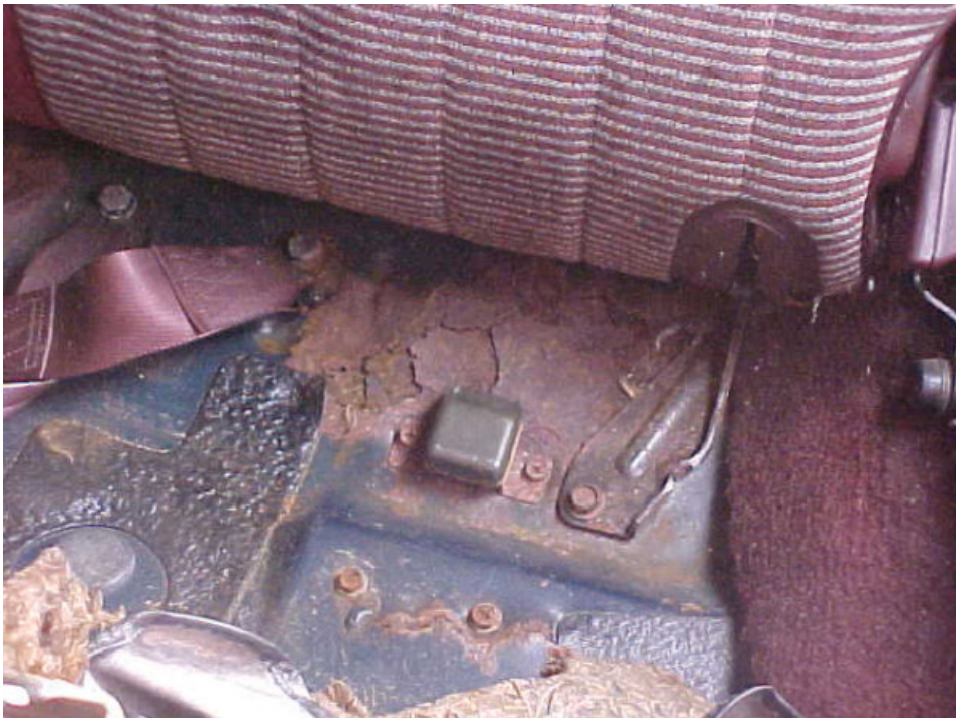
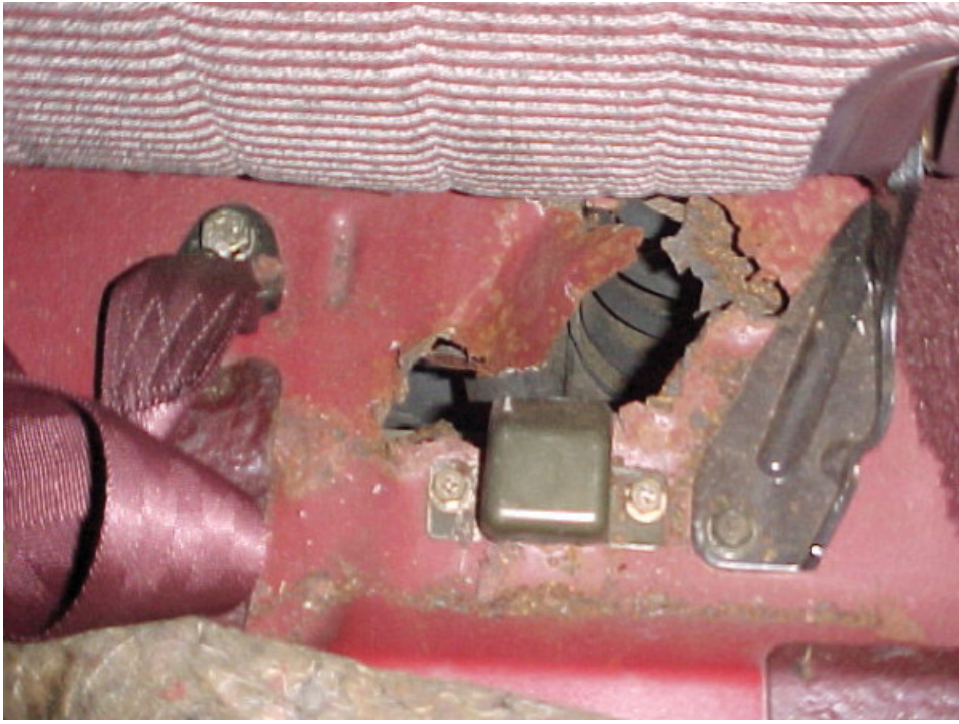
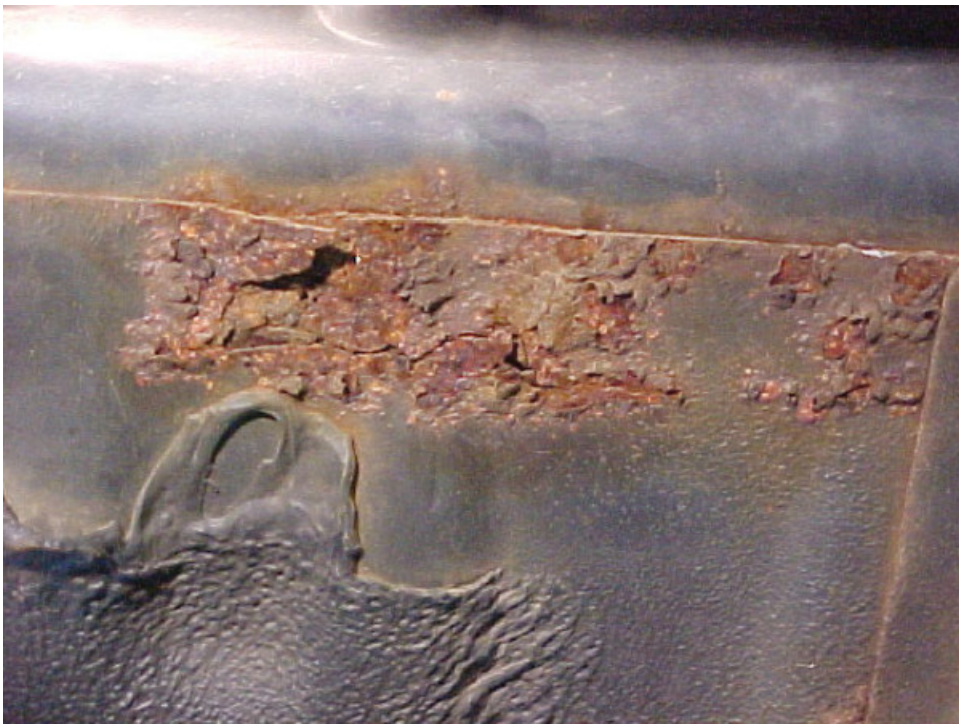
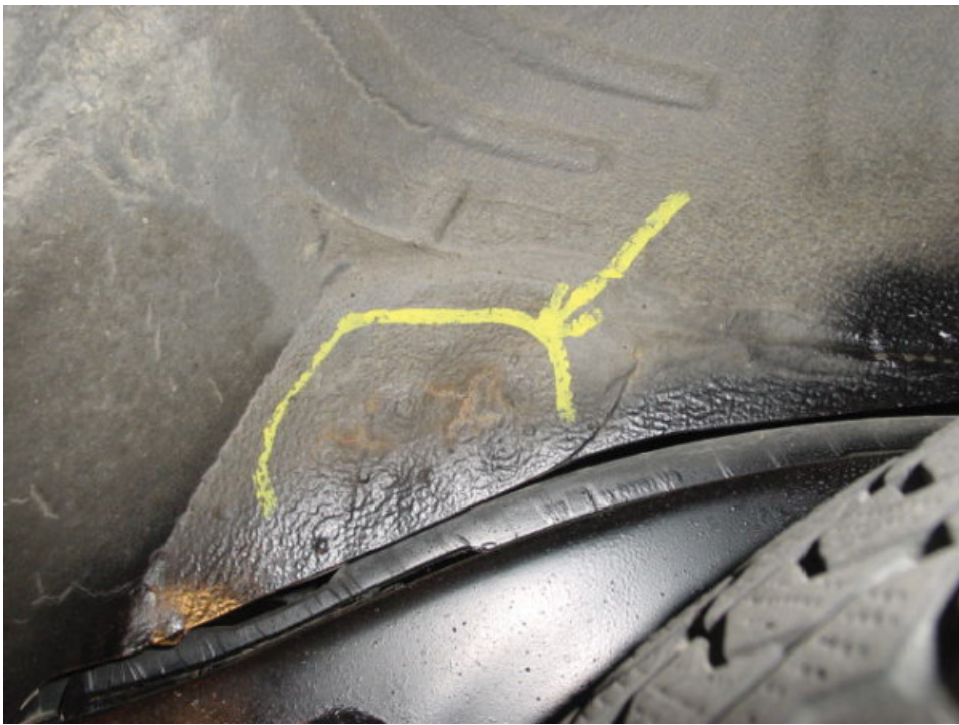
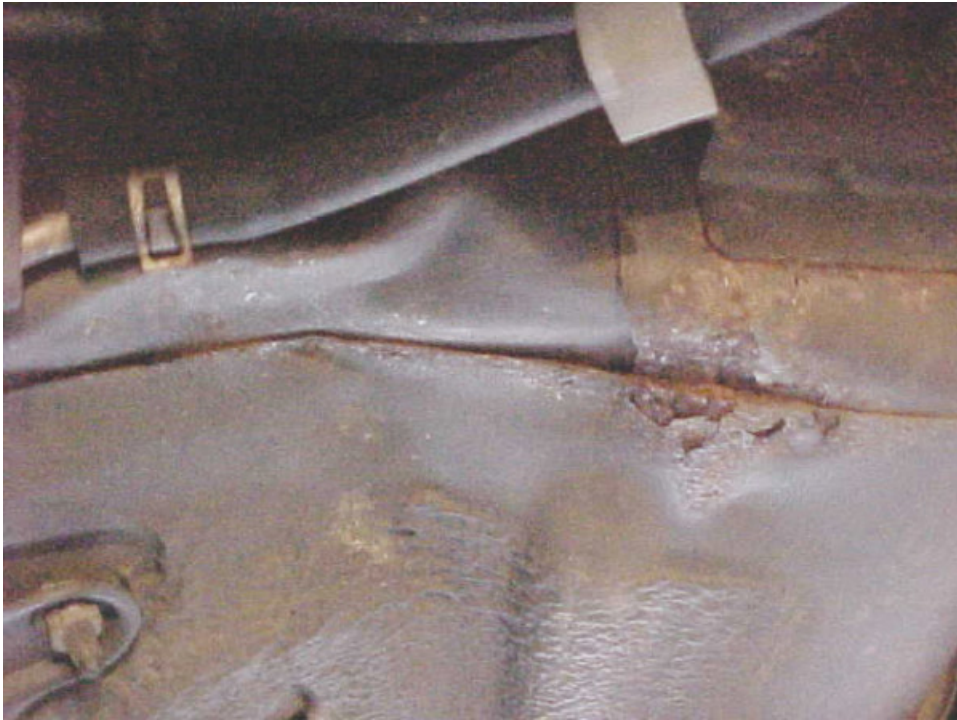
71-10 Corrosion which has resulted in perforation or flaking of the metal: Nissan Terrano and Mistral

When inspecting Nissan Terranos or Mistrals always check for corrosion of the floor under the rear seat (examples are shown in the first three photos below).
