Extract taken from: Entry certification > Reference materials > Examples of major structural damage and corrosion

71 Examples of major structural damage and corrosion

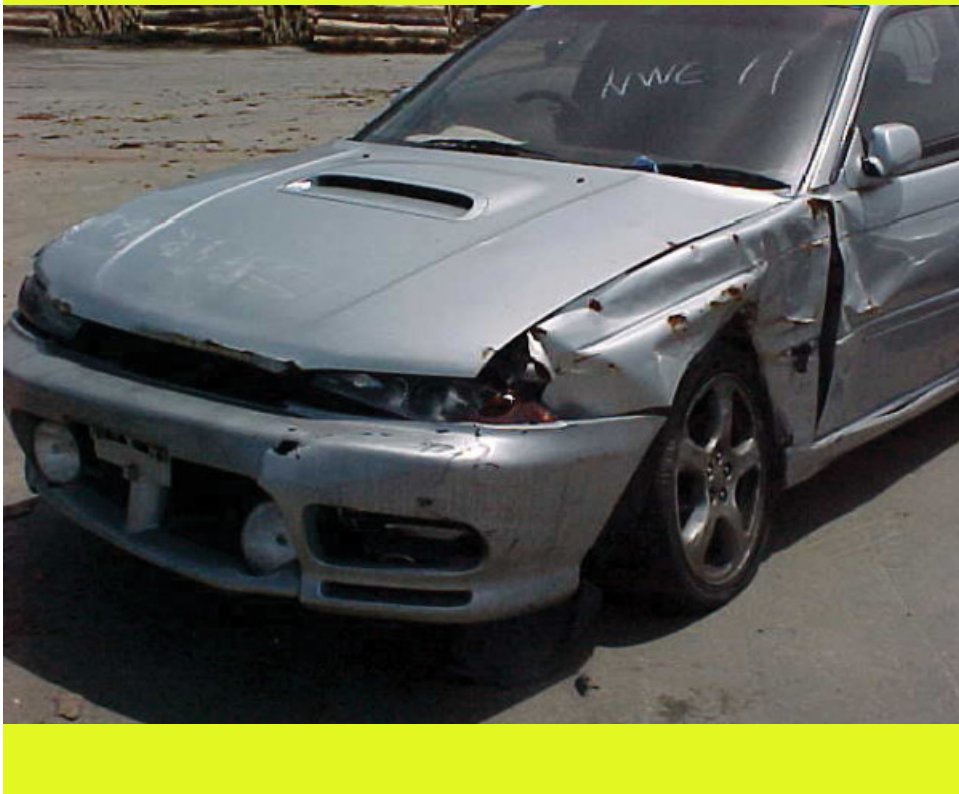
71-9 Damage to the vehicle's outer body panels: seam or joint integrity

Damage to the vehicle's outer body panels which affect the integrity of any of the seams or joints installed by the vehicle manufacturer (and may have also caused secondary damage - further inspection may be required)

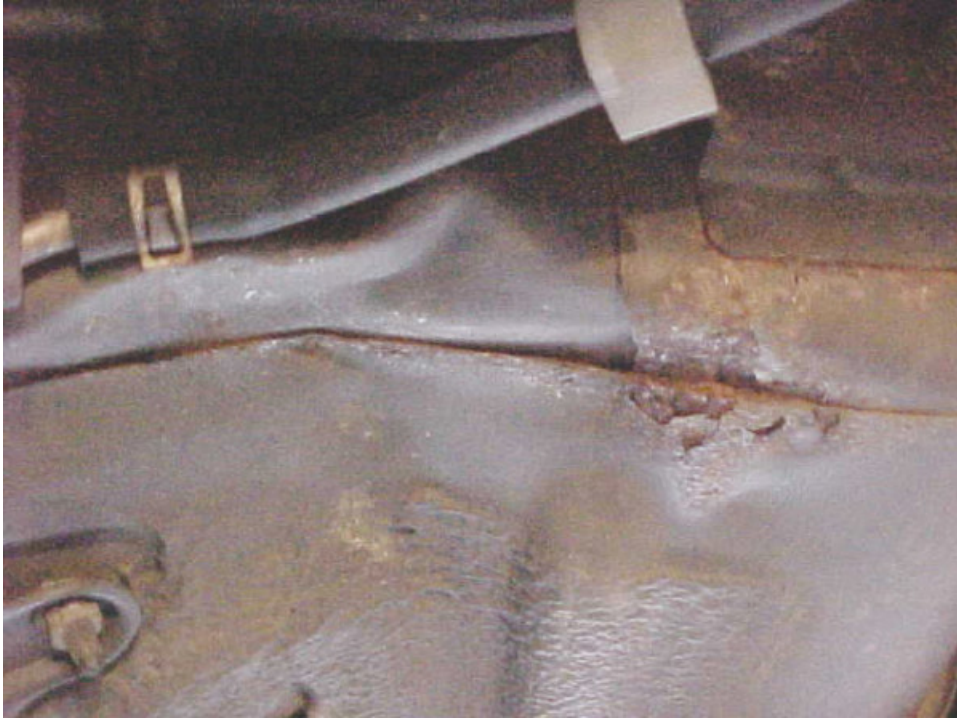
71-10 Corrosion which has resulted in perforation or flaking of the metal: Nissan Terrano and Mistral

When inspecting Nissan Terranos or Mistrals always check for corrosion of the floor under the rear seat (examples are shown in the first three photos below).
