Extract taken from: In-service certification (WoF and CoF) > General trailers > Vehicle structure > Structure

3-1 Structure

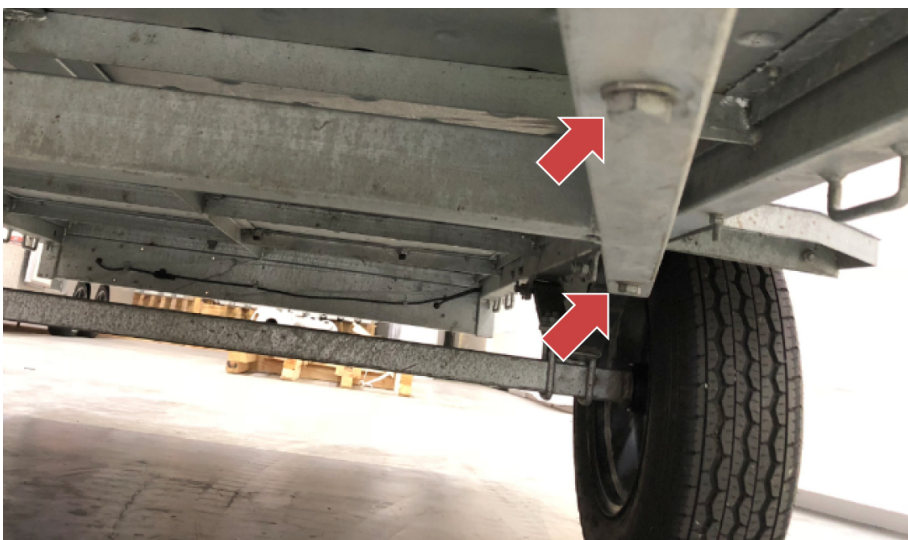
Bolted through drawbar attachment to trailer

There is a safety risk with the Trailpro brand of light trailers which were sold through Bunnings NZ between 1 January 2006 and 12 October 2018. Bunnings is now recalling all Trailpro trailers, other than Trailpro 8x4 Tradesman (TP5) or 8x5 Tandem (TP8) models that have undergone Bunnings-approved repairs as part of an earlier recall. These can be identified by the serial number on the identification plate ending with an “R” (see Figure 3-1-6). A TP5 or TP8 trailer with a serial number ending with an “R” may be issued a WoF if it passes all other checks. More information can be found in the [safety recall notice](#) on the Transport Agency website.

The identification tag may be missing, faded, damaged or obscured. All Trailpro models have drawbars that are **bolted rather than welded** to the trailer. The TP5 has a single axle and a tray size of 8'x4' (2.4m x 1.2m). The TP8 is a tandem axle model with a tray size of 8'x5' (2.4m x 1.5m).
