Extract taken from: In-service certification (WoF and CoF) > General trailers > Vehicle structure > Structure

## 3-1 Structure

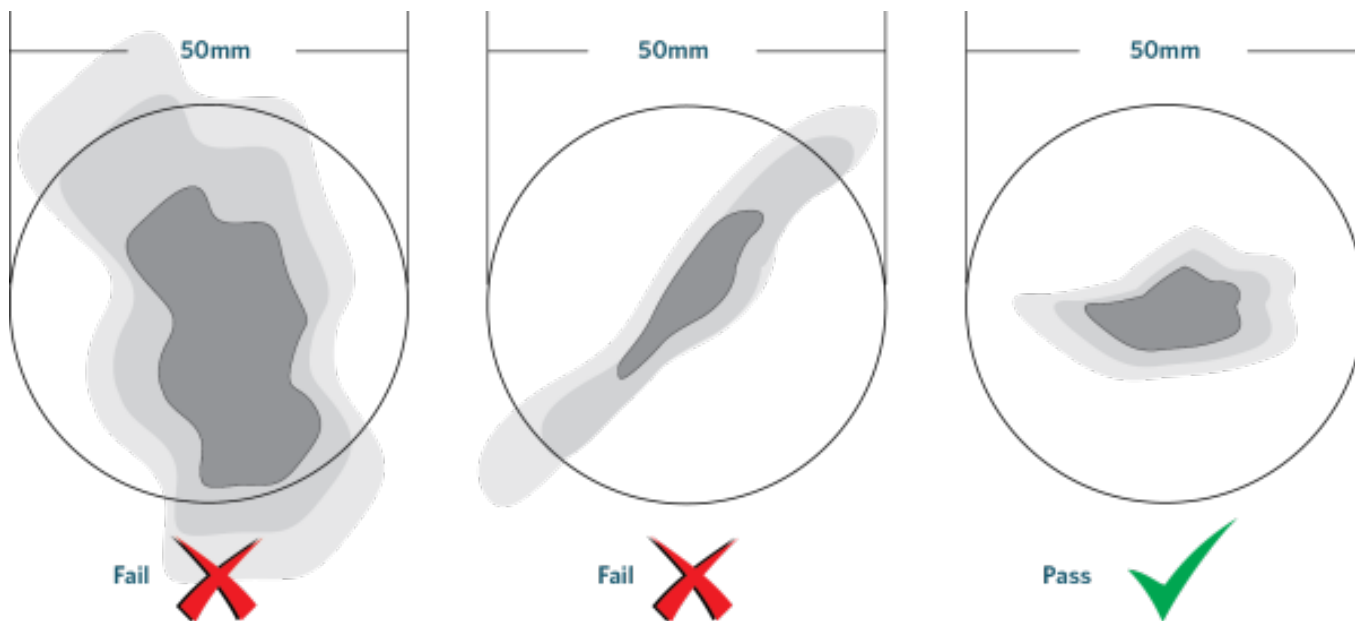
**Figure 3-1-1. Corrosion or wood rotting damage 50mm diameter limit**

- b) cracking (Note 3) (Figure 3-1-3), or
  - c) fracture, or
  - d) corrosion **or wood rotting** damage (Note 1) that is individually larger than 50mm in diameter (Figure 3-1-1), or

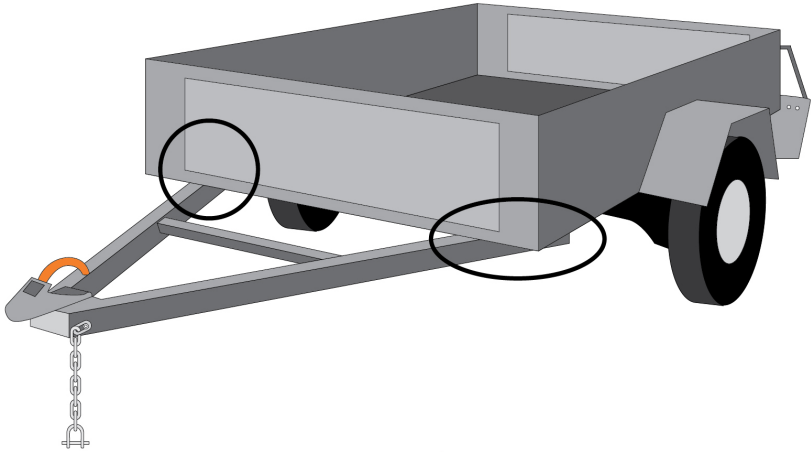
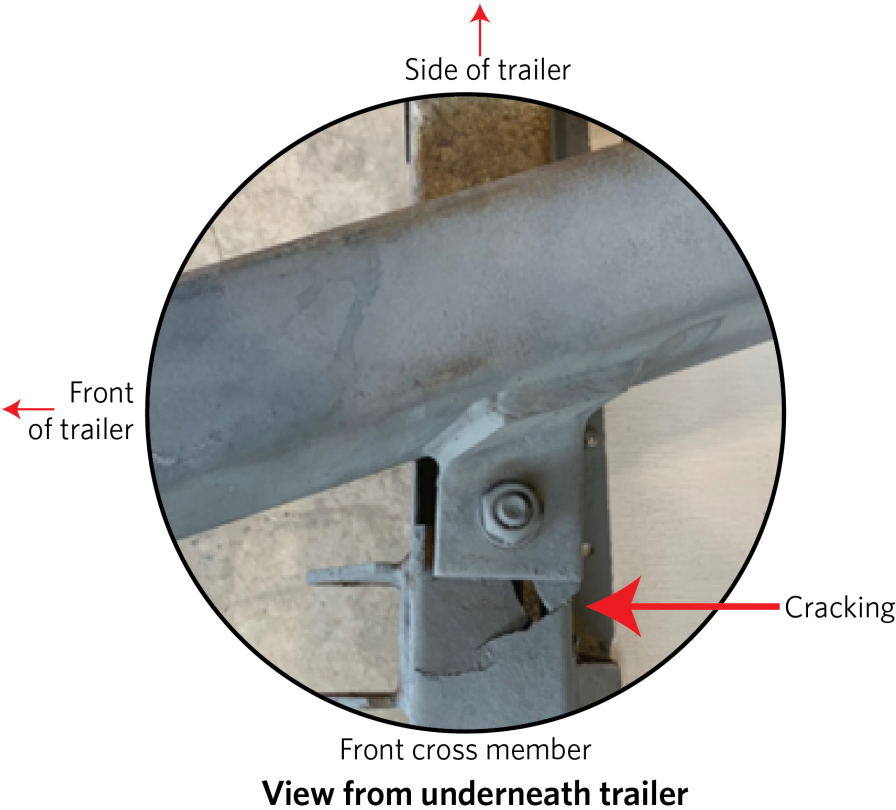
Figure 3-1-3. Drawbar attachment to trailer

Special attention should be given to the point or points where the drawbar attaches to the body of the trailer. This is often the first point of structural failure on trailers.

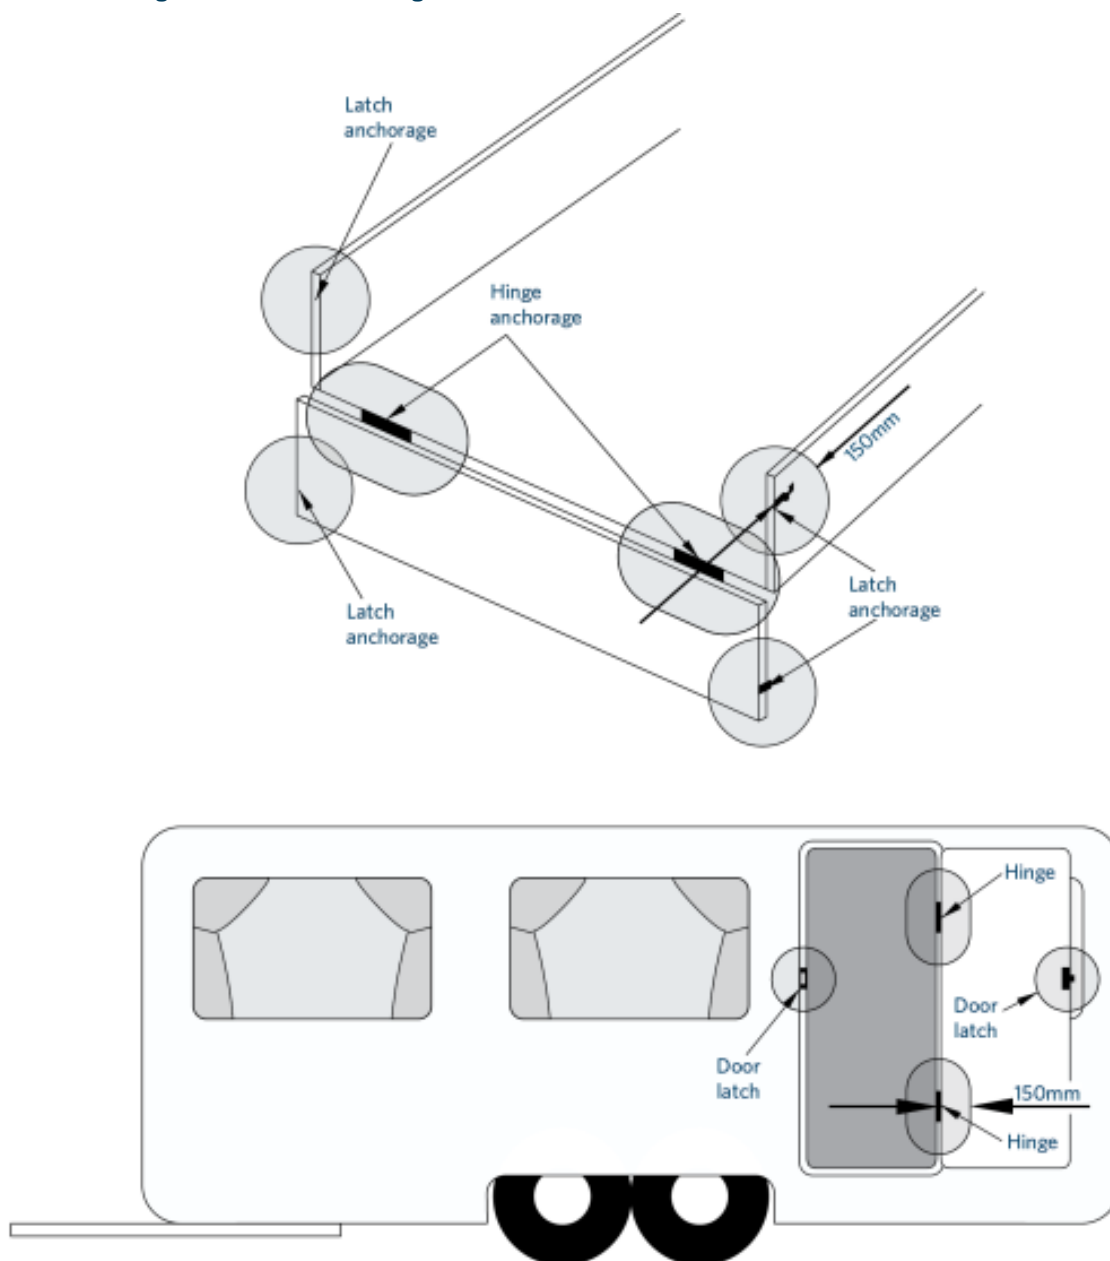
**Figure 3-1-4. Hinge and latch anchorages**

3. There is corrosion **or wood rotting** damage within 150mm of the hinge of a hinged panel (Figure 3-1-4).
4. There is corrosion **or wood rotting** damage within 150mm of the latch of a hinged panel (Figure 3-1-4).

No structural damage is allowed within 150mm of a circle around the outside of a hinge, latch or load anchorage component.

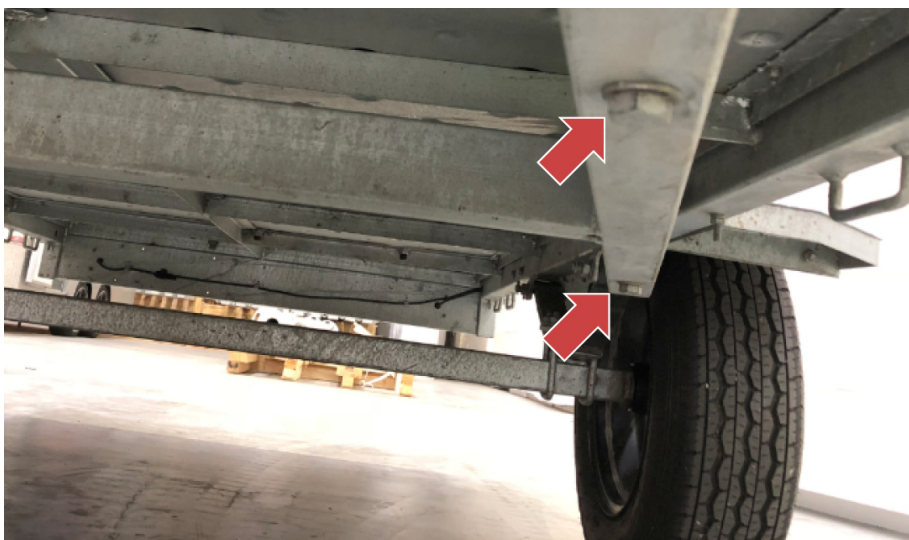
### Bolted through drawbar attachment to trailer

5. A hinged panel does not remain secure in a closed or locked position.
6. The trailer is an unrepaired Trailpro 8x4 Tradesman (model number TP5) or a Trailpro 8x5 Tandem (model number TP8), with a bolt-through drawbar attachment (these trailers are subject to safety recall) (Note 4). See Figure 3-1-5 for advice on identifying these trailers. See Figure 3-1-6 and Figure 3-1-7 for advice on identifying repaired Trailpro trailers.

The identification tag may be missing, faded, damaged or obscured. All Trailpro models have drawbars that are **bolted rather than welded** to the trailer. The TP5 has a single axle and a tray size of 8'x4' (2.4m x 1.2m). The TP8 is a tandem axle model with a tray size of 8'x5' (2.4m x 1.5m).

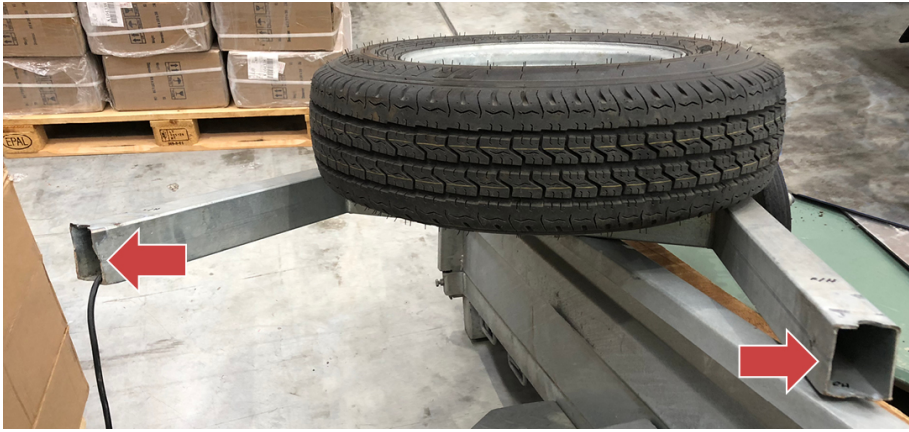
**Broken drawbar (sitting on trailer)**

There is a safety risk with the Trailpro brand of light trailers which were sold through Bunnings NZ between 1 January 2006 and 12 October 2018. Bunnings is now recalling all Trailpro trailers, other than Trailpro 8x4 Tradesman (TP5) or 8x5 Tandem (TP8) models that have undergone Bunnings-approved repairs as part of an earlier recall. These can be identified by the serial number on the identification plate ending with an “R” (see Figure 3-1-6). A TP5 or TP8 trailer with a serial number ending with an “R” may be issued a WoF if it passes all other checks. More information can be found in the [safety recall notice](#) on the Transport Agency website.
