### WoF

## What is 'excessive' when it comes to an in-service inspection?

## Cargo barriers: VIRM change to modifications that don't require LVV certification

## Roller brake machine testing of cardan shaft brakes

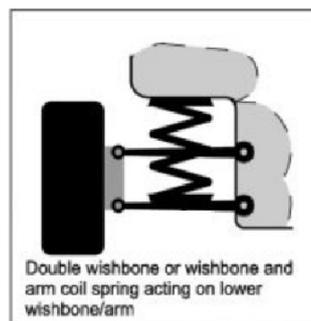
- 4 Where is the correct jacking point?

**Technical bulletins (general) 4: Jacking points for common suspension types**
- 2 load indices  
**10 Tyres, wheels and hubs: 10-1**  
**Tyres and wheels**  
Reason for rejection 4

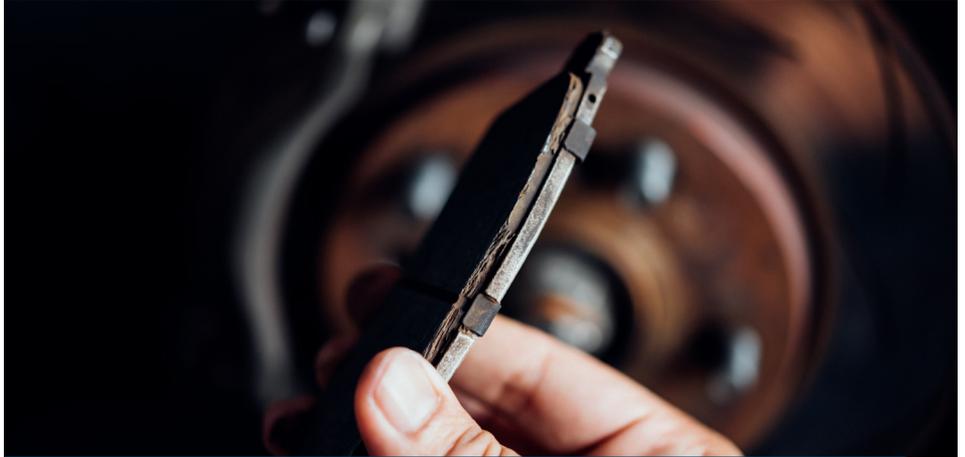
This is an example of a worn pad (removed from the vehicle for the photo) that is within manufacturers specifications and will most likely pass the brake test. However, this pad wouldn't last 12 months until the next inspection so a note or explanation to the owner should be made.

As a general rule, friction materials (including brake pads and shoe linings) wear much faster as they get thinner, so for in-service inspection purposes a minimum thickness cannot be used to determine pass or fail - the brake performance must meet the requirements. However, since brakes may become noncompliant between inspections, a note should be made on the check

sheet and you should mention the issue to the vehicle owner customer if you can see the material is worn down to approximately these amounts:

Disc pads: 1.5 - 3mm

(motorcycles 1-1.5mm)

Shoe linings (bonded): 1.5-3mm

Shoe linings (riveted): 1.5-2mm above the head of the rivet

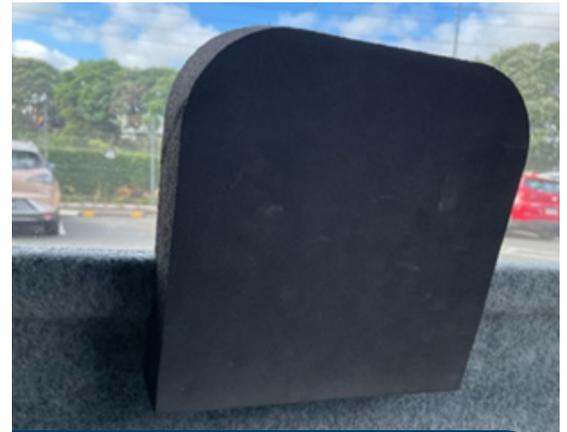
Suitable impact absorbing padding on a solid cargo barrier

Recently it's come to light that there are approximately 4000 Hyundai i-Load vans with cargo barriers fitted that were not certified. The barriers don't meet the technical requirements for LVV certification as they're less than 300mm from the back of a seat that doesn't have a head rest.

Removing the cargo barriers is not a suitable solution as they provide a significant safety benefit to the vehicle occupants (removing them may increase the risk of injury). There are other economic options available that remove the safety risk of a head hitting a hard surface.

These options are detailed in the **General vehicles 7-7 Interior impact** section of the VIRM. The modification threshold table has been updated and we've added images to explain the options.

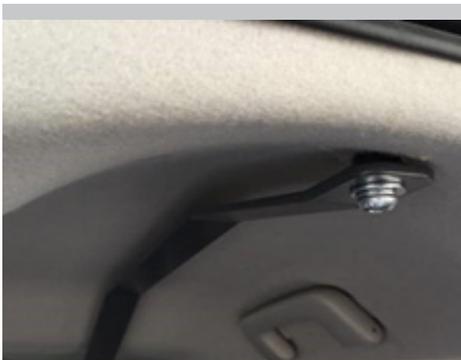
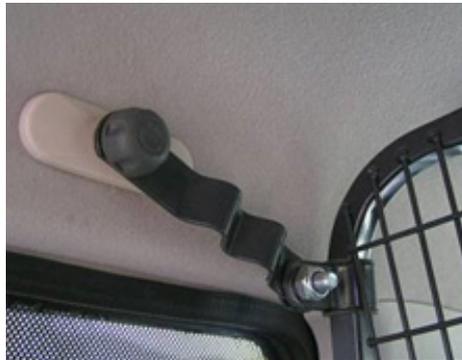
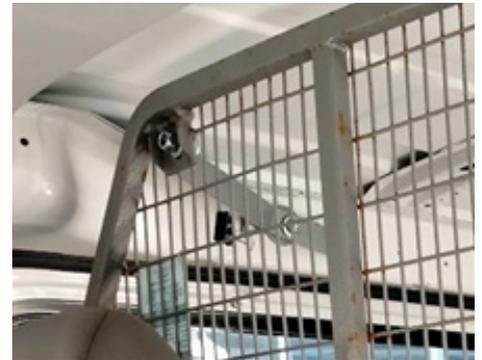
Collapsible mechanisms

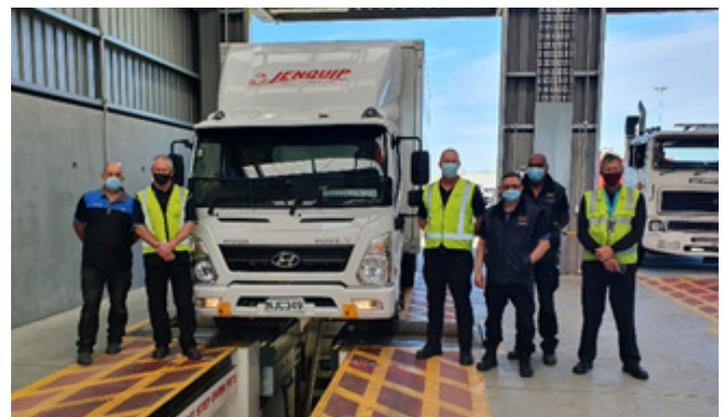
There have been incidents of the park brakes failing, causing vehicles to run away, which led Waka Kotahi to commission **independent research** to find out if roller brake machines could be used to test vehicles fitted with cardan shaft brakes. The cardan shaft park brakes on two trucks were tested with a simulated slope (pull) test and in a brake roller machine and no damage to the trucks' driveline and park brake assemblies was found.

The next step for Waka Kotahi is to continue testing using a wider range of vehicles and roller brake machines. Testing was carried out at VINZ Palmerston North at the end of November and another round of testing is planned for early next year. This will inform decisions on whether to mandate roller brake testing for cardan shaft brakes.

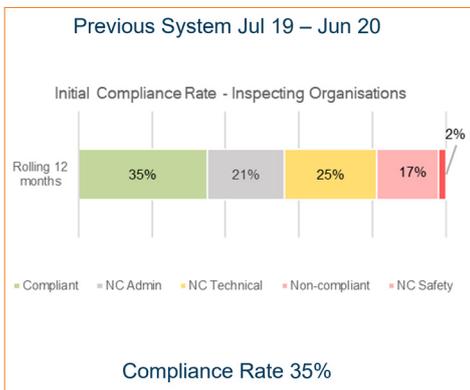
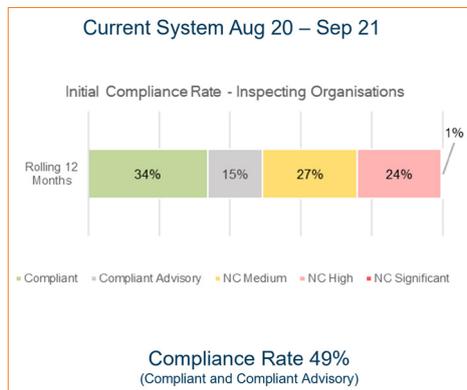
### Inspecting organisations

As seen in the graphs below, since the risk matrix and the CWA outcome was introduced, compliance has increased and everyone is welcoming the fair results.
