WoF news

Issue 20 February 2014

Rusty boat trailer

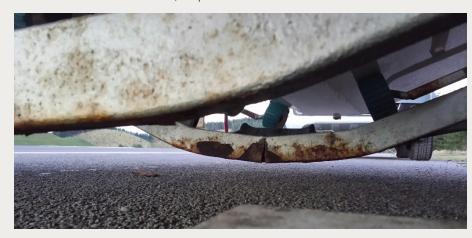
Check out this photo of a galvanised boat trailer that was issued with a WoF a month before two of the three main crossmembers fractured, causing the trailer to collapse while it was being towed.

The crossmembers failed because the galvanised coating has significantly deteriorated, leading to significant internal corrosion in the box sections of the crossmembers. This corrosion was further exaggerated by the crossmember design where their lowest points were also the points of maximum load. This type of design is common on boat trailers. Overloading could also have played a part in the failure, but that could not be determined for certain.

A visual inspection raised no concerns regarding the condition of the trailer structure. Areas of minor surface corrosion were visible, but no thinning of the metal was evident externally.

However, an invasive inspection revealed that considerable internal corrosion of the metal adjacent to the failure area which caused the crossmembers to fail, despite the metal appearing sound externally.

In summary, by the time a galvanised boat trailer shows external corrosion, the galvanising is likely to be significantly deteriorated inside the box sections, and this should be assessed by a suitably qualified person, such as an engineer or trailer manufacturer, before issuing a WoF.

Therefore, inspectors should look out for the following tell-tale signs on galvanised trailers:

- Paint touch-ups (should't be required if the galvanised coating was still intact)
- An obviously galvanised boat trailer that appears to have been painted, or partially painted, for reasons other than to improve its 'cosmetic appearance'
- Patch repairs to a galvanised trailer.

Owners of boat trailers should maintain their boat trailers in a roadworthy condition by following the manufacturer's instructions or recommended practices to reduce the potential effects of saltwater corrosion.
