Extract taken from: Border inspection of imported used vehicles > Reference materials > Examples of major structural damage and corrosion > Under body damage: splitting of seam wells

5-2 Under body damage: splitting of seam wells

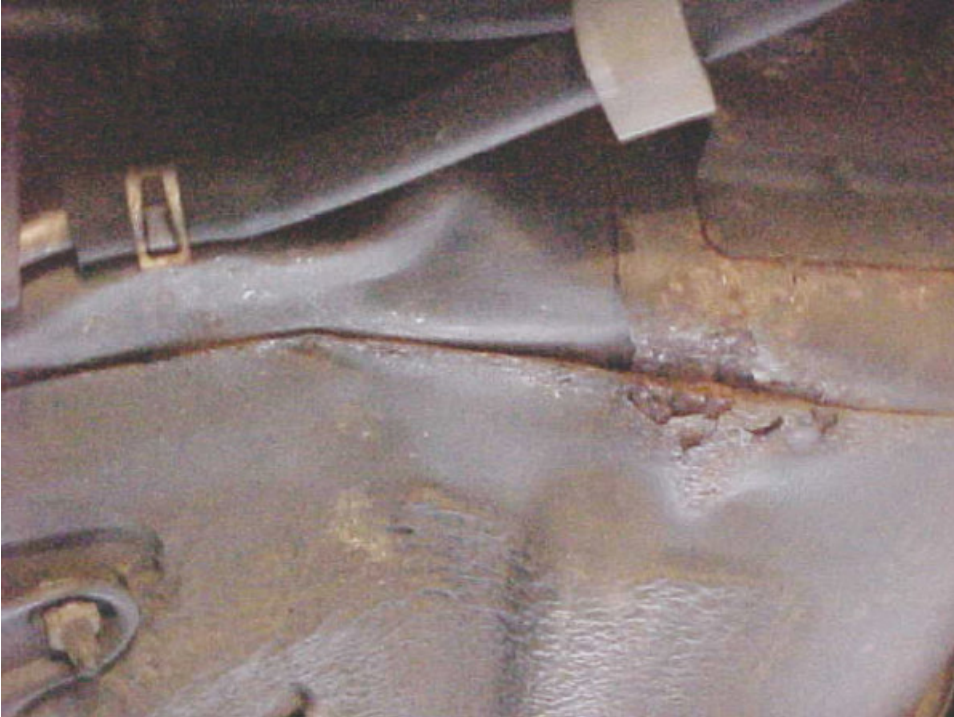
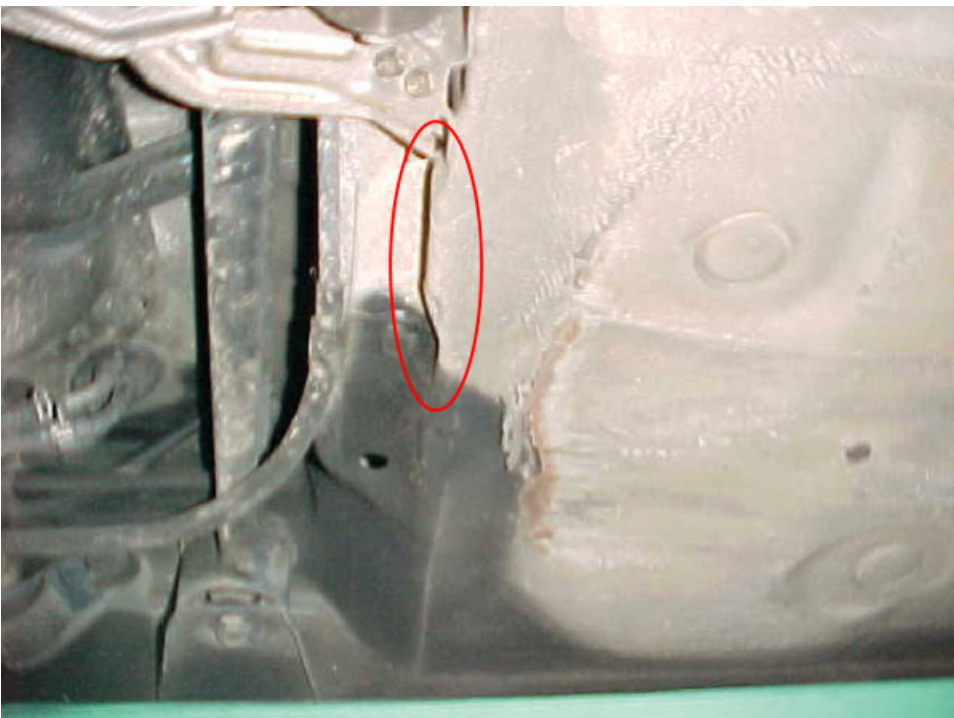
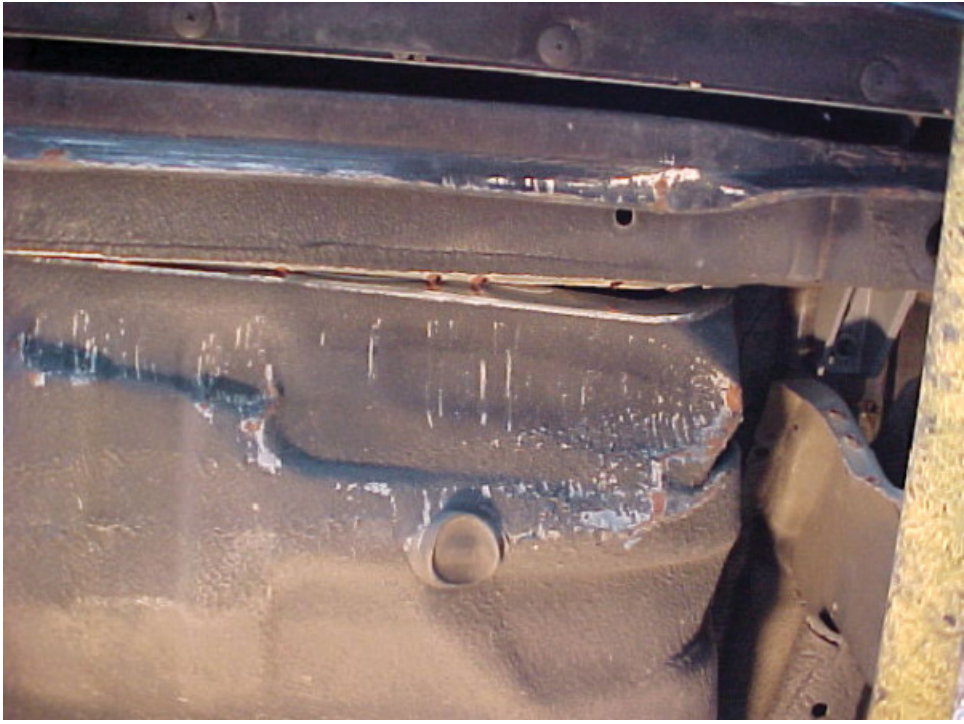
Under body damage: splitting of seam wells
