Extract taken from: Border inspection of imported used vehicles > Reference materials > Examples of major structural damage and corrosion > Under body damage: splitting of seam wells

5-2 Under body damage: splitting of seam wells

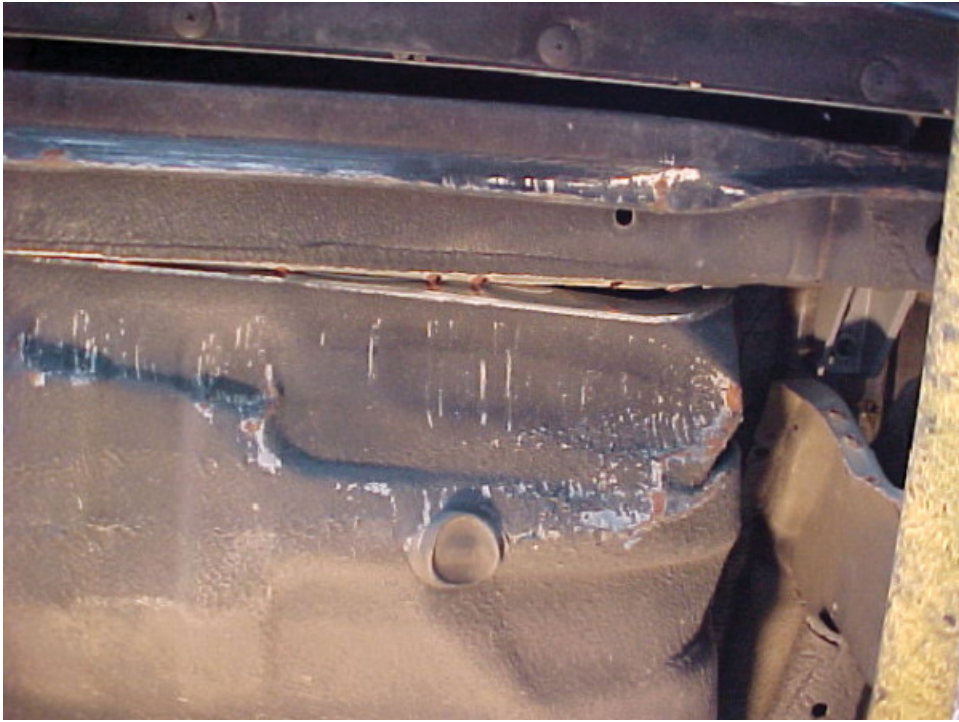
Under body damage: splitting of seam wells
