Extract taken from: Border inspection of imported used vehicles > Reference materials > Examples of major structural damage and corrosion > Dogleg flag

## 5-6 Dogleg flag

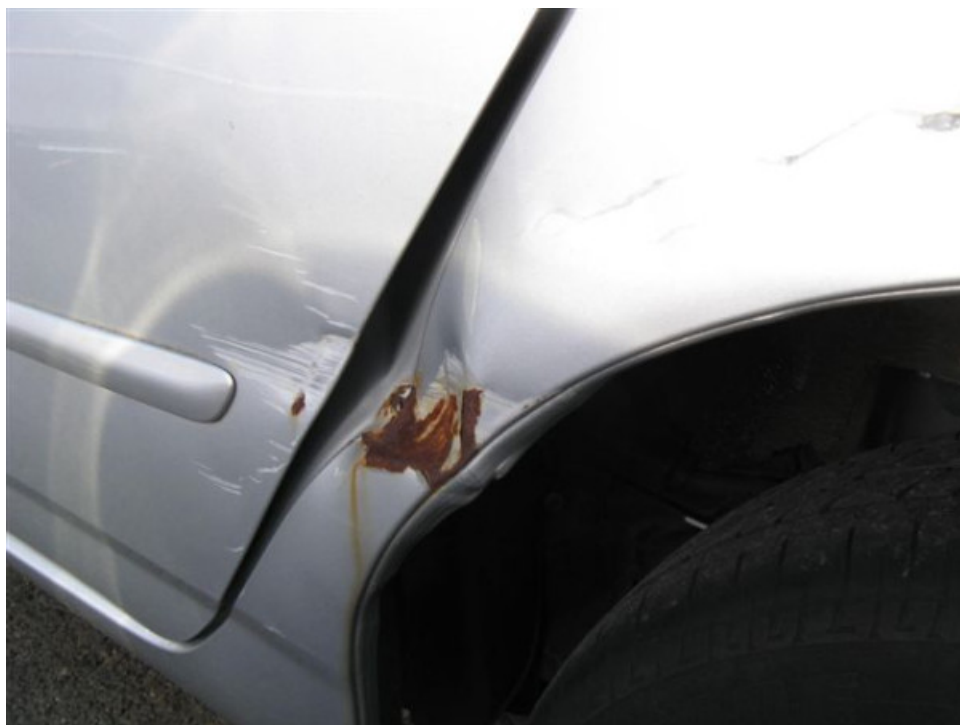
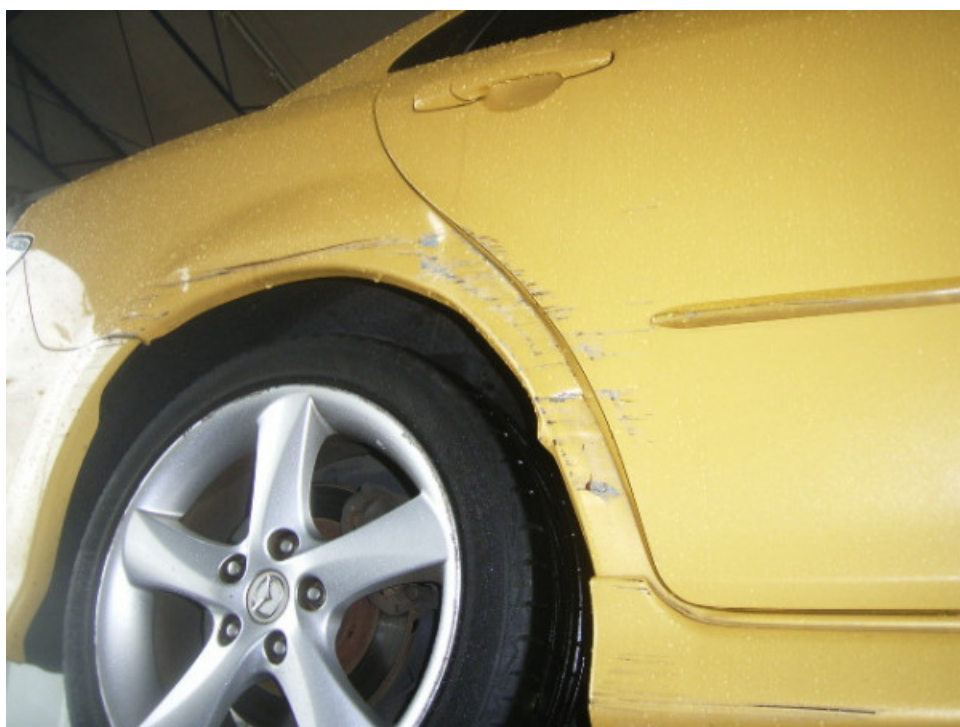
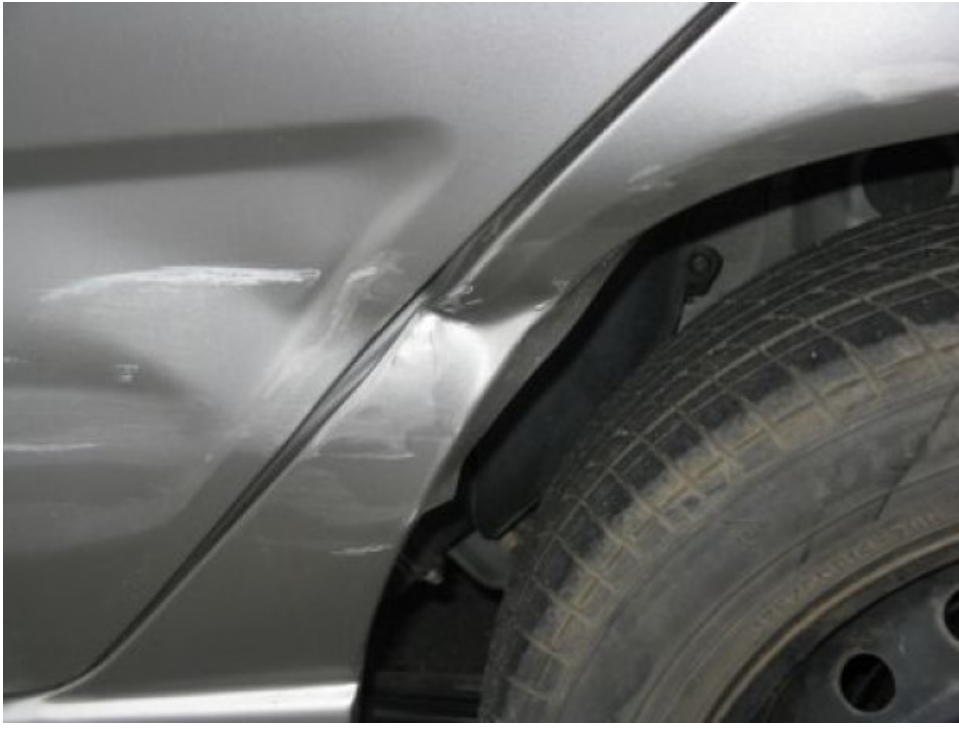
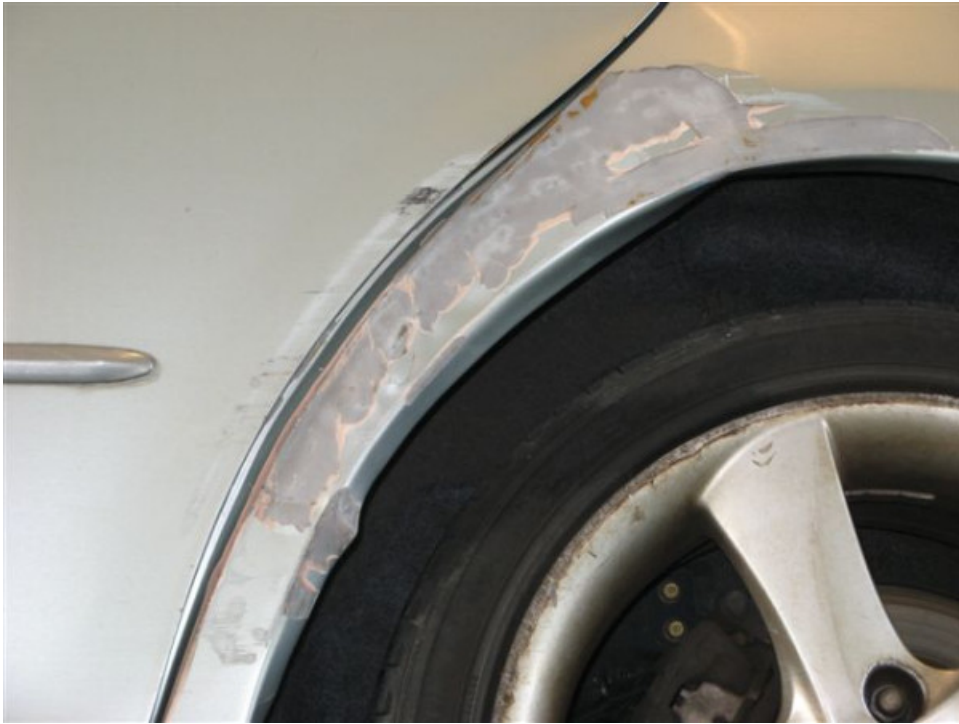
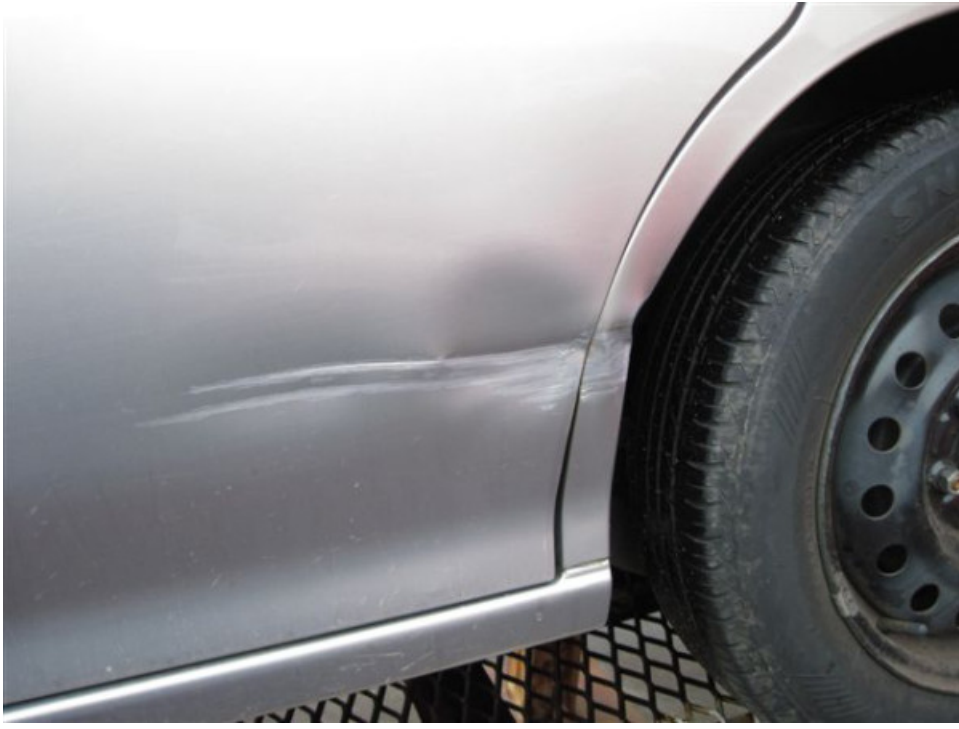
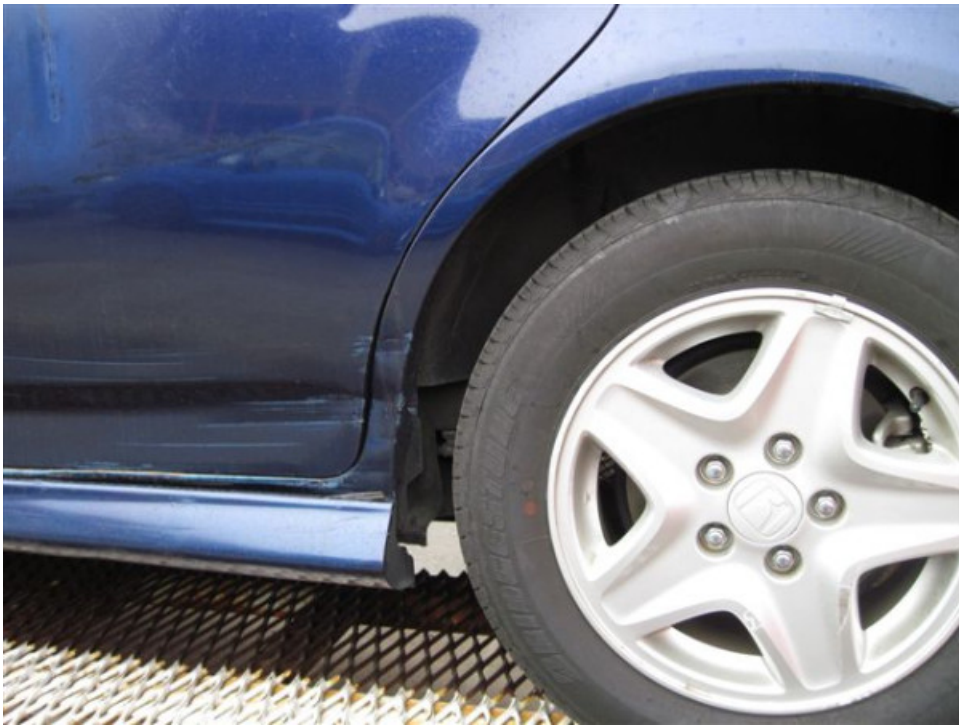
Look for discrepancies in the door gap.
