Extract taken from: Border inspection of imported used vehicles > Reference materials > Examples of minor non-structural cosmetic damage

6 Examples of minor non-structural cosmetic damage

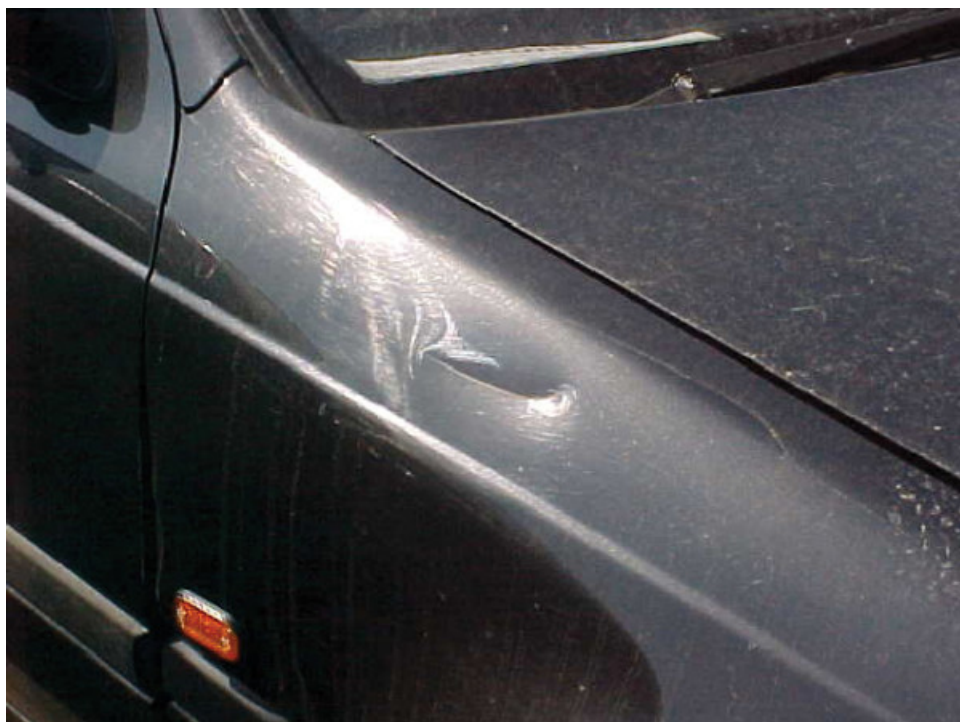
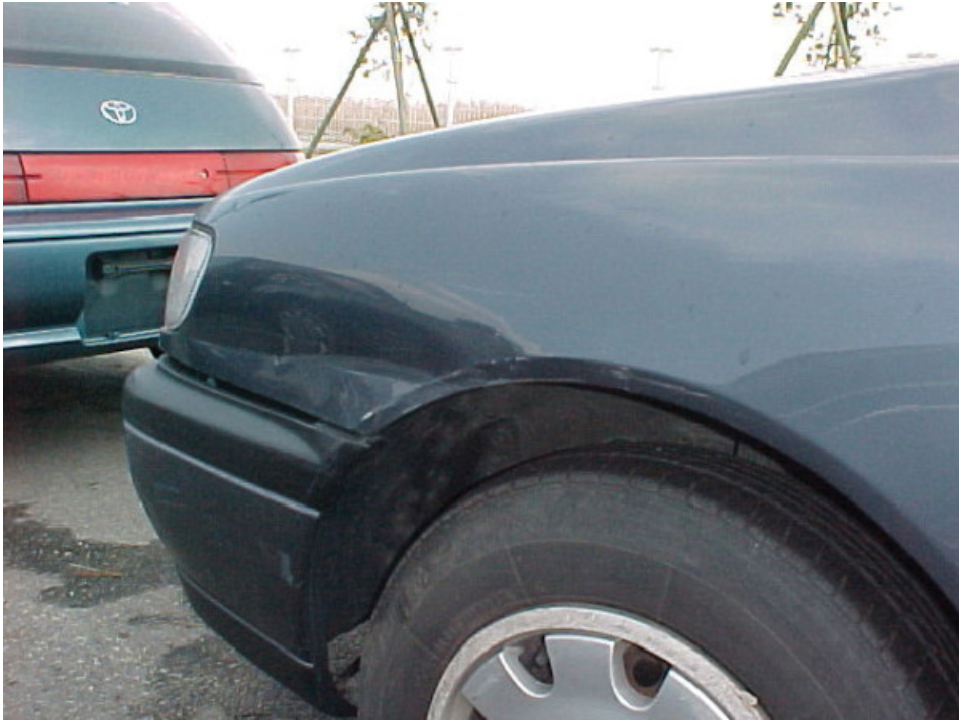
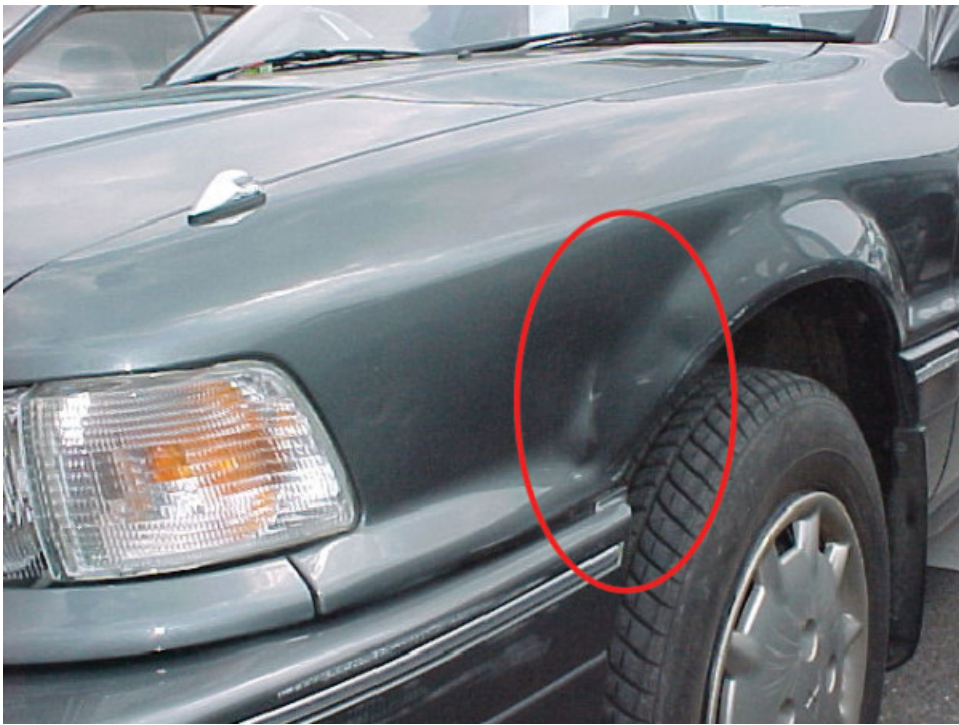
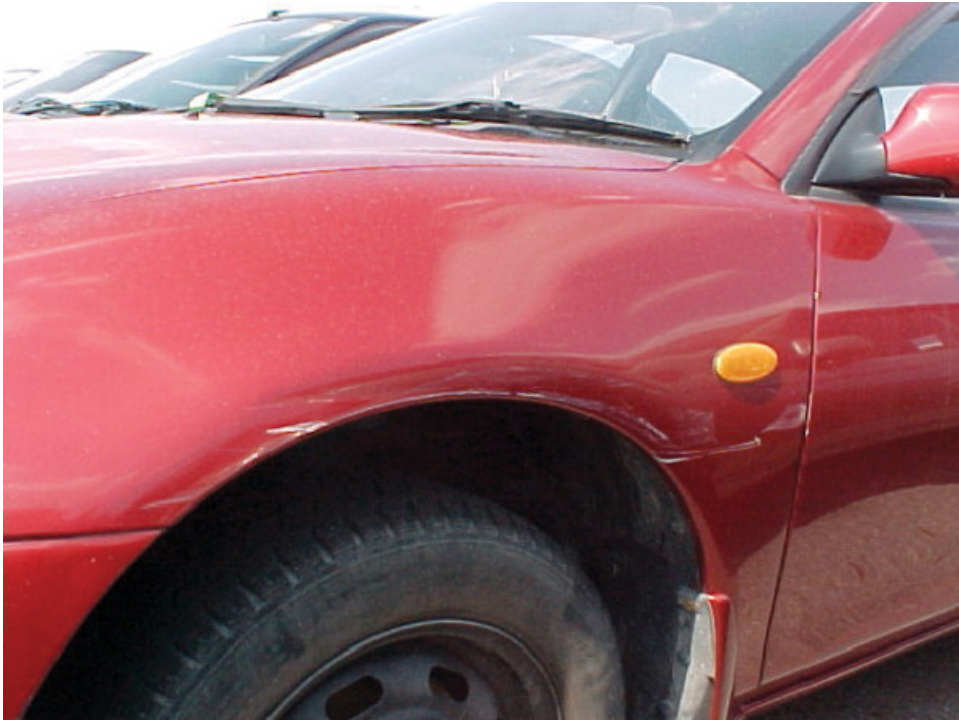
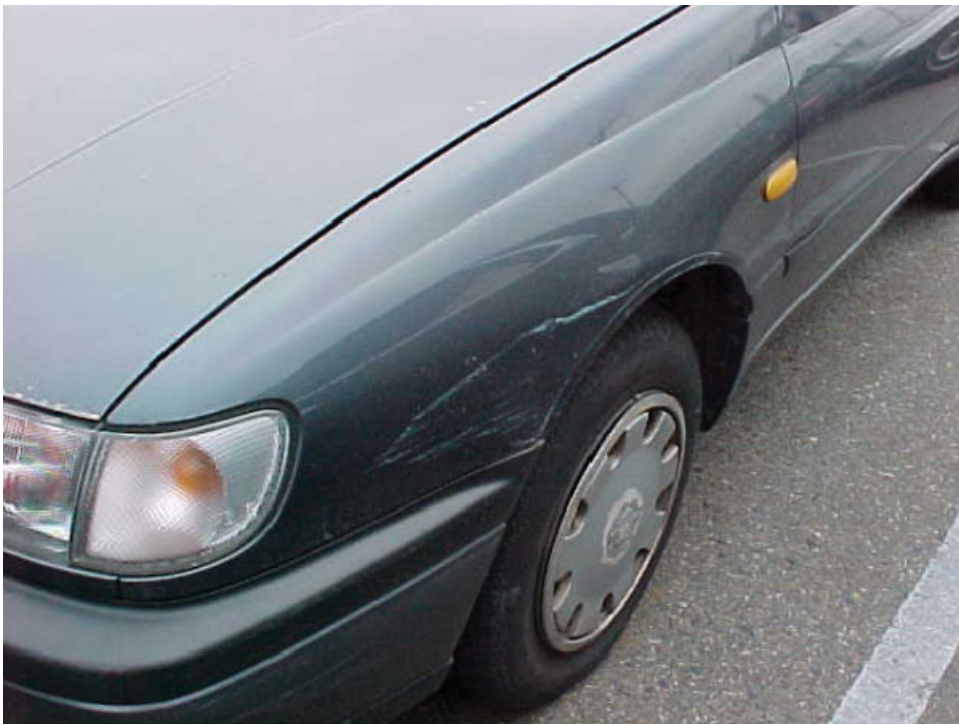
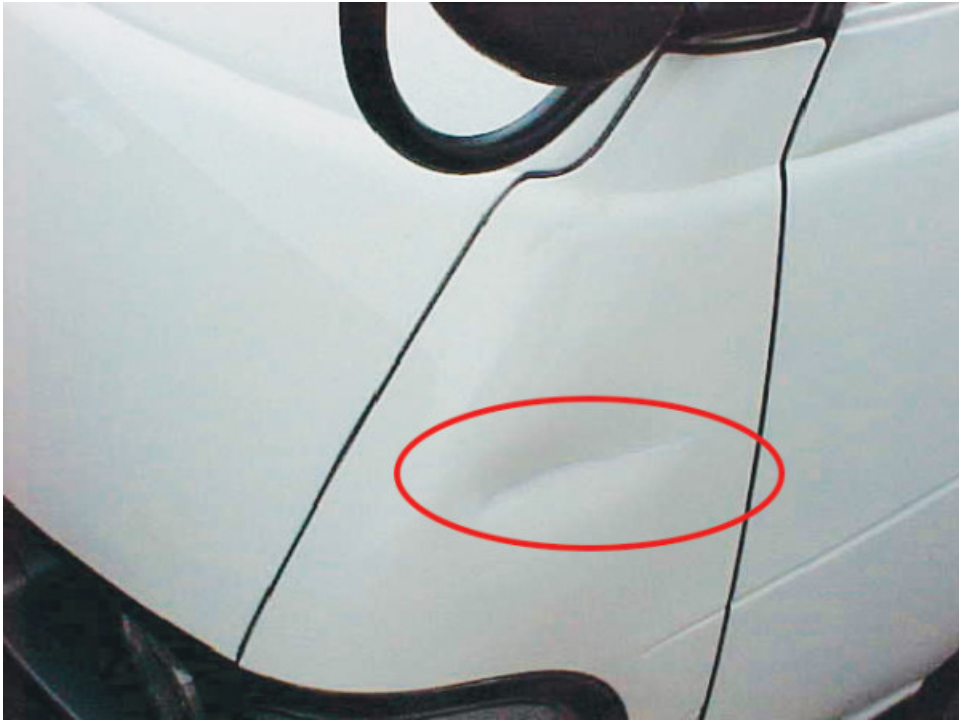
6-1 Front guards

Front guards

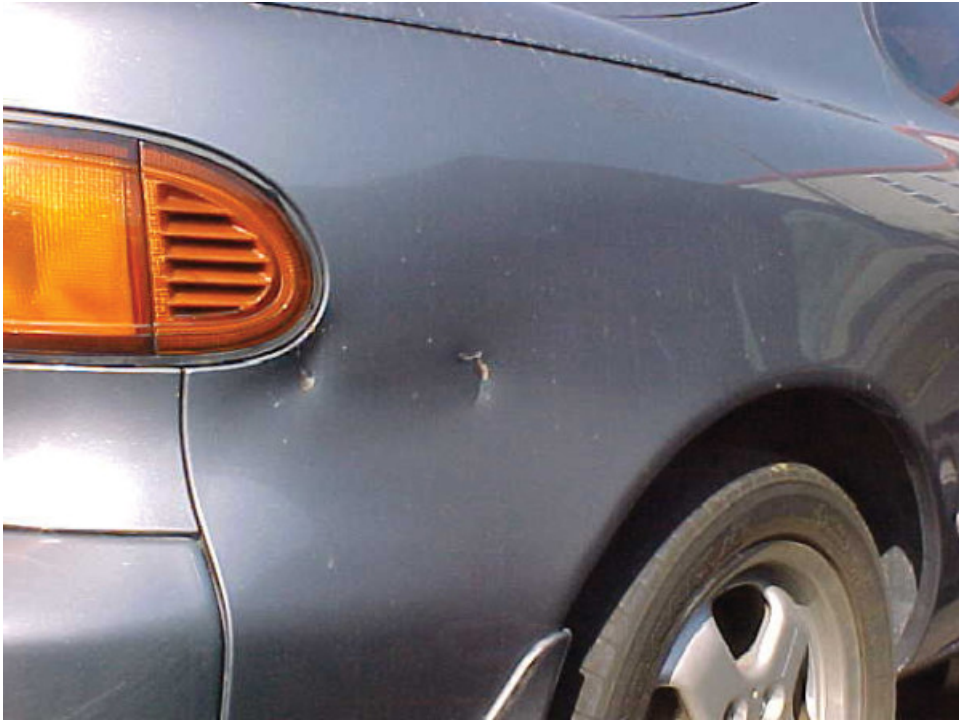
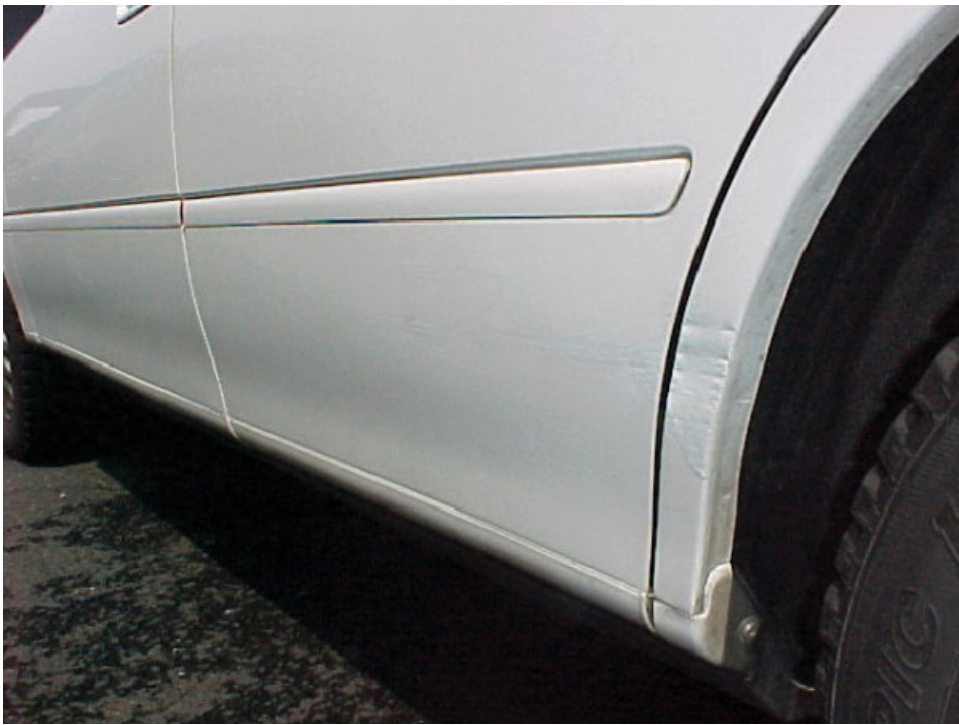
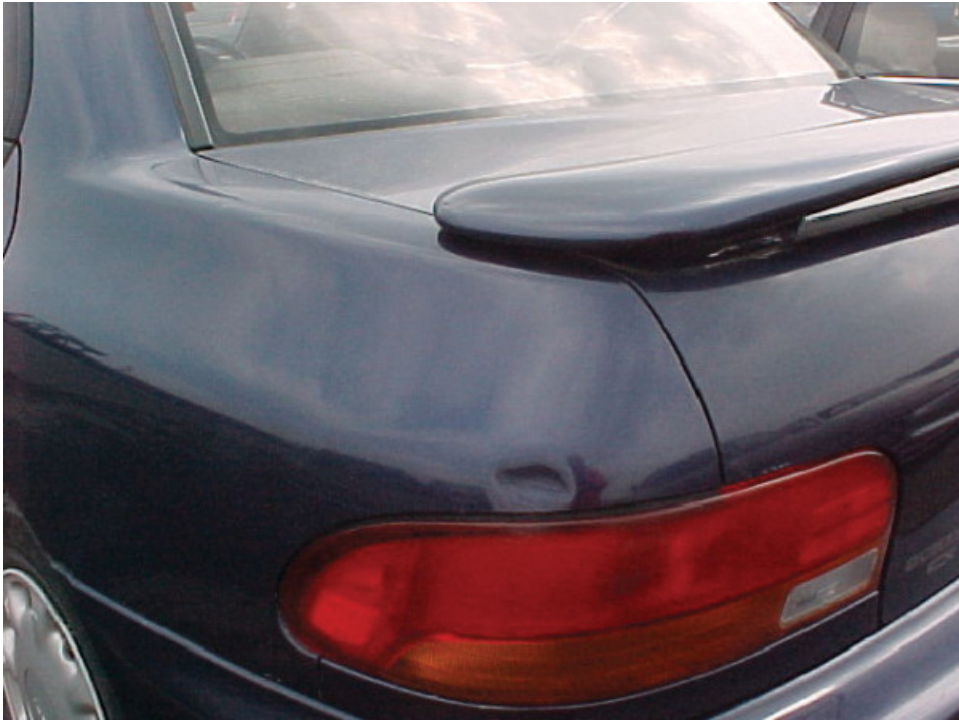
6-3 Minor/cosmetic damage: rear quarter panel and dogleg

Minor/cosmetic damage: rear quarter panel and dogleg

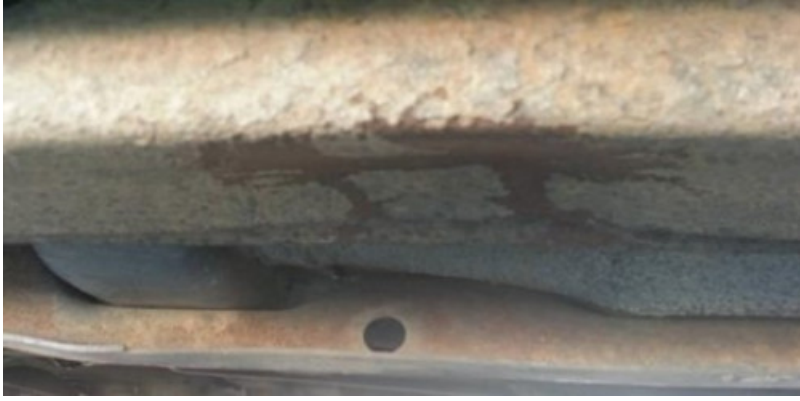
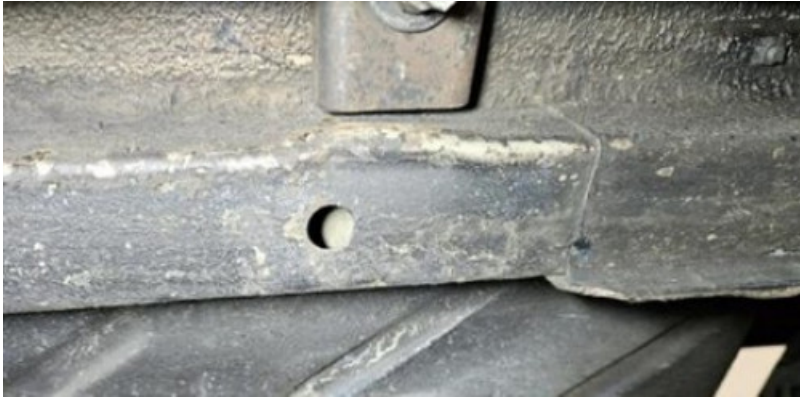
6-4 Minor/cosmetic damage: floor pan stiffening members

The minor/cosmetic damage in these images doesn't need to be referred to a repair certifier.
