Tow coupling safety alert

Axle-stop/retention devices - important warning

Holland FW31 series fifth wheels - warning

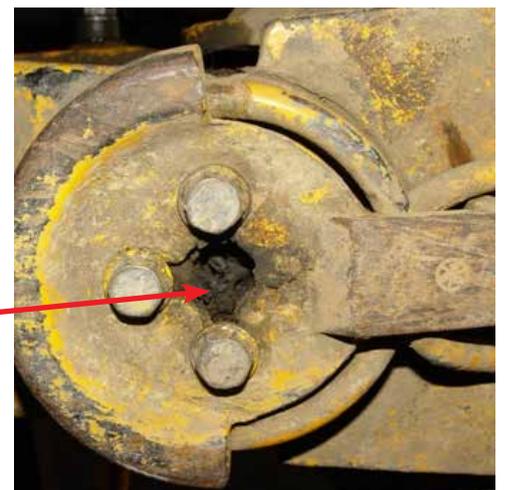
Investigation into the cause of the detachment identified that there was evidence that the tow drop pin had not fully engaged due to debris packed in the lower bush. It was also noted that the outlet hole beneath the bush was blocked due to stones and other material. This appears to be a particular issue with logging trucks where the trailer is placed on the back of the truck when empty (piggy-backed). This can lead to dirt and other foreign material settling on wet and oiled surfaces and becoming compacted preventing full engagement of the drop pin. Two other cases have been identified where the release handle had insufficient force to hold the drop pin in place, or the lock plungers were not fully engaged.

Locking plunger not engaged

This outlet hole must be completely clear of any stones or dirt etc

When inspecting a pin type coupling for condition and performance ensure that:

- there is no material present in and around the lower drop pin bush and the outlet hole beneath which could prevent full engagement of the drop pin
- the release handle has a strong downward force or resistance when raising the drop pin to connect/disconnect a trailer
- any form of locking mechanism engages fully without any physical assistance.
