Extract taken from: Border inspection of imported used vehicles > Reference materials > Examples of major structural damage and corrosion > Corrosion which has resulted in perforation or flaking of the metal: Nissan Terrano and Mistral

5-10 Corrosion which has resulted in perforation or flaking of the metal: Nissan Terrano and Mistral

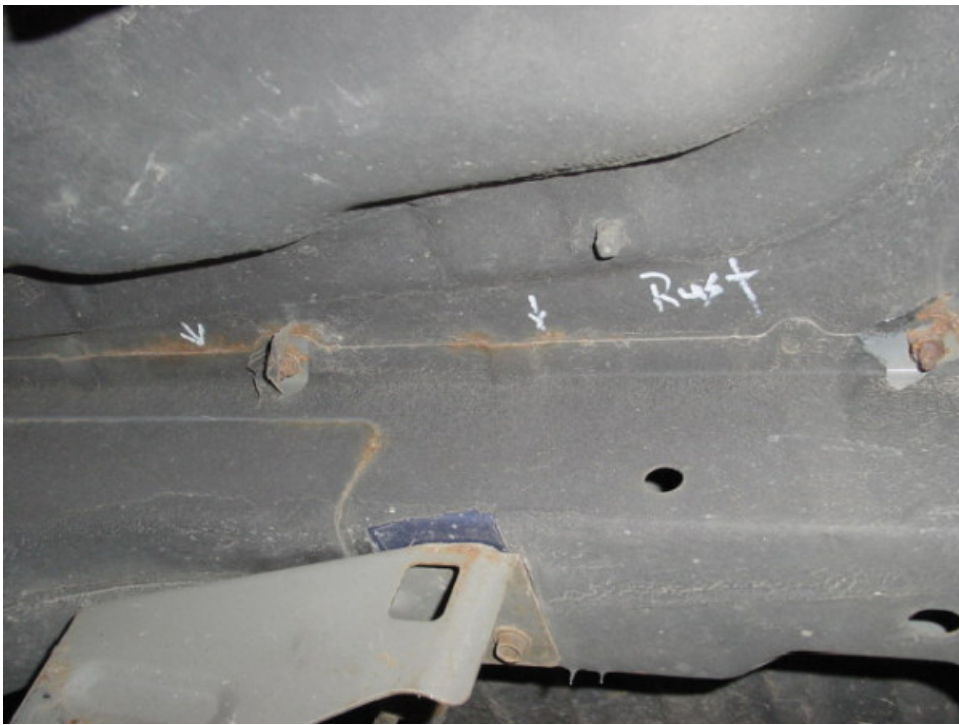
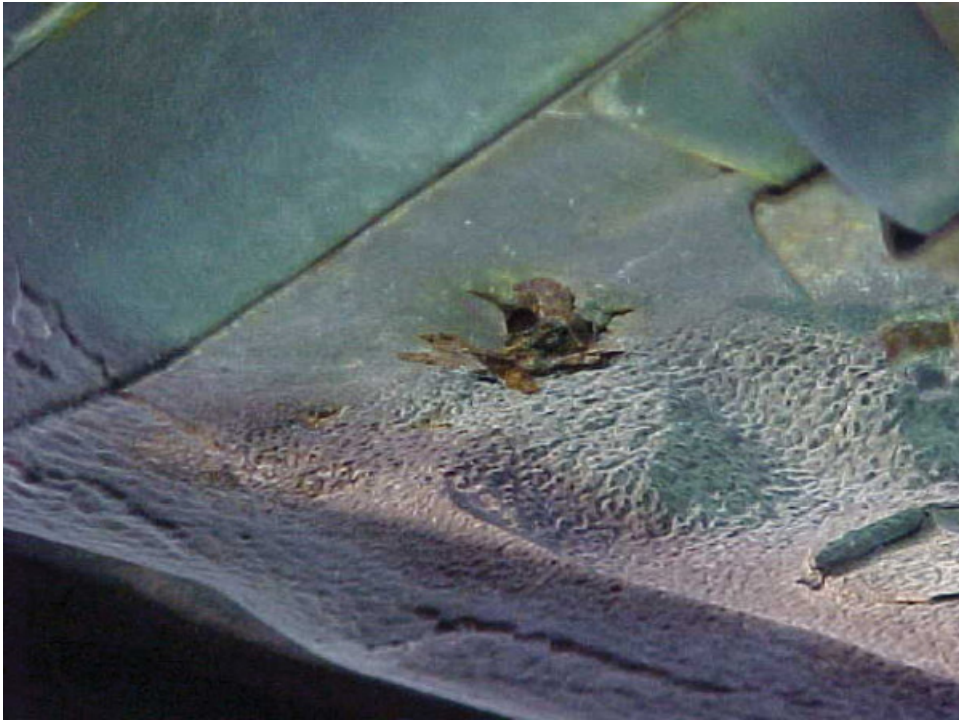
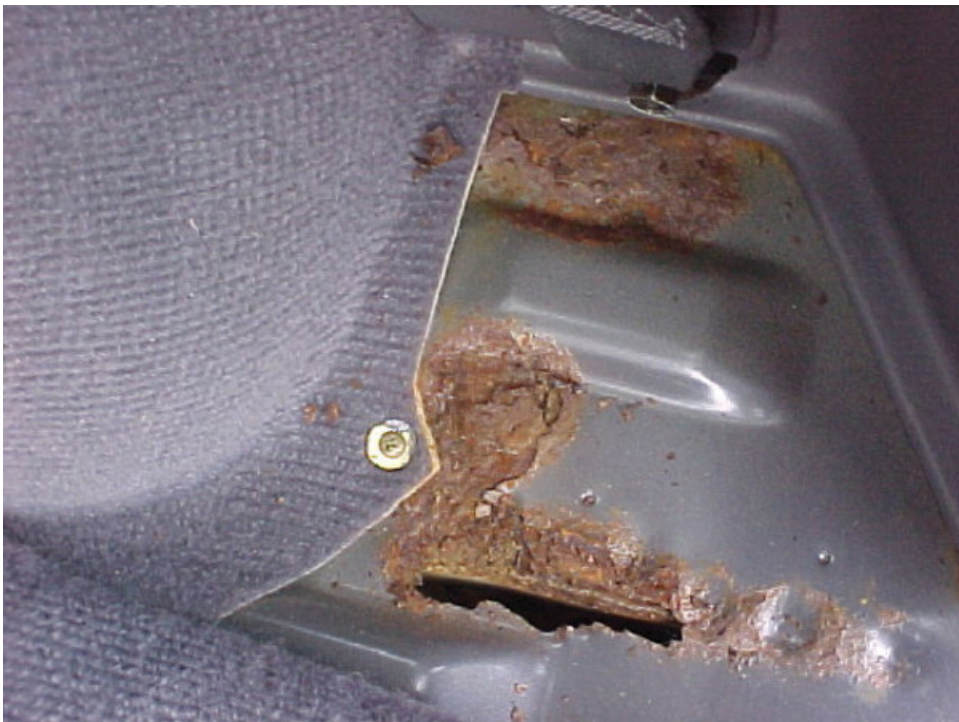
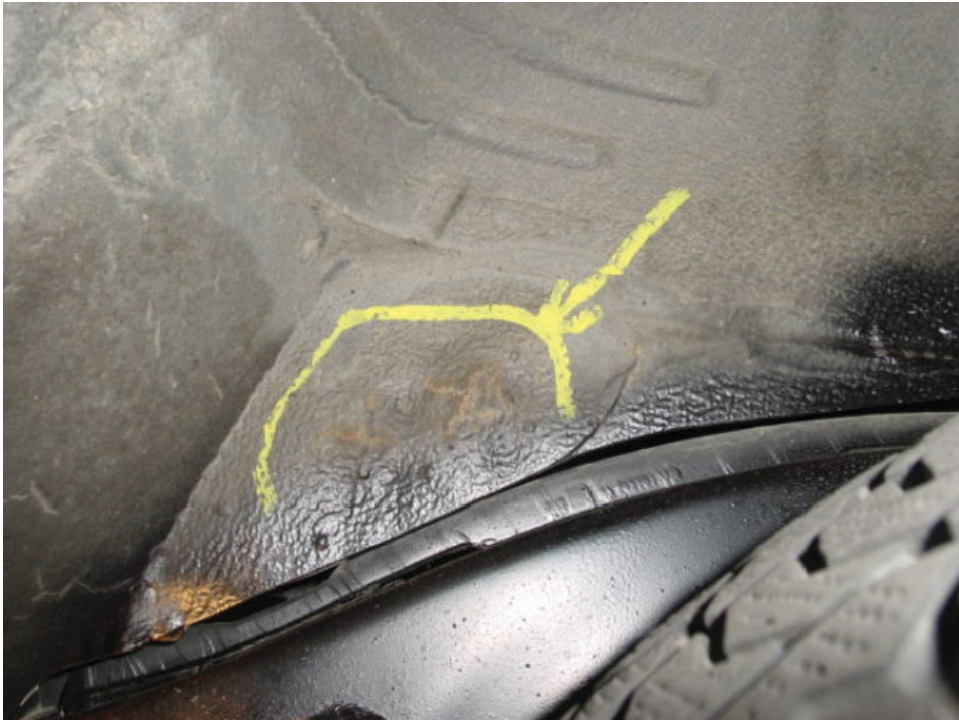
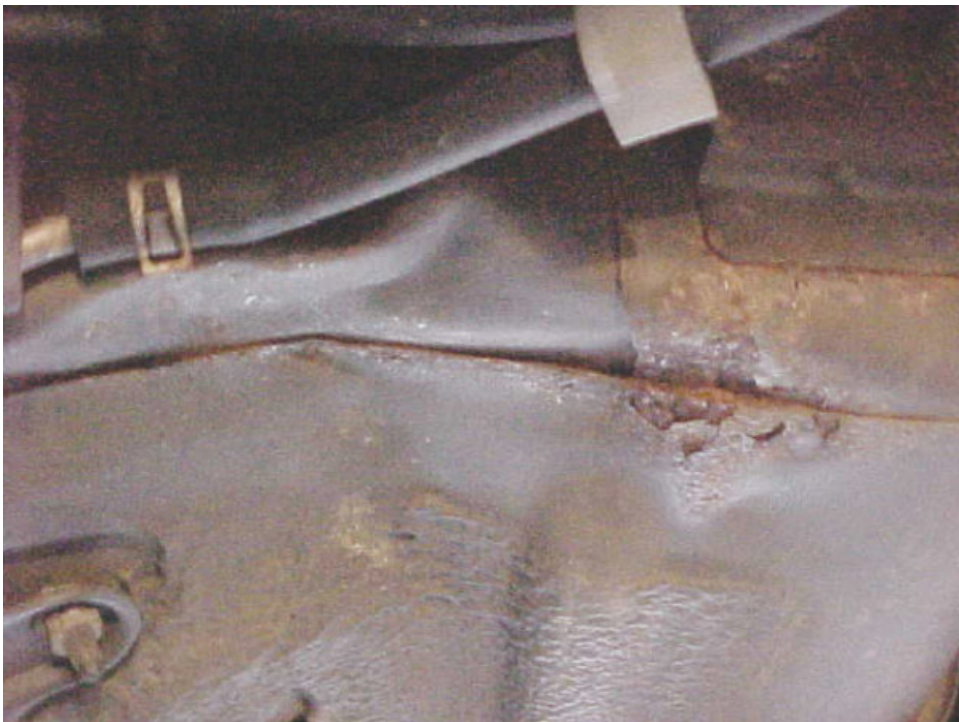
When inspecting Nissan Terranos or Mistrals always check for corrosion of the floor under the rear seat (examples are shown in the first three photos below).
