Extract taken from: In-service certification (WoF and CoF) > General trailers > Vehicle structure

3 Vehicle structure

3-1 Structure

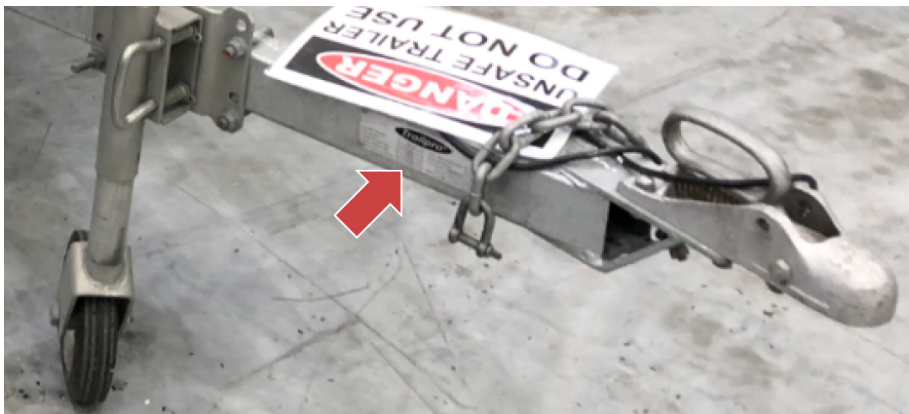
Location of the trailer identification plate

There is a safety risk with the Trailpro brand of light trailers which were sold through Bunnings NZ between 1 January 2006 and 12 October 2018. Bunnings is now recalling all Trailpro trailers, other than Trailpro 8x4 Tradesman (TP5) or 8x5 Tandem (TP8) models that have undergone Bunnings-approved repairs as part of an earlier recall. These can be identified by the serial number on the identification plate ending with an “R” (see Figure 3-1-6). A TP5 or TP8 trailer with a serial number ending with an “R” may be issued a WoF if it passes all other checks. More information can be found in the [safety recall notice](#) on the Transport Agency website.

Affected trailers are fitted with an identification plate which is located on the outside of the trailer drawbar near the tow coupling.

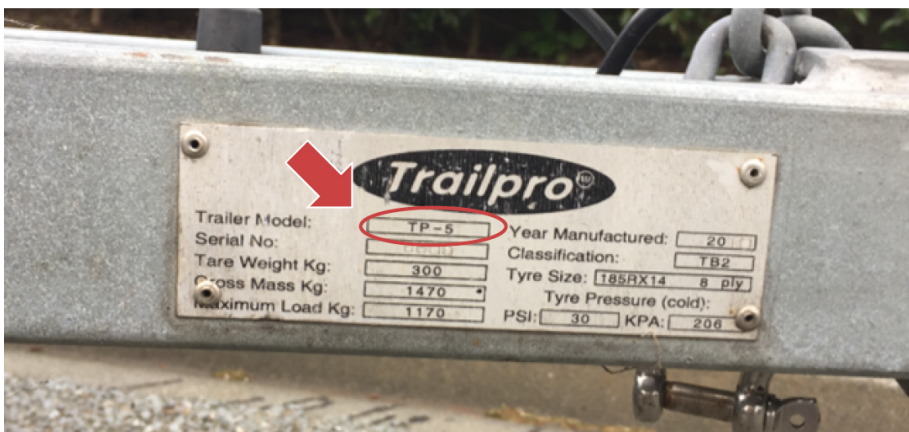
Identification plate similar showing model number

The identification tag may be missing, faded, damaged or obscured. All Trailpro models have drawbars that are **bolted rather than welded** to the trailer. The TP5 has a single axle and a tray size of 8'x4' (2.4m x 1.2m). The TP8 is a tandem axle model with a tray size of 8'x5' (2.4m x 1.5m).
