Extract taken from: In-service certification (WoF and CoF) > General trailers > Vehicle structure > Structure

3-1 Structure

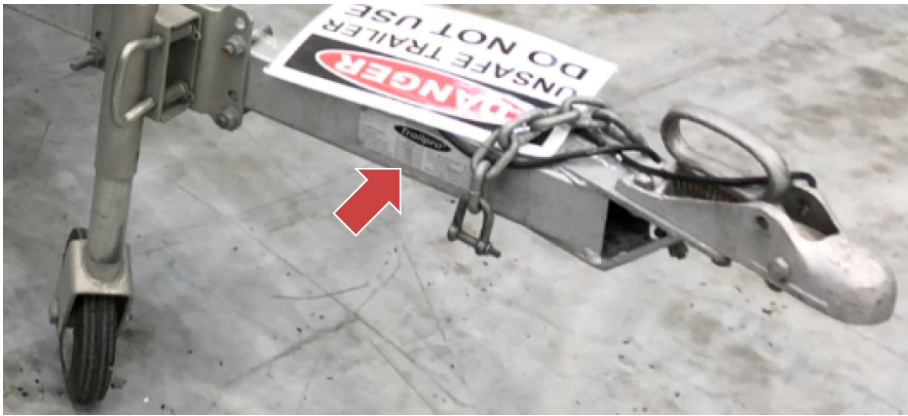
Location of the trailer identification plate

5. A hinged panel does not remain secure in a closed or locked position.
6. The trailer is an unrepaired Trailpro 8x4 Tradesman (model number TP5) or a Trailpro 8x5 Tandem (model number TP8), with a bolt-through drawbar attachment (these trailers are subject to safety recall) (Note 4). See Figure 3-1-5 for advice on identifying these trailers. See Figure 3-1-6 and Figure 3-1-7 for advice on identifying repaired Trailpro trailers.

Affected trailers are fitted with an identification plate which is located on the outside of the trailer drawbar near the tow coupling.

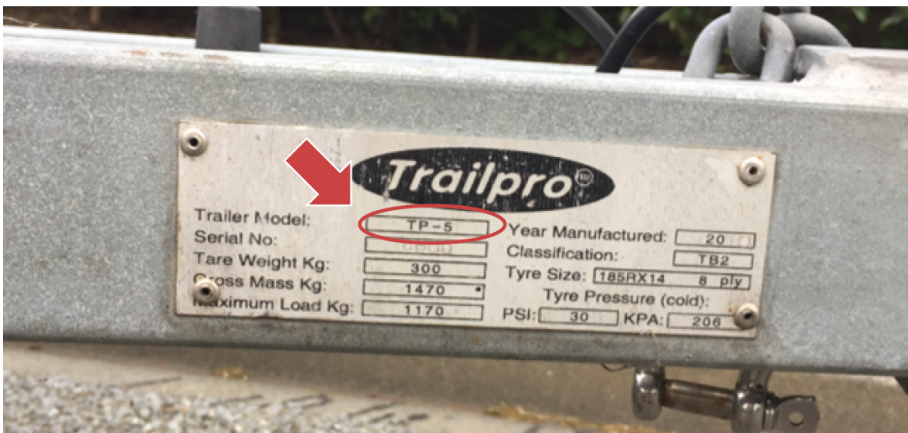
Identification plate similar showing model number

The identification tag may be missing, faded, damaged or obscured. All Trailpro models have drawbars that are **bolted rather than welded** to the trailer. The TP5 has a single axle and a tray size of 8'x4' (2.4m x 1.2m). The TP8 is a tandem axle model with a tray size of 8'x5' (2.4m x 1.5m).
