Extract taken from: In-service certification (WoF and CoF) > General trailers > Vehicle structure > Structure

## 3-1 Structure

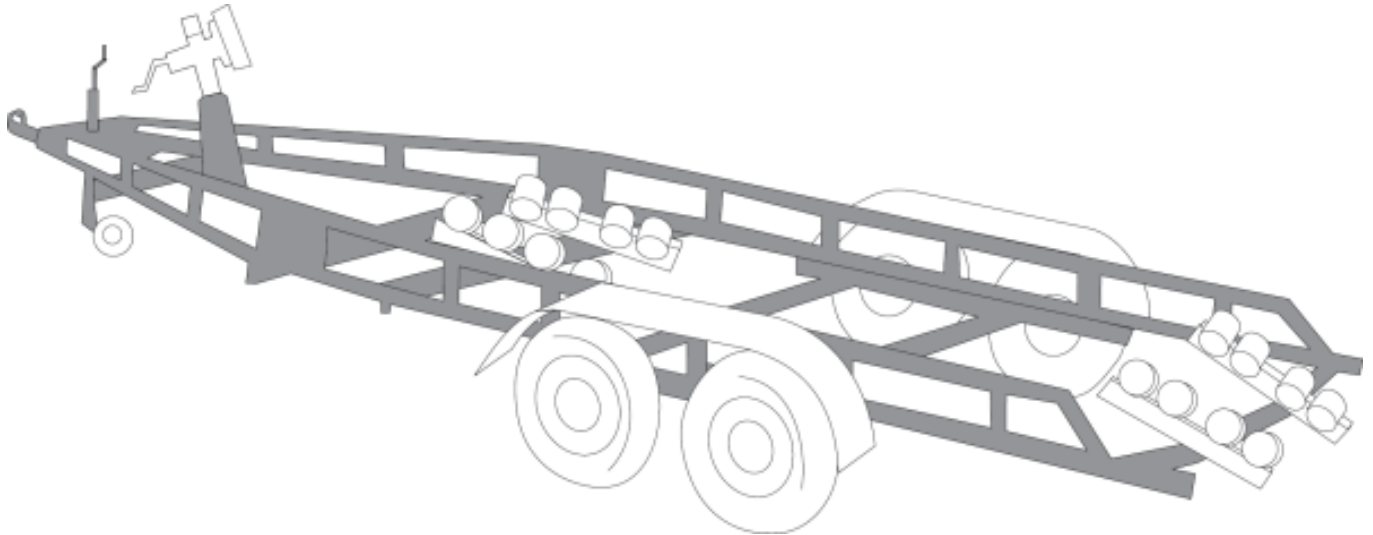
Figure 3-1-2. Shaded areas referred to in 'Condition' above

1. The structure of the vehicle (shaded areas of Figure 3-1-2) has visible:
  - a) deformation from the original shape that has affected the vehicle's structural integrity (Note 2), or

- a) The chassis rails, cross members, subframes, suspension and body mounting points of a vehicle with a separate chassis, and
- b) the load-bearing structure of a monocoque body, including body mounting points, and
- c) the body fitted to a trailer where the structure supports the chassis, similar to a unitary body (for example, some livestock carriers, horse floats, and UK-sourced caravans with wooden or wood laminate structures).

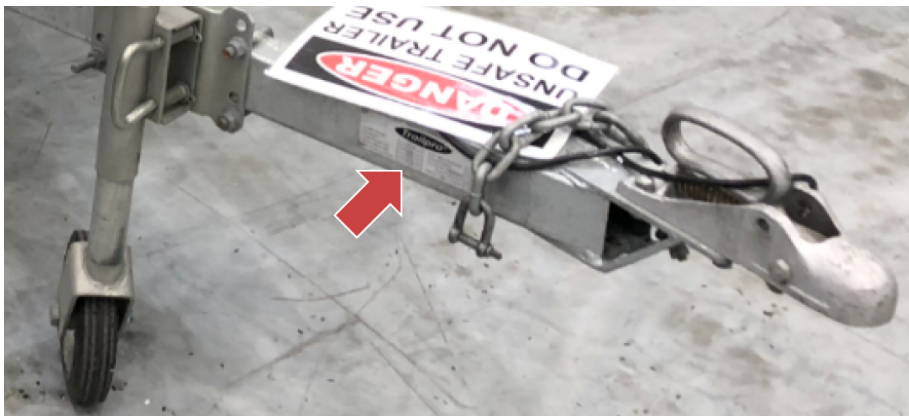
### Location of the trailer identification plate

There is a safety risk with the Trailpro brand of light trailers which were sold through Bunnings NZ between 1 January 2006 and 12 October 2018. Bunnings is now recalling all Trailpro trailers, other than Trailpro 8x4 Tradesman (TP5) or 8x5 Tandem (TP8) models that have undergone Bunnings-approved repairs as part of an earlier recall. These can be identified by the serial number on the identification plate ending with an “R” (see Figure 3-1-6). A TP5 or TP8 trailer with a serial number ending with an “R” may be issued a WoF if it passes all other checks. More information can be found in the [safety recall notice](#) on the Transport Agency website.

Affected trailers are fitted with an identification plate which is located on the outside of the trailer drawbar near the tow coupling.

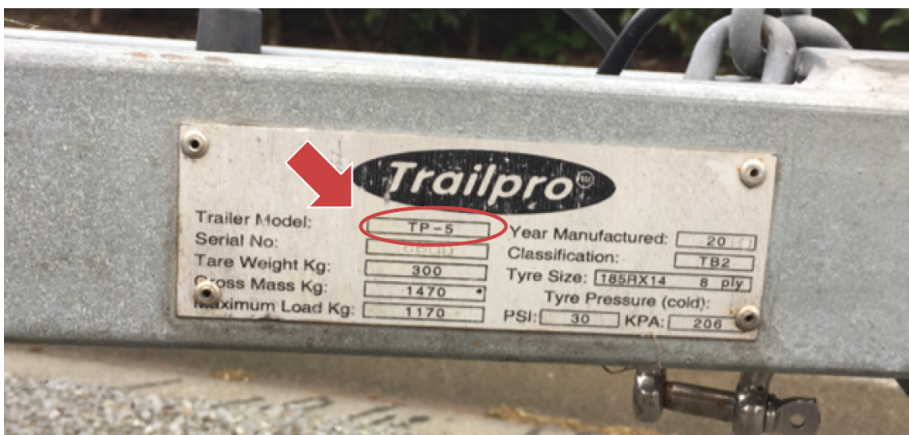
### Identification plate similar showing model number

The identification tag may be missing, faded, damaged or obscured. All Trailpro models have drawbars that are **bolted rather than welded** to the trailer. The TP5 has a single axle and a tray size of 8'x4' (2.4m x 1.2m). The TP8 is a tandem axle model with a tray size of 8'x5' (2.4m x 1.5m).
