Extract taken from: NZTA Vehicle Portal > VIRMs > Light vehicle repair certification > Motorcycles

## 10 Motorcycles

### 10-2 Measurements

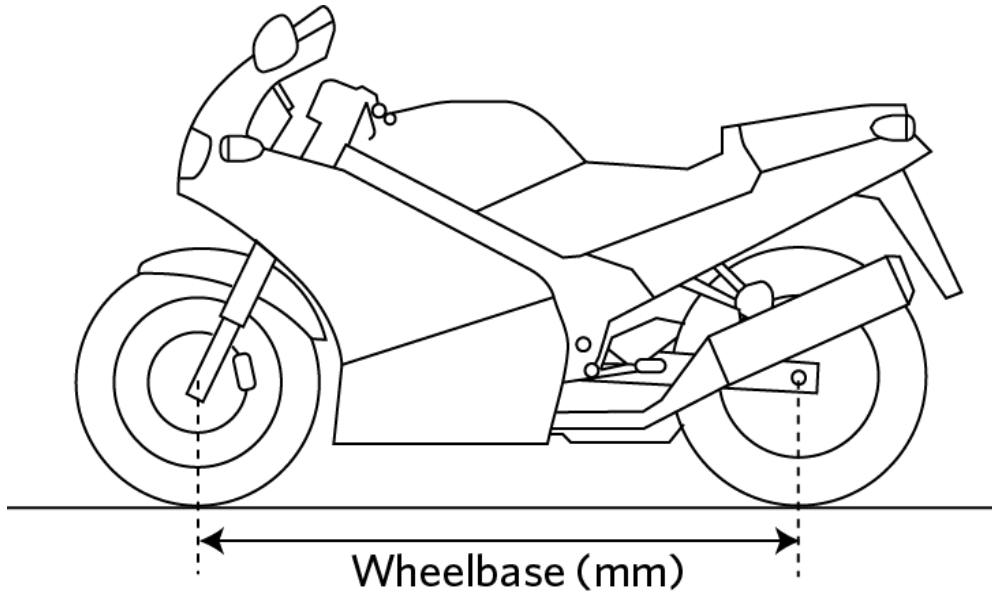
**Figure 10-2-1. Wheelbase measurement**

Wheelbase is measured between the centre of the contact patches of the front and rear wheels.

1. A fork has runout in excess of 0.4mm (unless permitted by the manufacturer).
2. One of the following measurements is not within the manufacturers specifications:
  - a) wheelbase (**Figure 10-2-1**)
  - b) steering head angle (**Figure 10-2-2**)
  - c) front wheel castor angle (**Figure 10-2-3**)

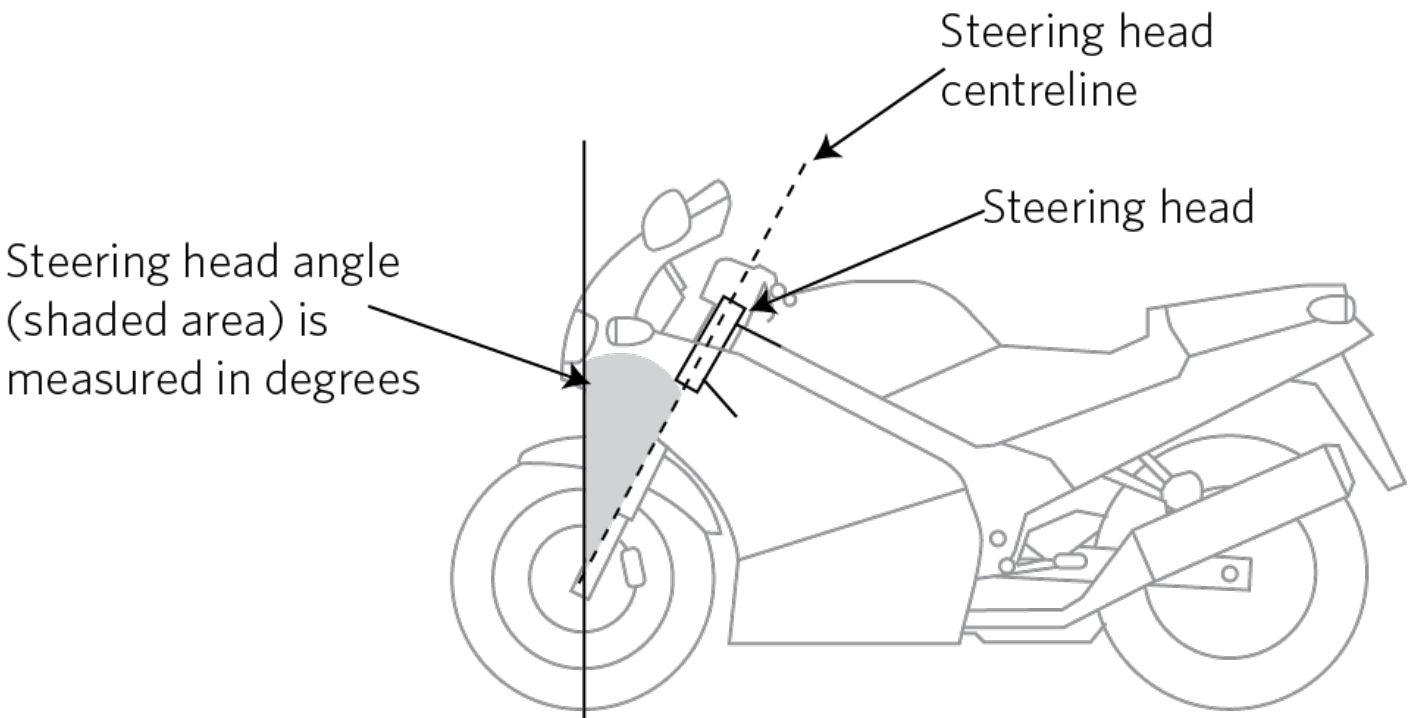
**Figure 10-2-2. Steering head angle measurement**

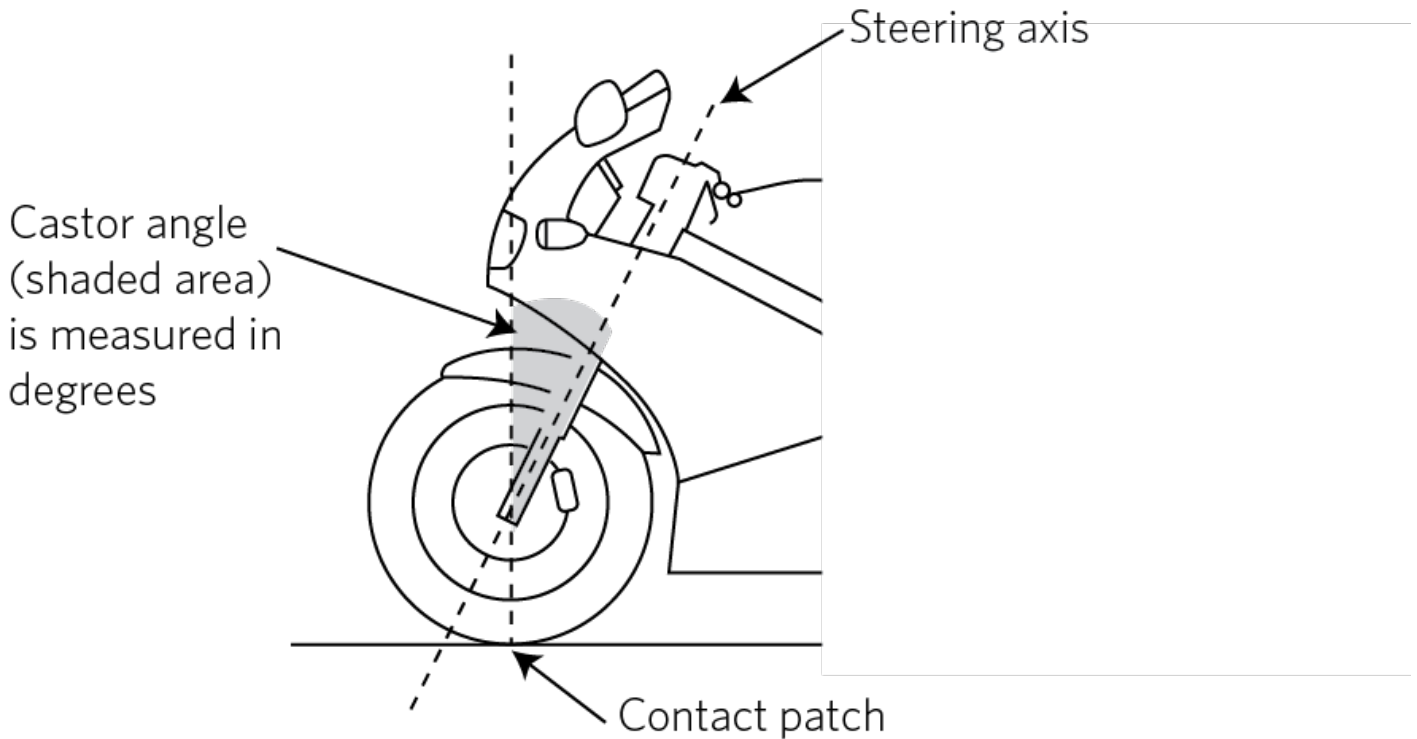
**Figure 10-2-3. Front wheel castor angle measurement**

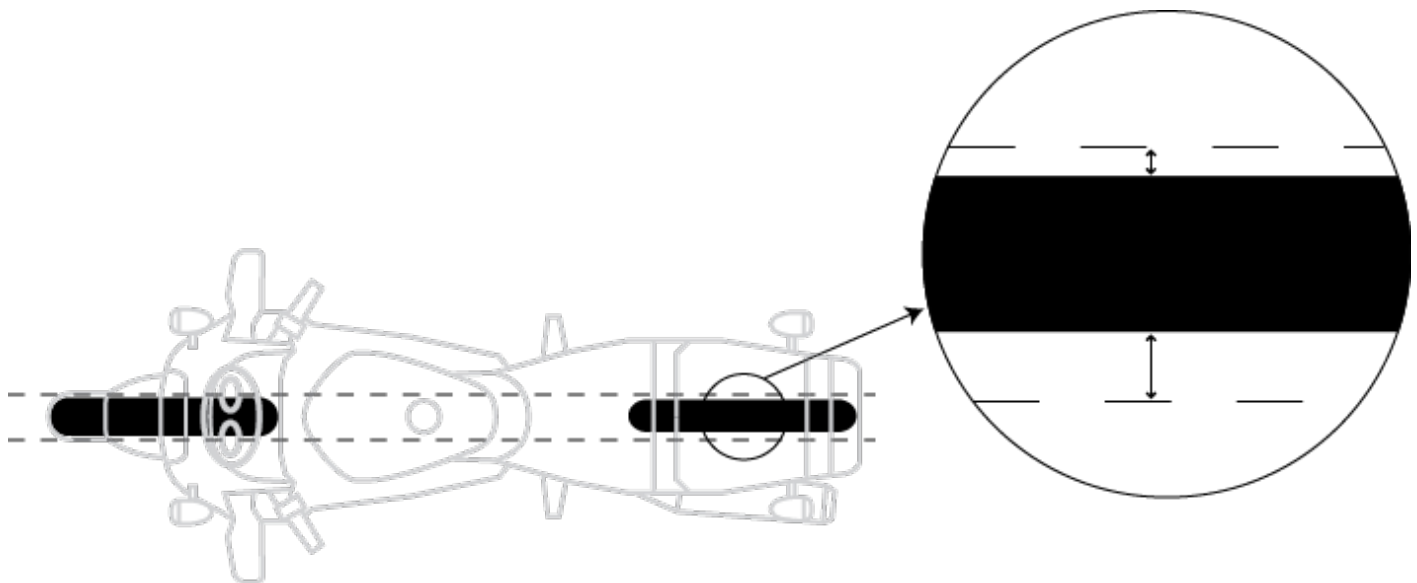
**Figure 10-2-4. Wheel track offset measurement**

- d) wheel track offset (**Figure 10-2-4**).
- 3. The wheel alignment has not been measured.
- 4. The wheel alignment is not within specification.
- 5. A reference measurement of the frame has not been completed and recorded (**Note 1**).
- 6. A reference measurement of the frame shows a difference of more than 3mm (unless permitted by the manufacturers instructions).
