# VIRM: In-service certification (WoF and CoF) amendment

## 1 October 2023 amendment preview

September 2023

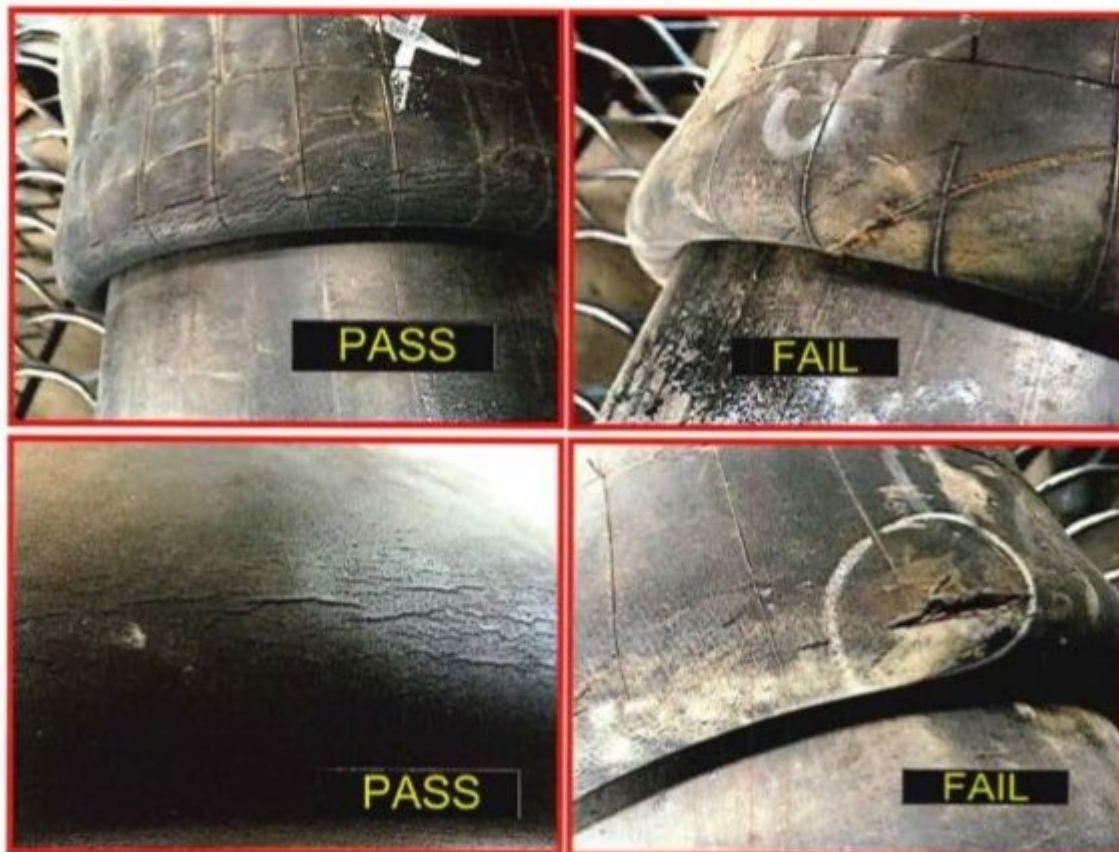
**Figure 9-1-2. Sample air bag bellows images**

9. **Air bag bellows** has obvious external damage – protruding or worn cords [\(Figure 9-1-2\)](#).

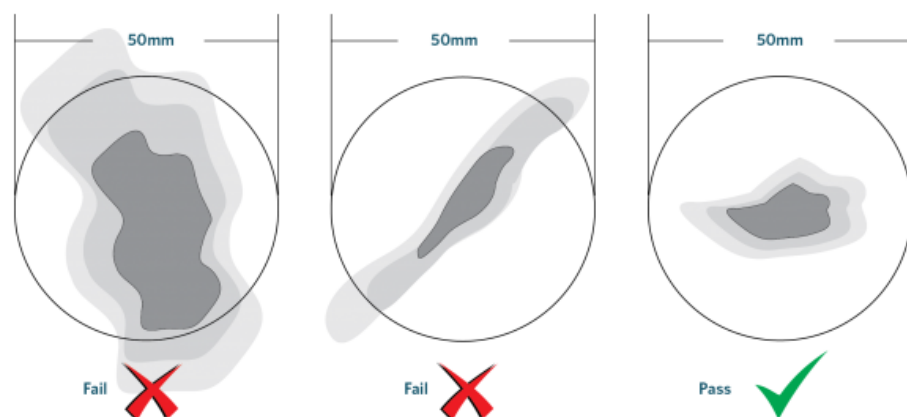
**Figure 3-1-1. Corrosion or wood rotting damage 50mm diameter limit**

- b) cracking, or
- c) fracture, or
- d) corrosion **or wood rotting** damage ([Note 2](#)) that is individually larger than 50mm in diameter ([Figure 3-1-1](#)), or

- b) cracking ([Note 3](#) ⓘ) ([Figure 3-1-3](#)), or
  - c) fracture, or
  - d) corrosion **or wood rotting** damage ([Note 1](#) ⓘ) that is individually larger than 50mm in diameter ([Figure 3-1-1](#)), or

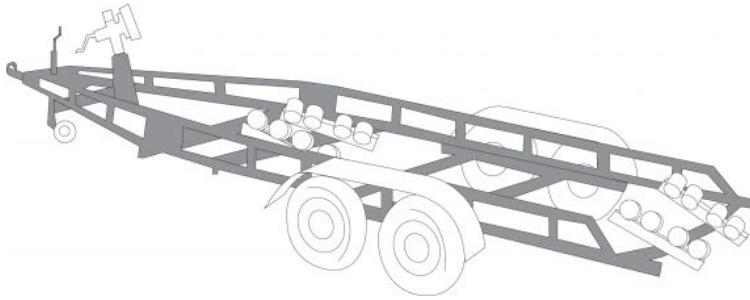
**Figure 3-1-2. Shaded areas referred to in 'Condition' above**

- e) corrosion **or wood rotting** damage within 150mm of the top of an A-pillar ([Figure 3-1-2](#)), or
- f) any corrosion **or wood rotting** that the inspector considers has caused weakening of a load-bearing structure ([Note 6](#)), or

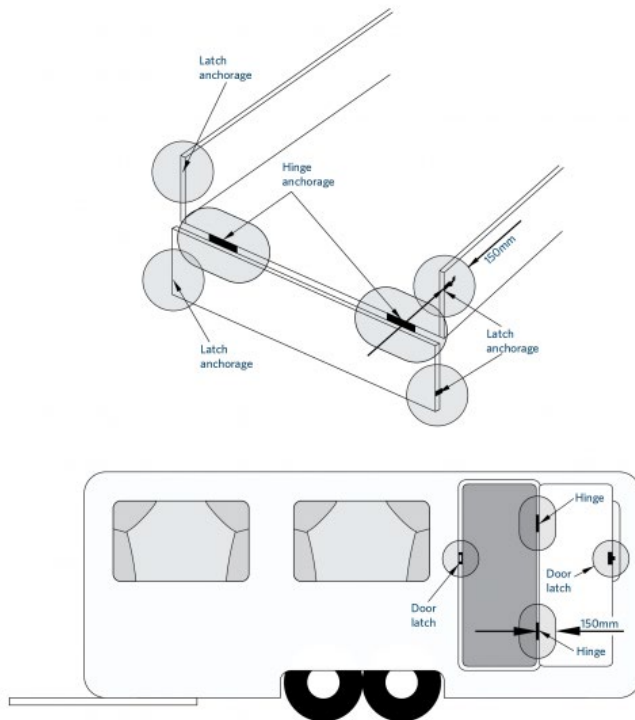
**Figure 3-1-4. Hinge and latch anchorages**

No corrosion structural damage is allowed within 150mm of a circle around the outside of hinge or latch components a hinge, latch or load anchorage component.

3. There is corrosion **or wood rotting** damage within 150mm of the hinge of a hinged panel ([Figure 3-1-4](#)).
4. There is corrosion **or wood rotting** damage within 150mm of the latch of a hinged panel ([Figure 3-1-4](#)).

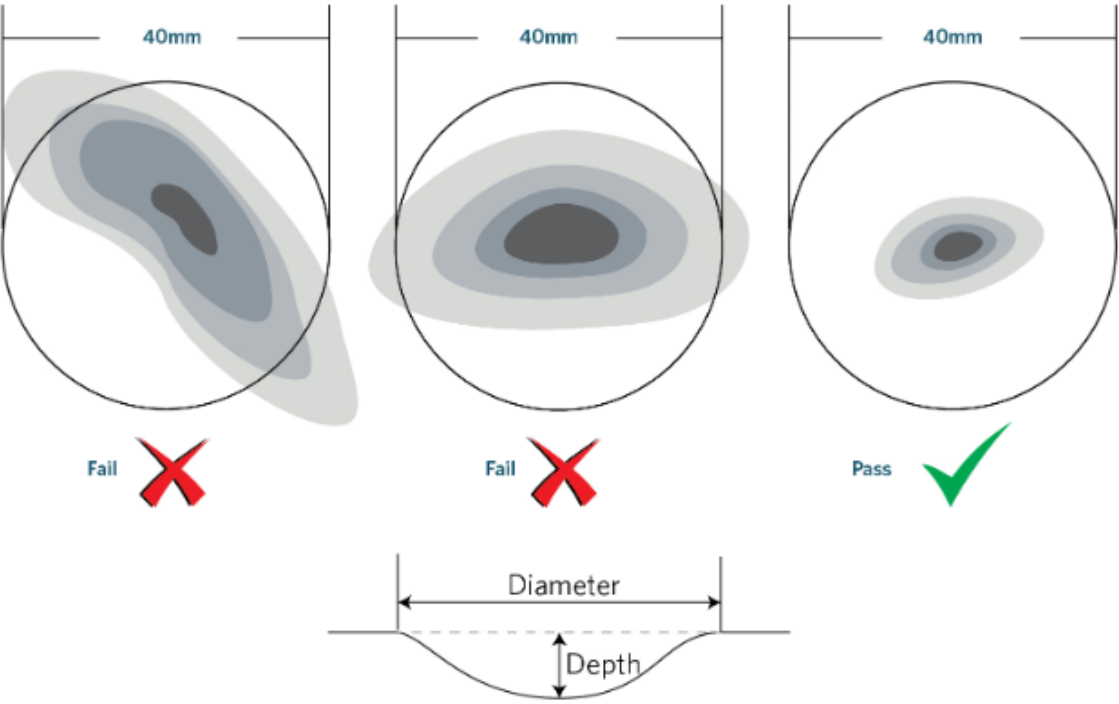
Dents smaller than 5mm deep and 40mm in diameter (to the outer edges of the crease), such as those caused by hail, in the pillars, cant rail or any other similar roof structure, should not be considered to affect the vehicles structural integrity. Any damage larger than above should be referred to a repairer for additional information (see Figure 3-1-4).

**Figure 3-1-4. Deformation limits**

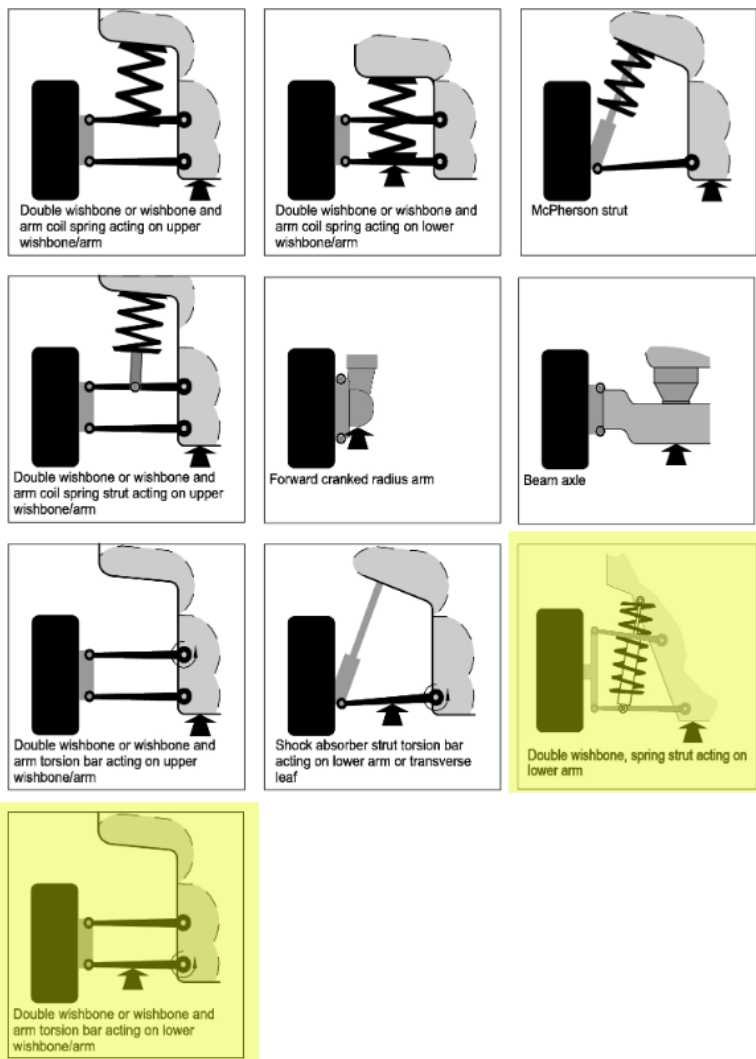
To help ensure ball joint wear is correctly detected, the images below show the jacking points for some common suspension types. They do not cover all suspension types or versions.

It's vital that the vehicle is jacked up correctly to avoid any damage. Depending on the type of suspension fitted to the vehicle, you may need to seek the manufacturer's guidance.
