Extract taken from: Border inspection of imported used vehicles > Reference materials

1 Guidelines for the detection of reportable damage on imported used vehicles (excl motorcycles)

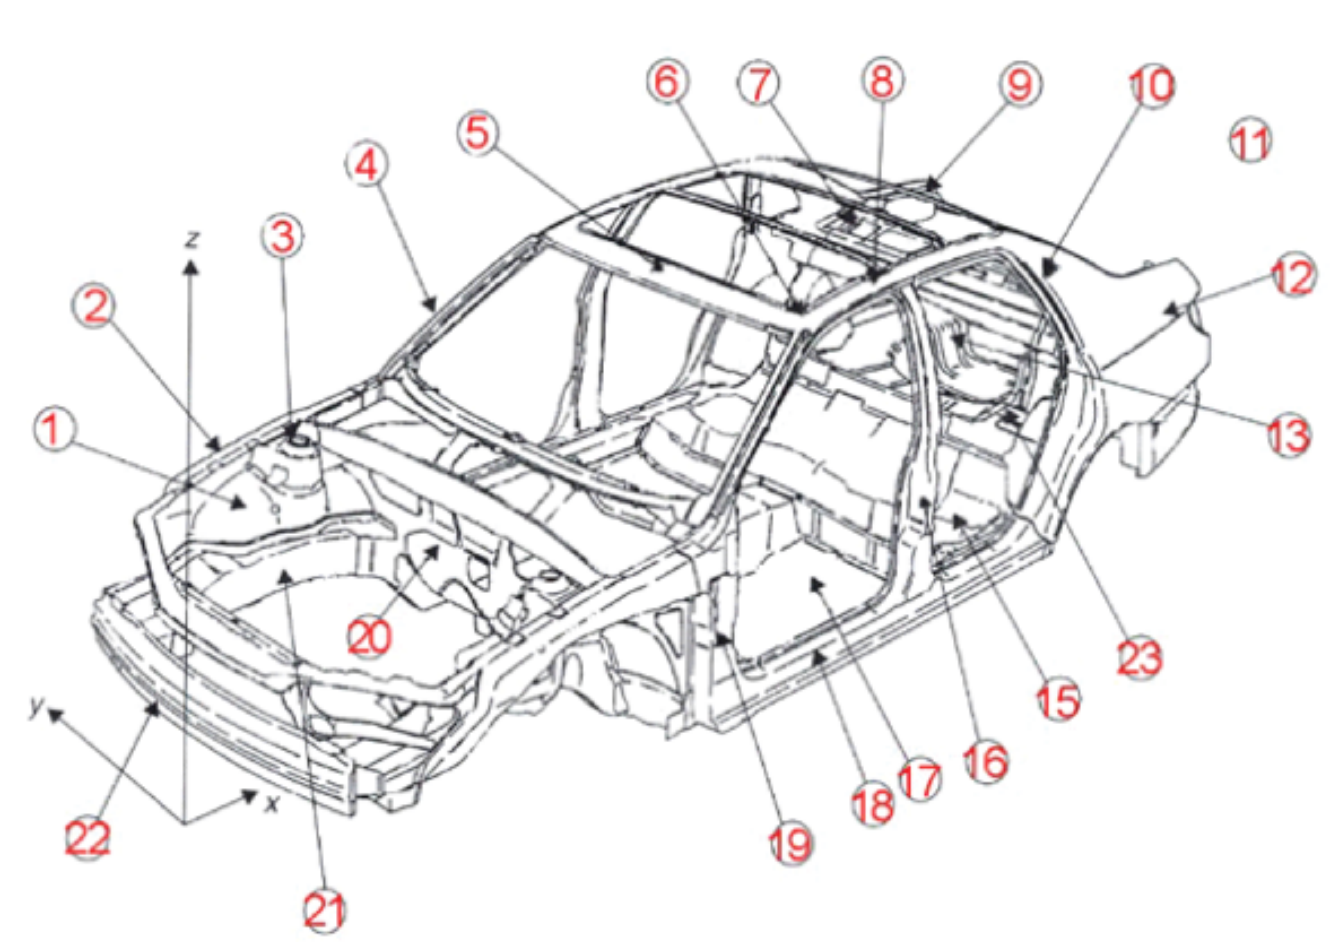
3 Overview – structural parts: unibody chassis

1 Inner guard	8 Cant rail	15 Rear seat floor	22 Front bumper
2 Upper chassis rail (reinforcer)	9 Roof (not shown)	16 B pillar	23 Spare wheel well
3 Strut tower	10 C pillar (upper)	17 Floor	24 Tunnel (longitudinal)
4 A pillar (upper)	11 Rear panel	18 Sill (rocker panel)	25 Rear seat cross beam
5 Windscreen header	12 Rear ¼ panel	19 A pillar (lower)	26 Rear suspension cross beam
6 Roof stiffener	13 Boot floor	20 Bulkhead	
7 Parcel tray	14 Rear seat back	21 Lower (engine) chassis rail

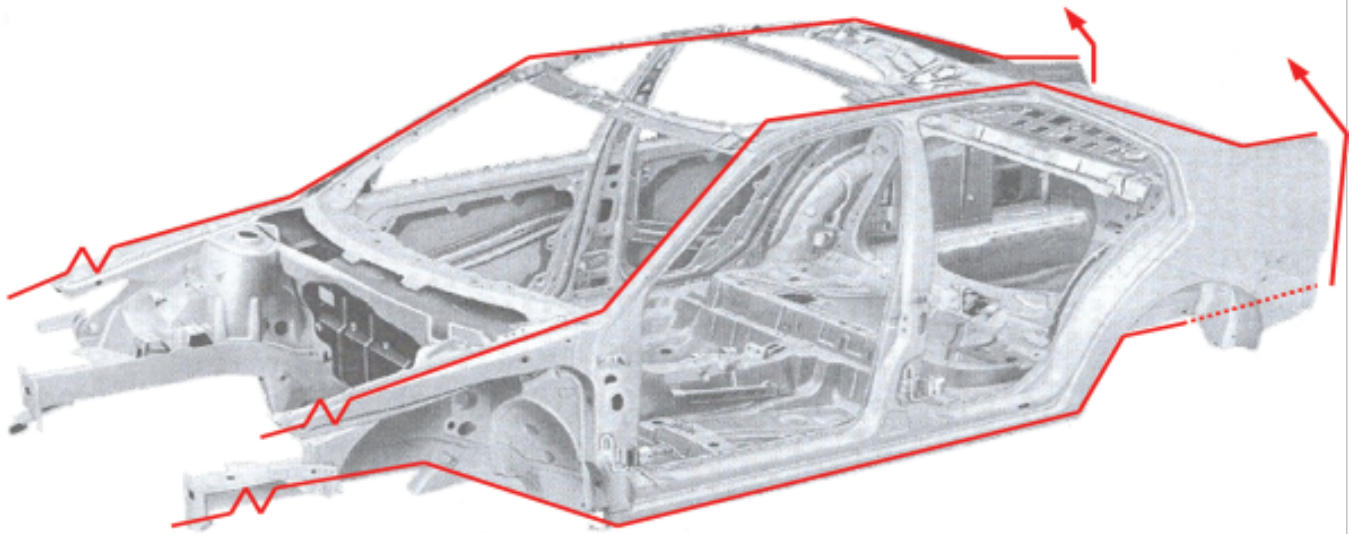
5 Overview – energy management path

The structural integrity of the passenger safety cell is a key feature of motor-vehicle design.

- Front and rear structural parts are designed to absorb or manage collision energy by collapsing in pre-determined areas called crush zones.
- Crush zones are built into the front and rear of the vehicle in the form of holes, slots, dimples, convolutions, or hydro-formed tailored blanks.
- Bonnets are designed to buckle and avoid windscreen penetration, and also minimise pedestrian injury.
- The unibody structure is designed to route collision energy around the passengers; with the passenger safety cell the last area to deform in a crash where collision energy exceeds the design.

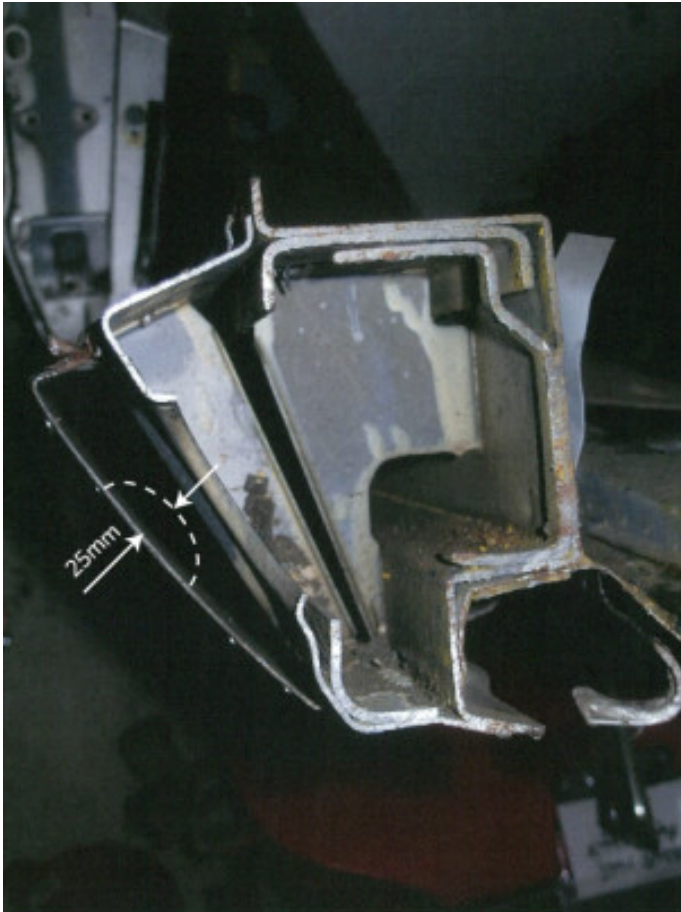
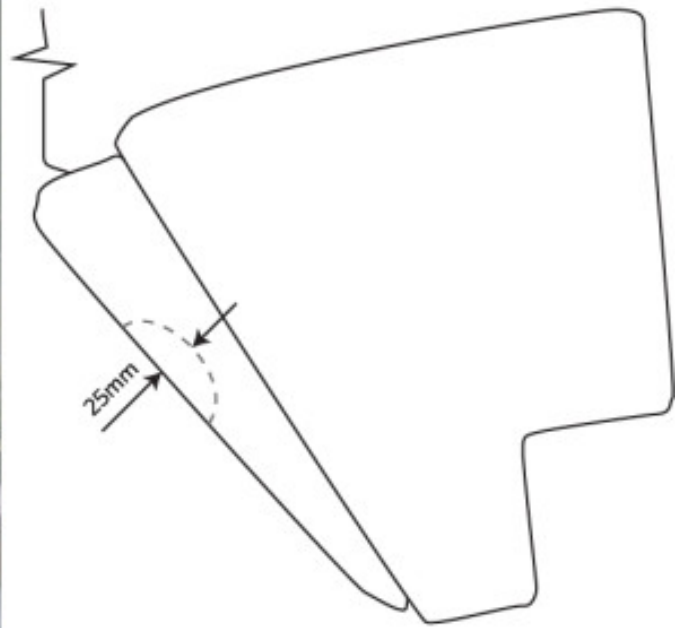
Outer sills cross section and rocker panels

- A vehicle must be reported if there is any discernible denting or distortion to the folds or swages in the dog leg, sill panel or structure of the inner/outer sill weld seam, other than minor scraping.
- A vehicle must be reported if rocker panels (outer sills) are dented or creased lengthways along the sill and the depth of the crease exceeds 25mm.
- A vehicle must be reported if rocker panels (outer sills) are vertically dented or creased across the sill regardless of the depth of the crease or dent.

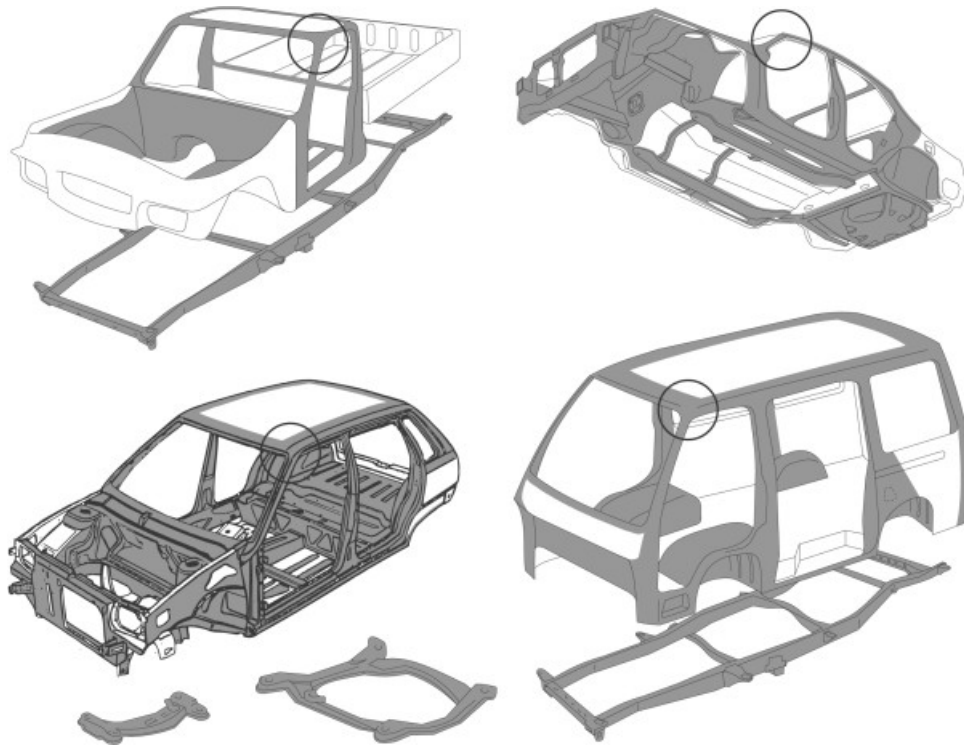
Figure 1-1-1. Structural corrosion damage limits

A vehicle must be reported if there is corrosion damage in any structural area, as indicated in the shaded areas of Figure 1-1-1.

If there is perforated corrosion in any other (non-structural) area, as indicated in the non-shaded areas of Figure 1-1-1, the vehicle requires to be reported.

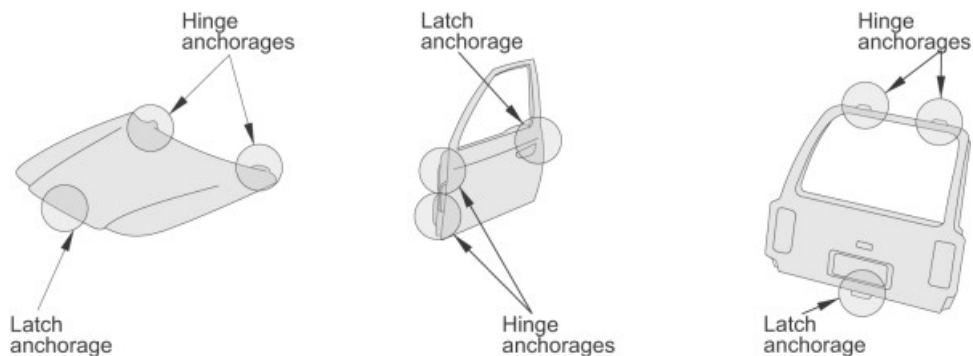
Figure 1-1-2. Hinge and latch anchorage corrosion damage limits

Corrosion, or the repair of corrosion on 'bolt on' parts (doors, bonnets, and boot lids) within a 150mm circle around the outside of hinge or latch components will require to be reported. These 'no corrosion' zones are circled in Figure 1-1-2.

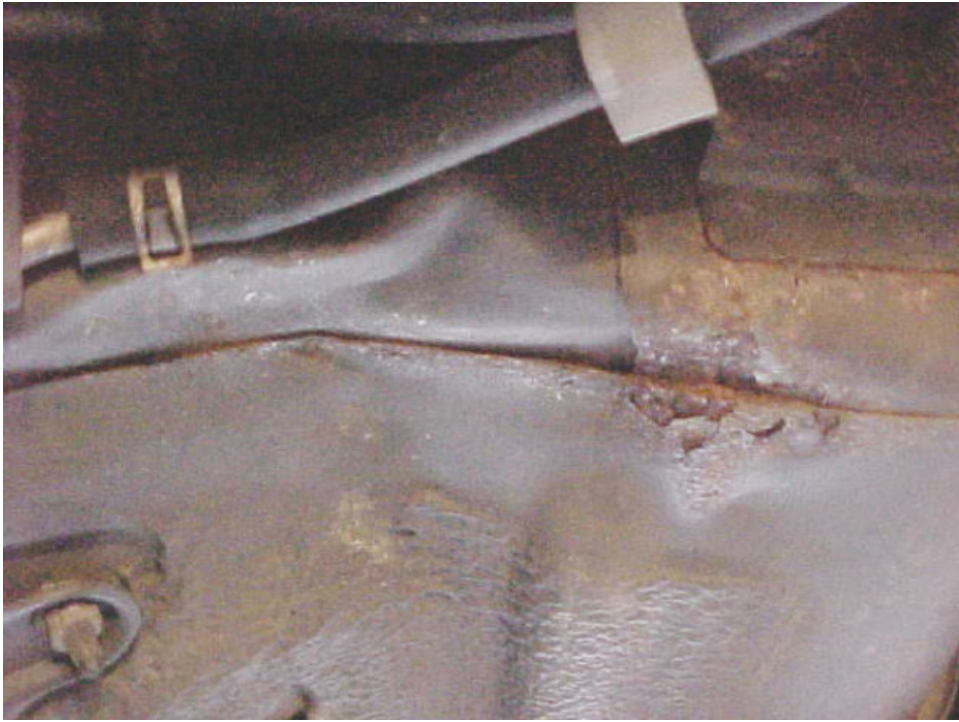
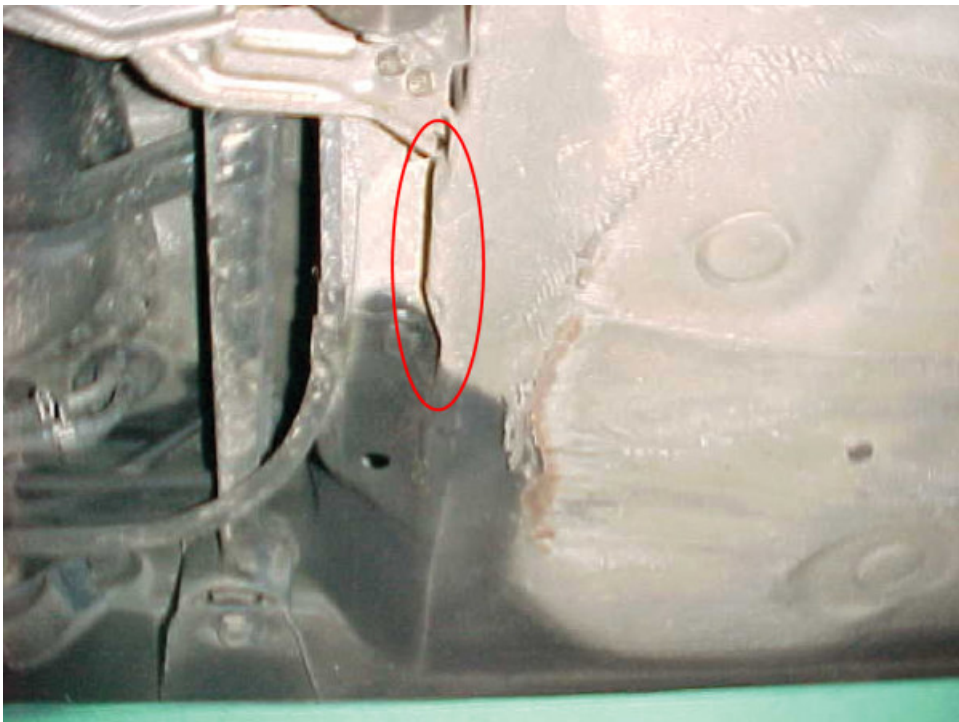
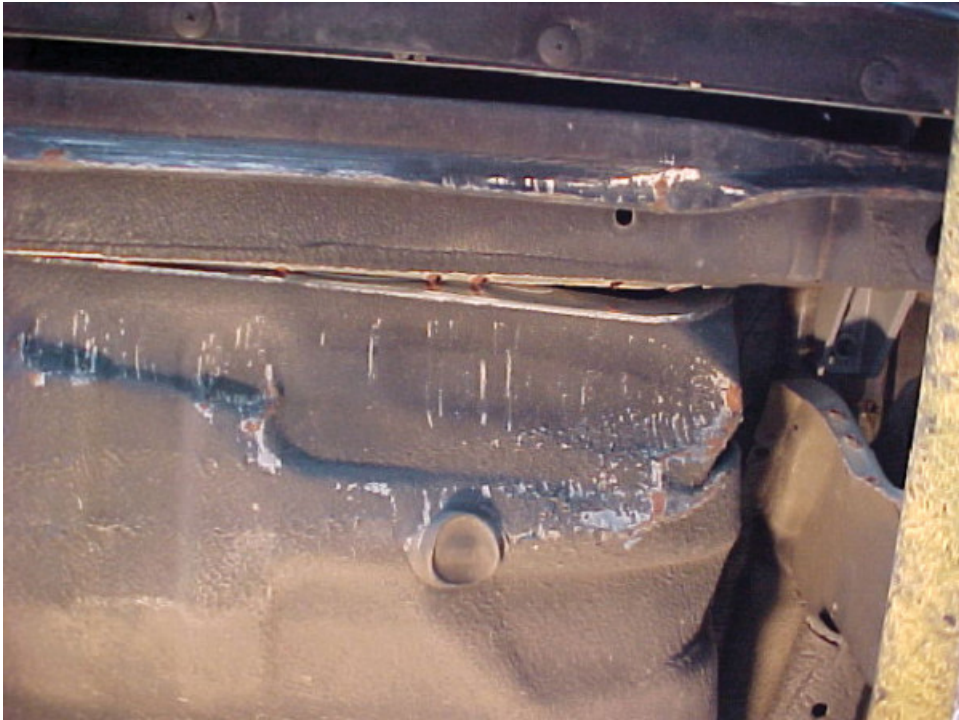
Under body damage: splitting of seam wells

A vehicle must be reported if it has underbody damage as a result of a collision with a substantial object, sufficient to cause the splitting of seam welds, distortion of suspension members or mounting points, or tearing of metal structures, excluding floorpan stiffeners (Note 1).

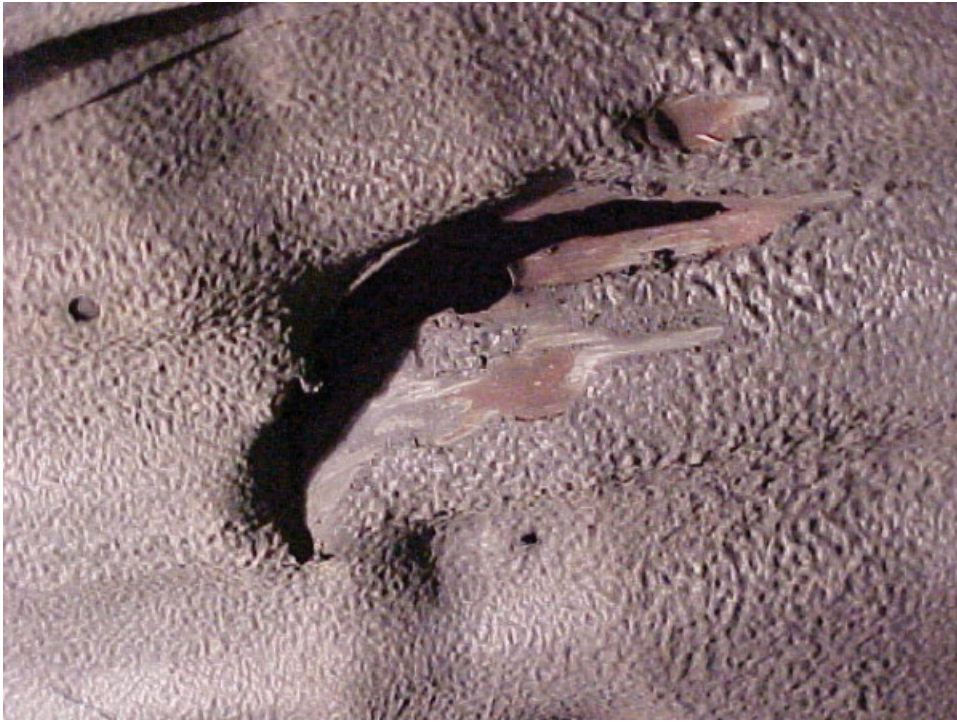
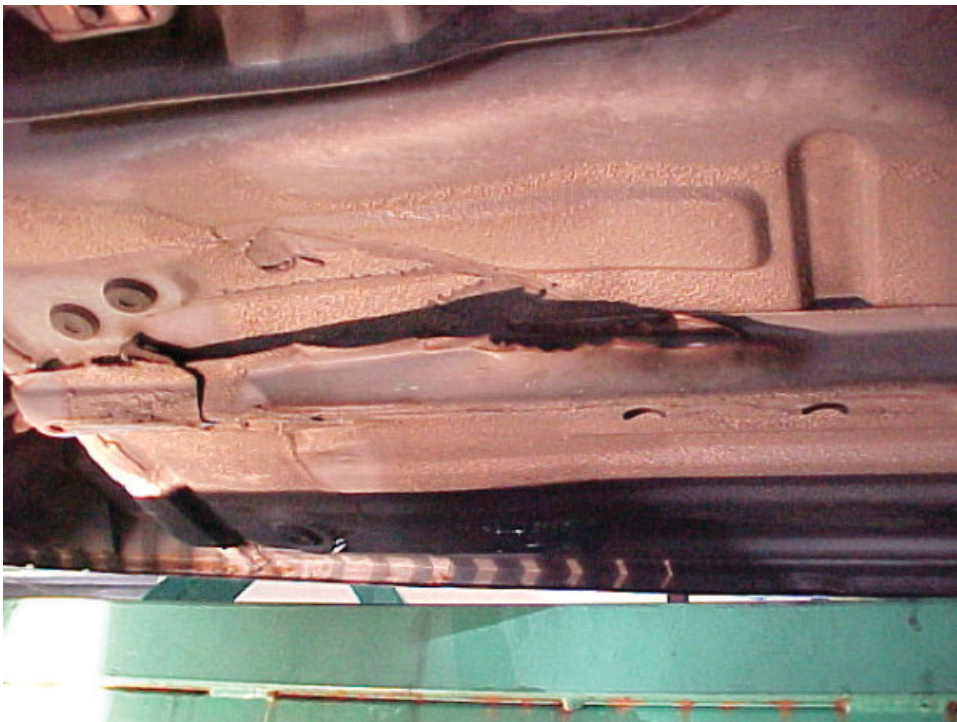
5-3 Under body damage: tearing of the metal

Under body damage: tearing of the metal

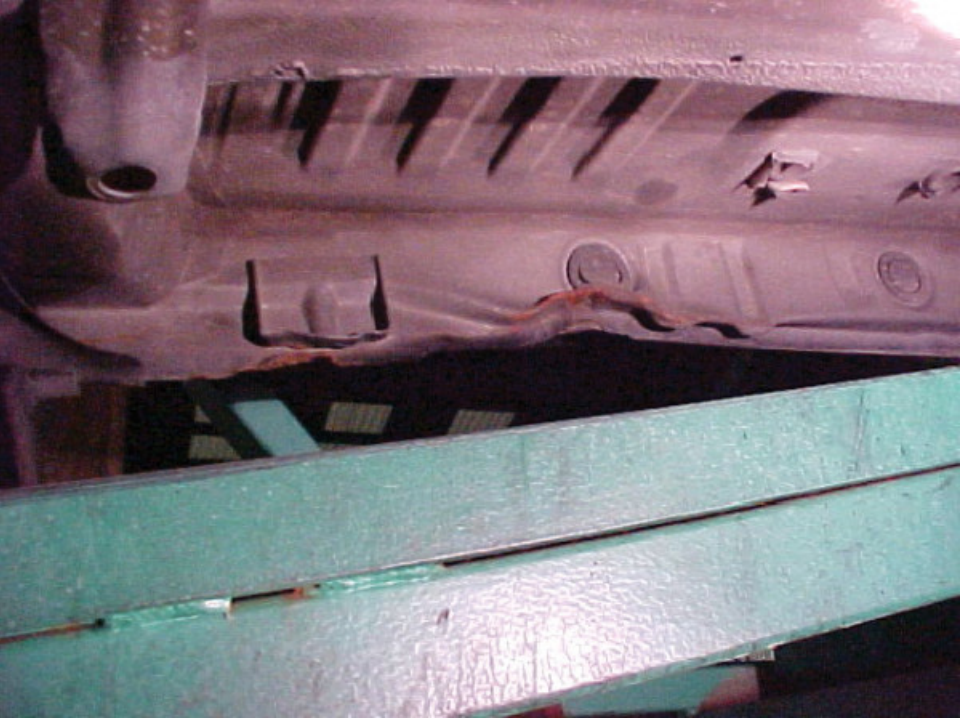
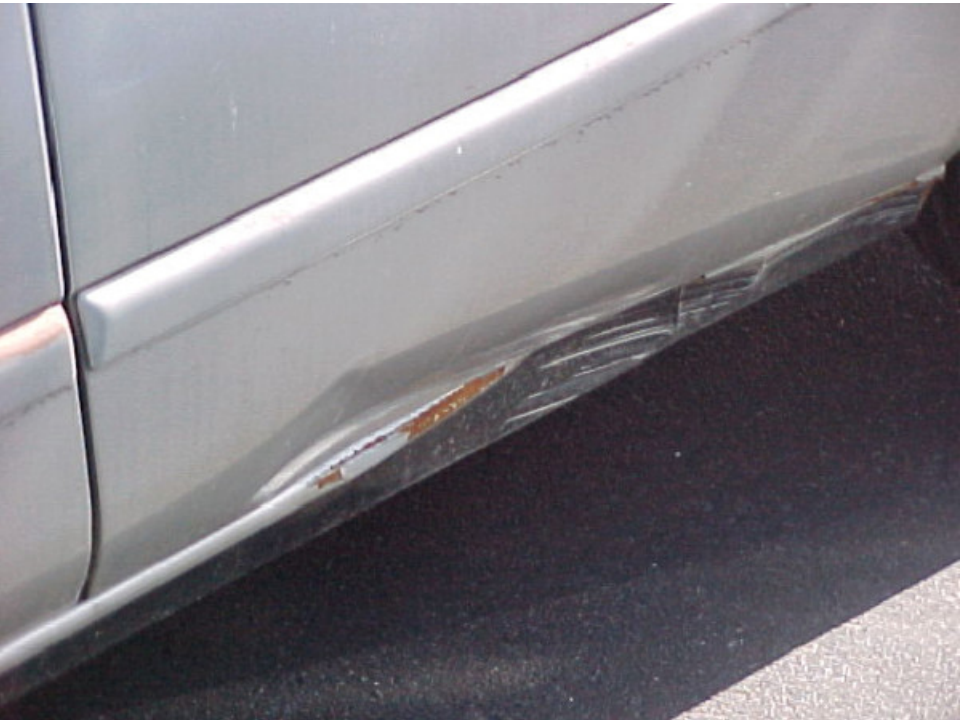
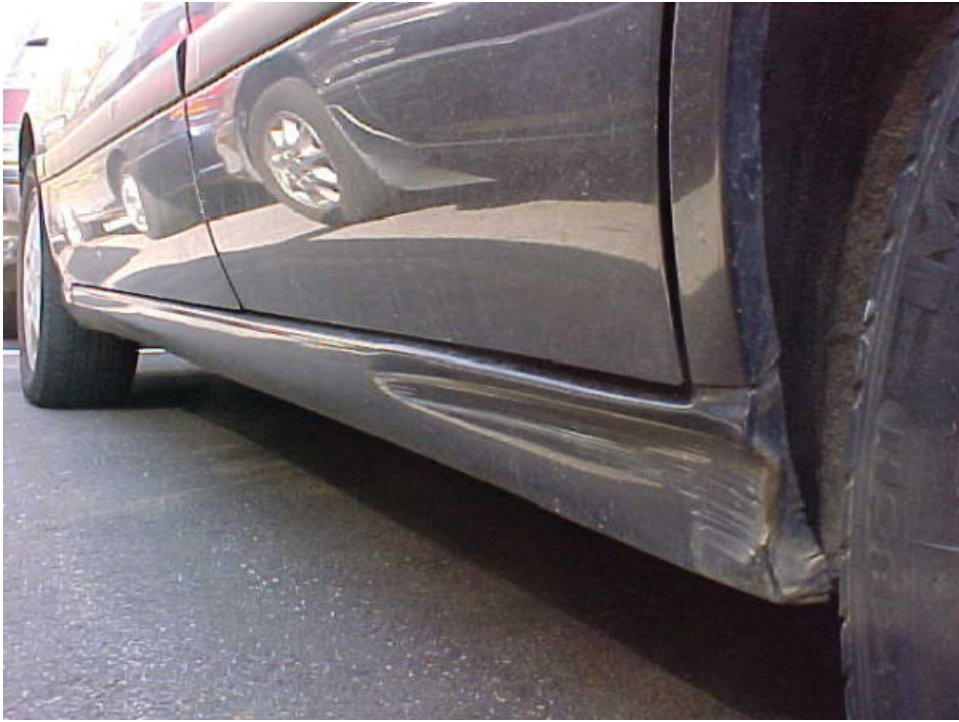
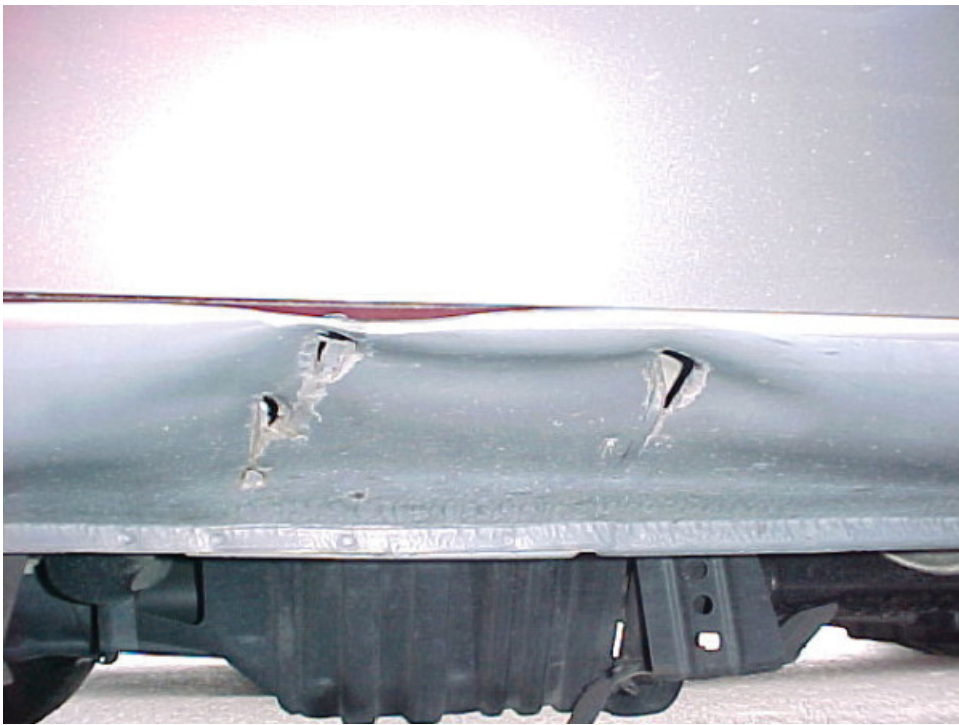
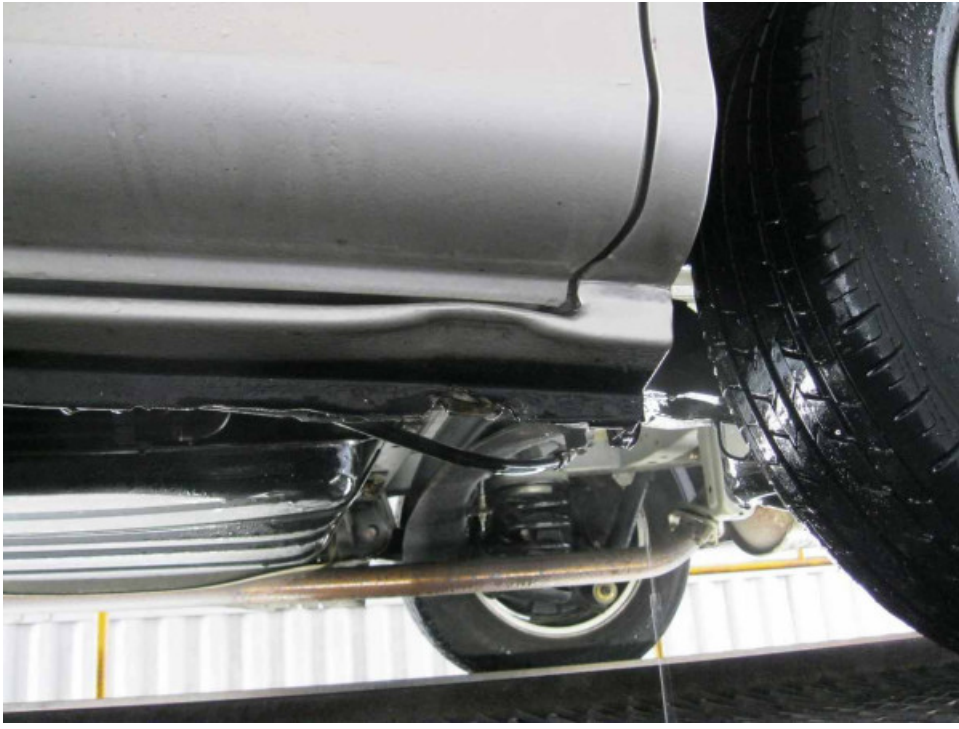
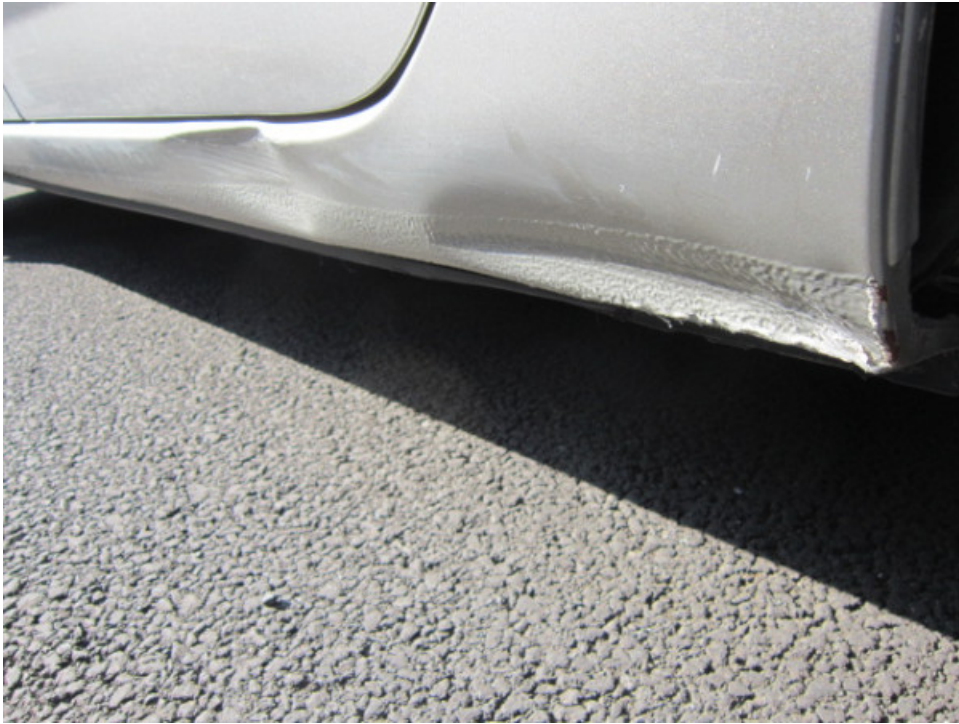
5-4 Damage to rocker panels and cant rails

Damage to rocker panels and cant rails

Rocker panels

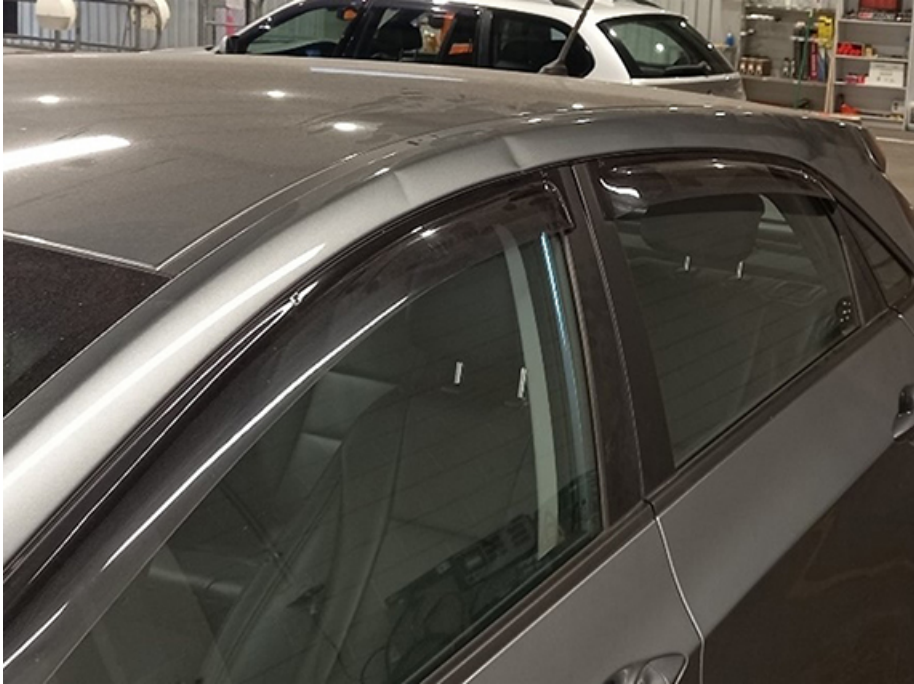
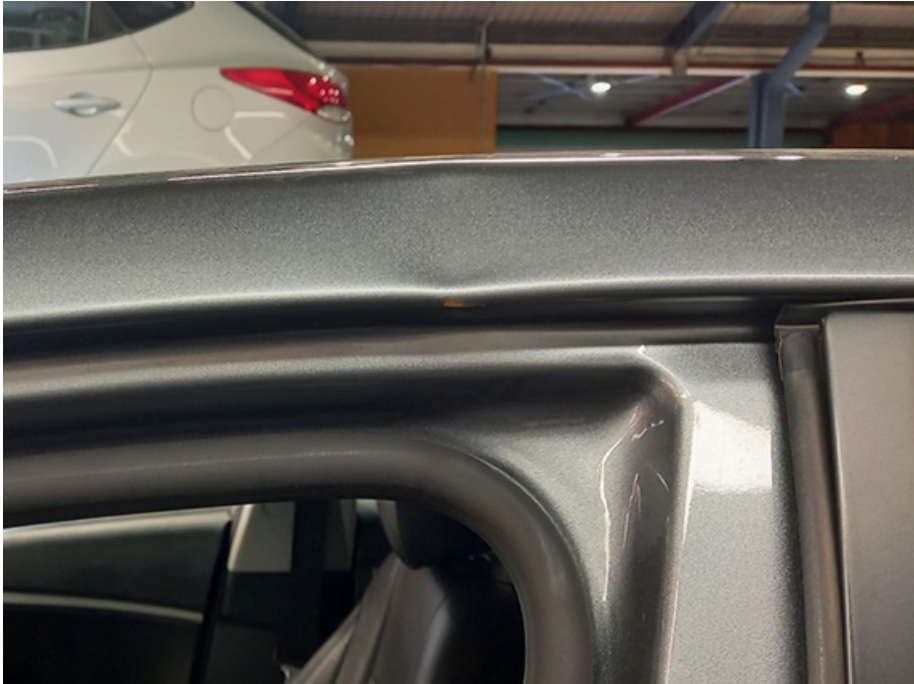
Cant rails

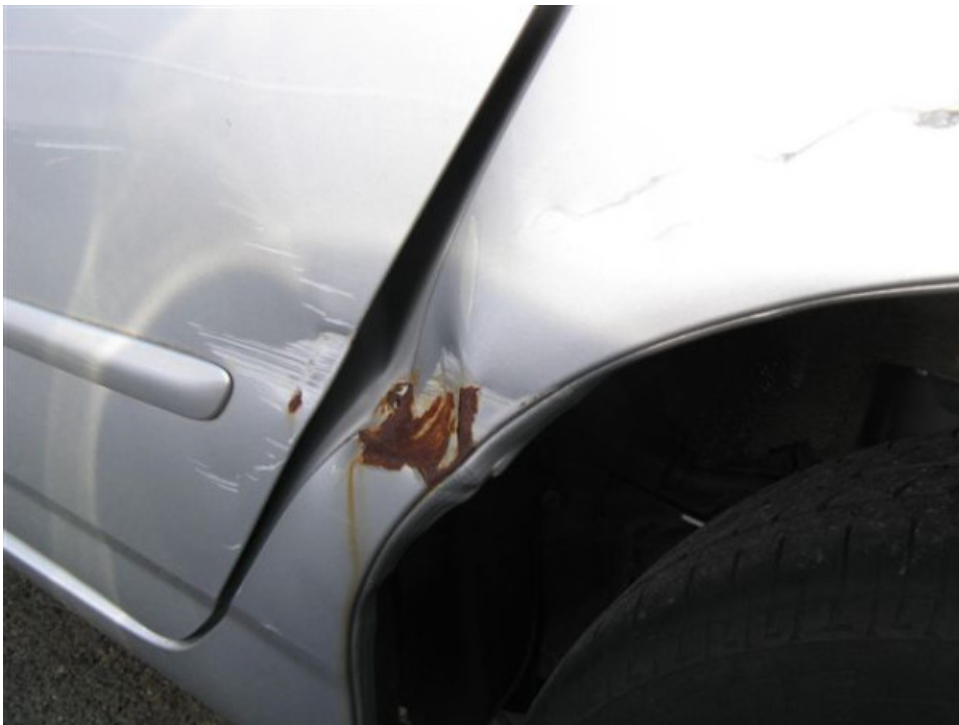
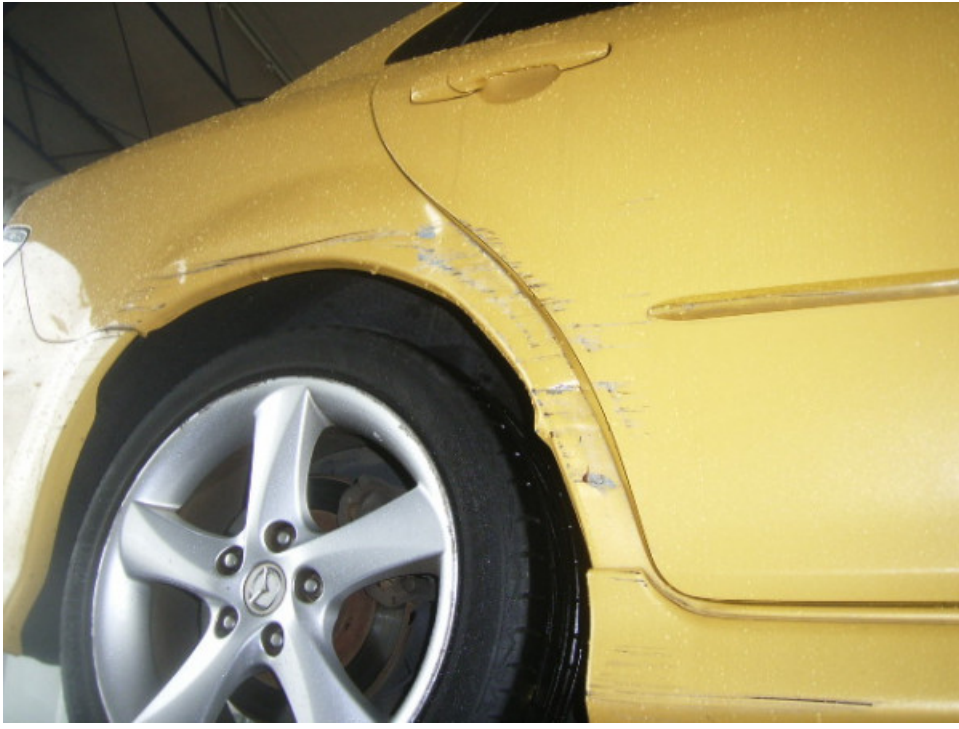
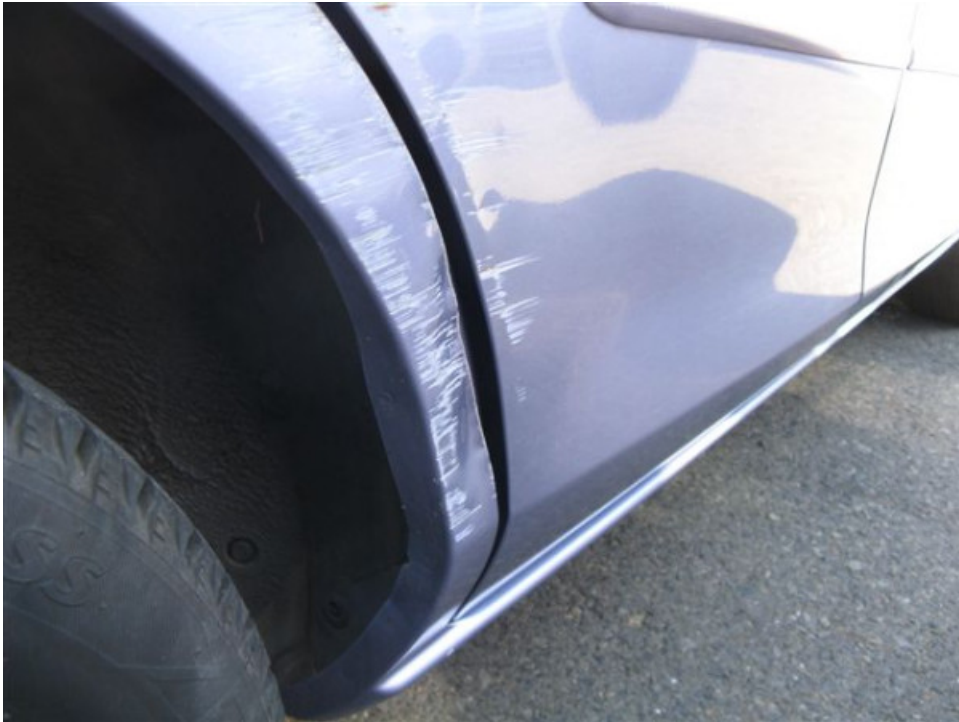
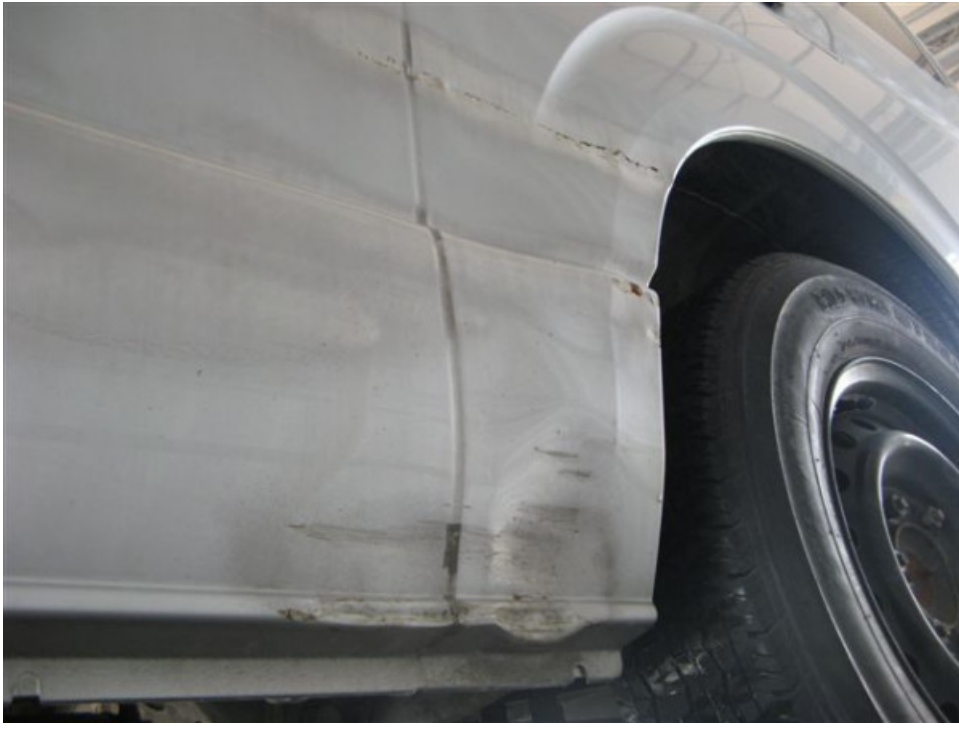
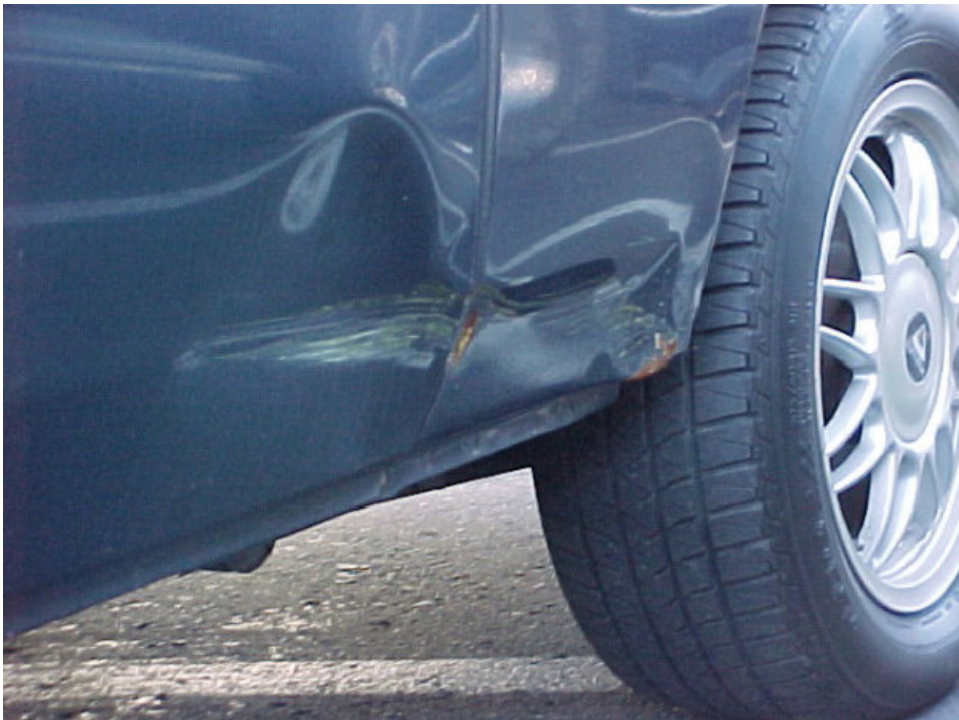
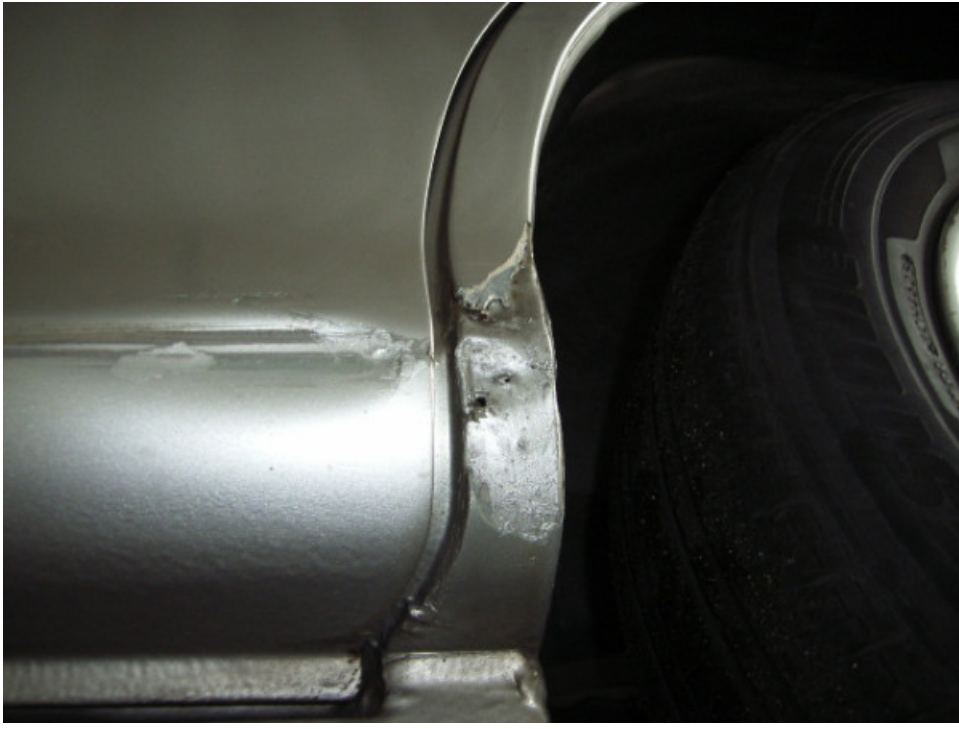
5-6 Dogleg flag

Look for discrepancies in the door gap.

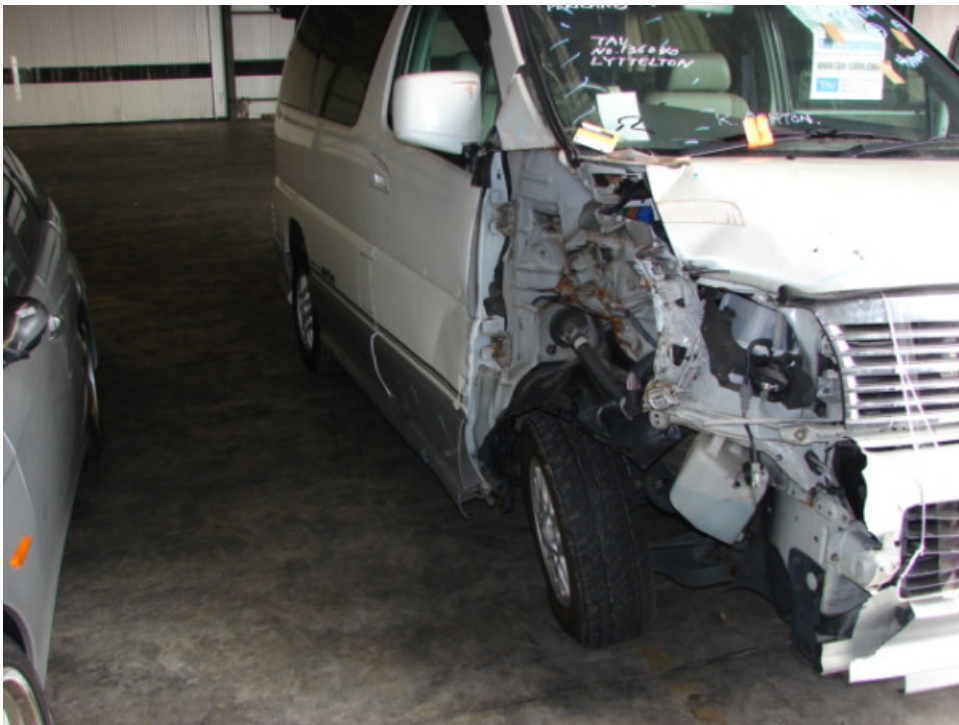
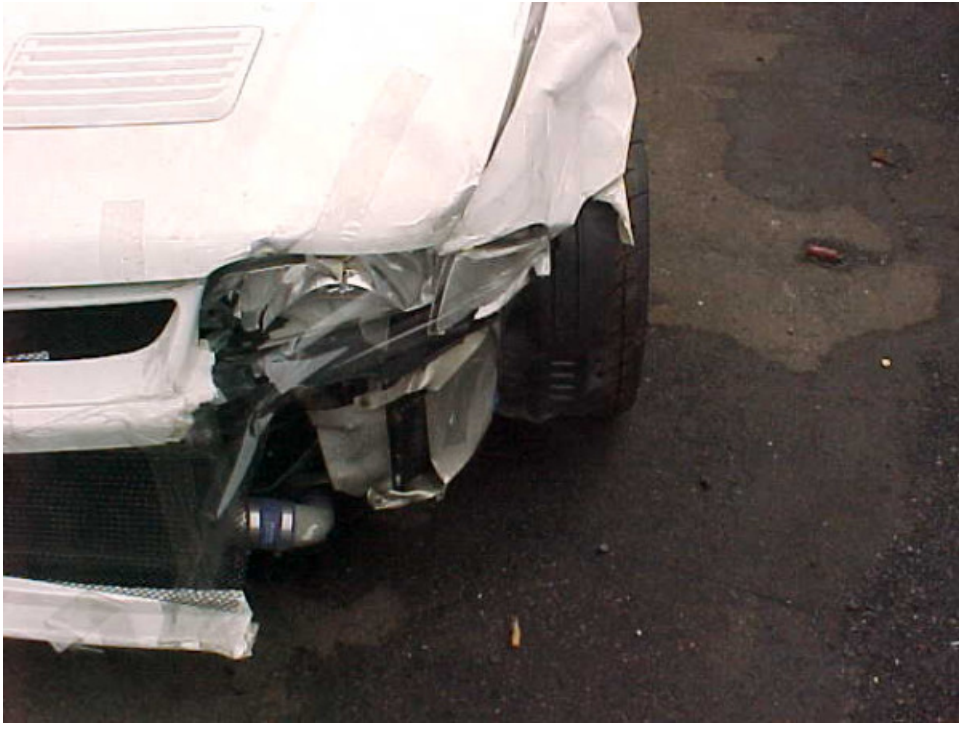
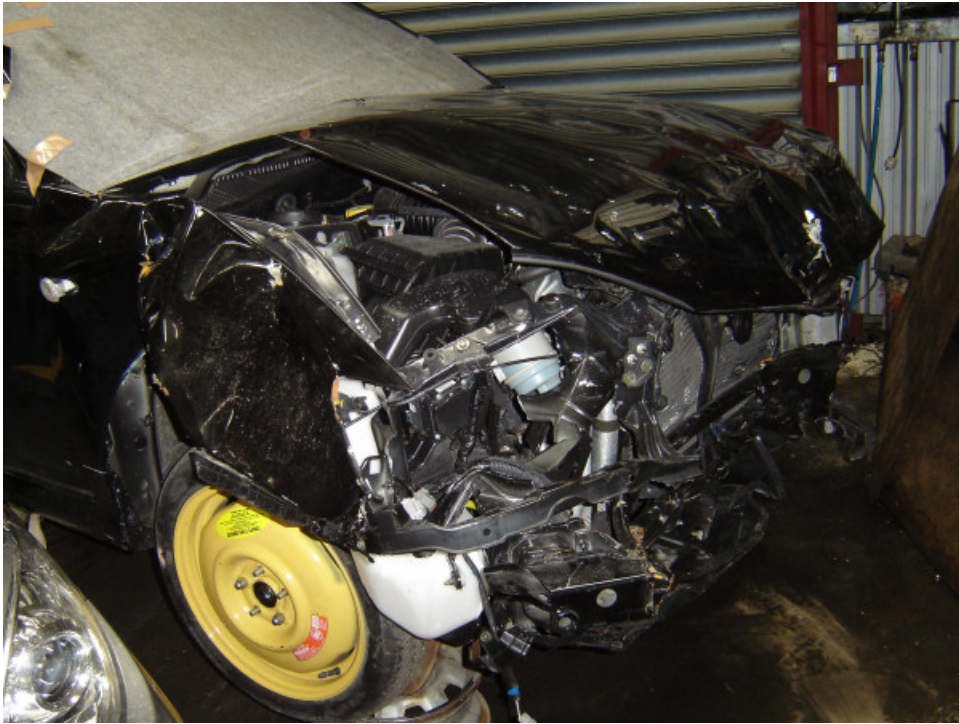
5-7 Distortion to longitudinal rails: front and rear crush zones

Distortion to longitudinal rails: front and rear crush zones
