Extract taken from: Border inspection of imported used vehicles > Reference materials

1 Guidelines for the detection of reportable damage on imported used vehicles (excl motorcycles)

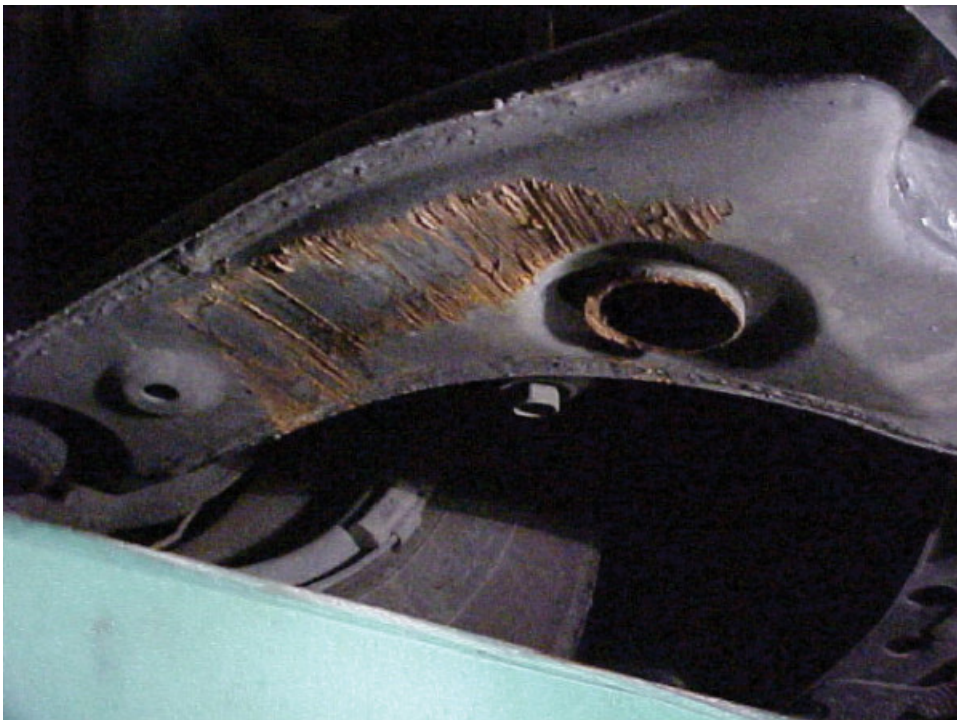
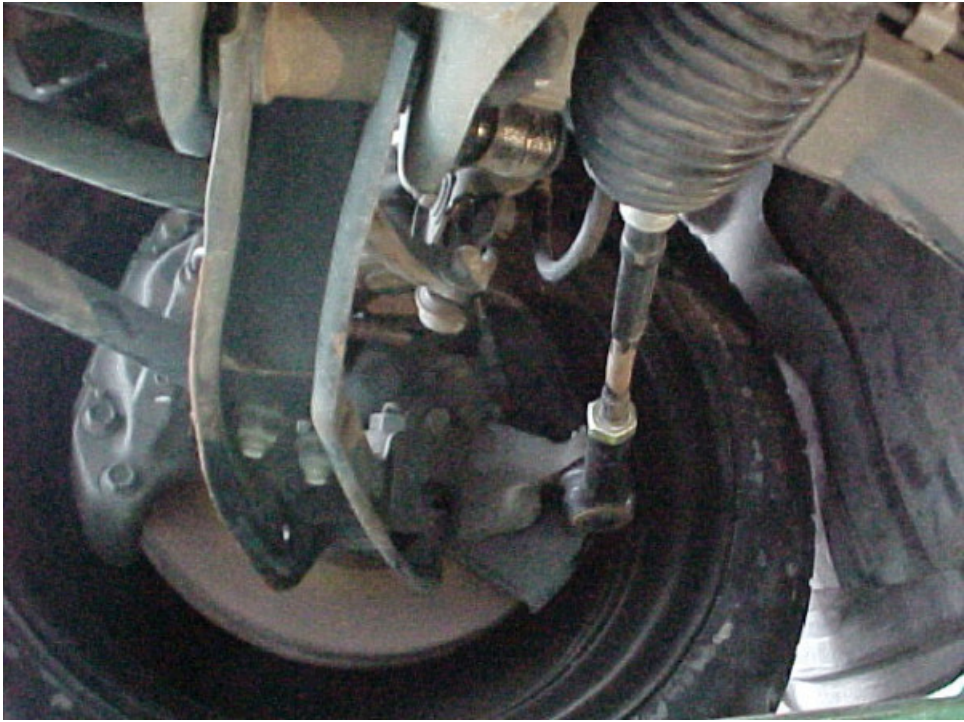
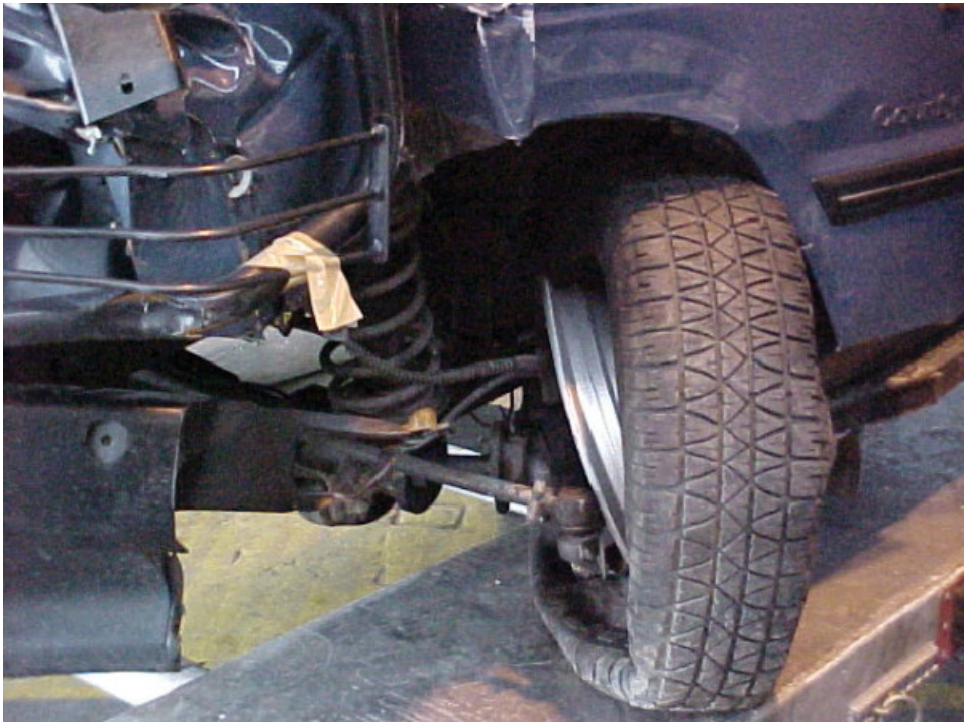
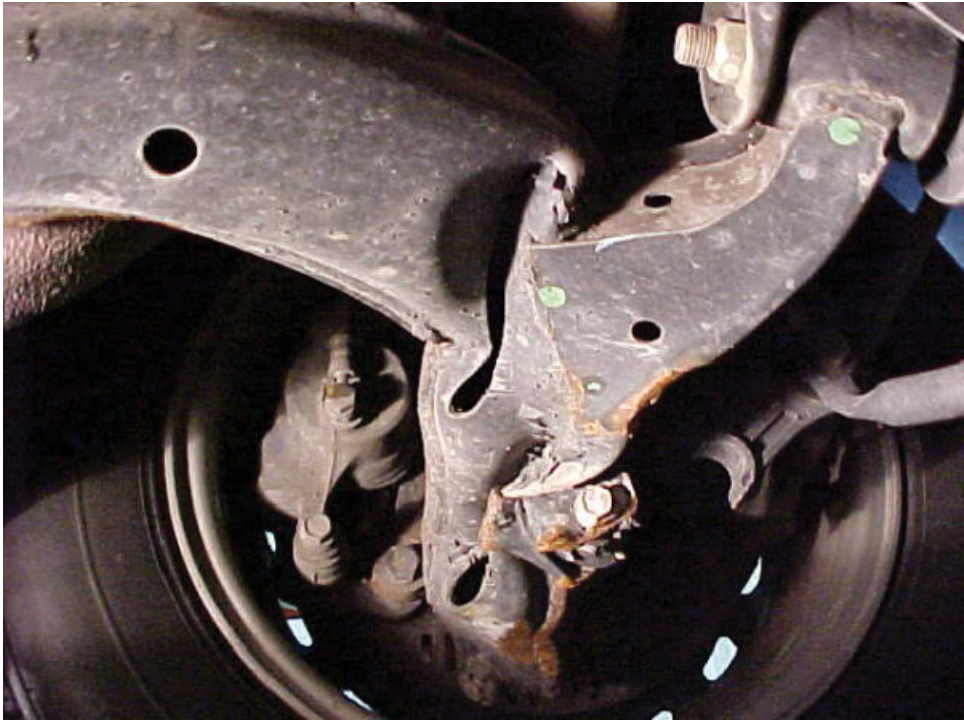
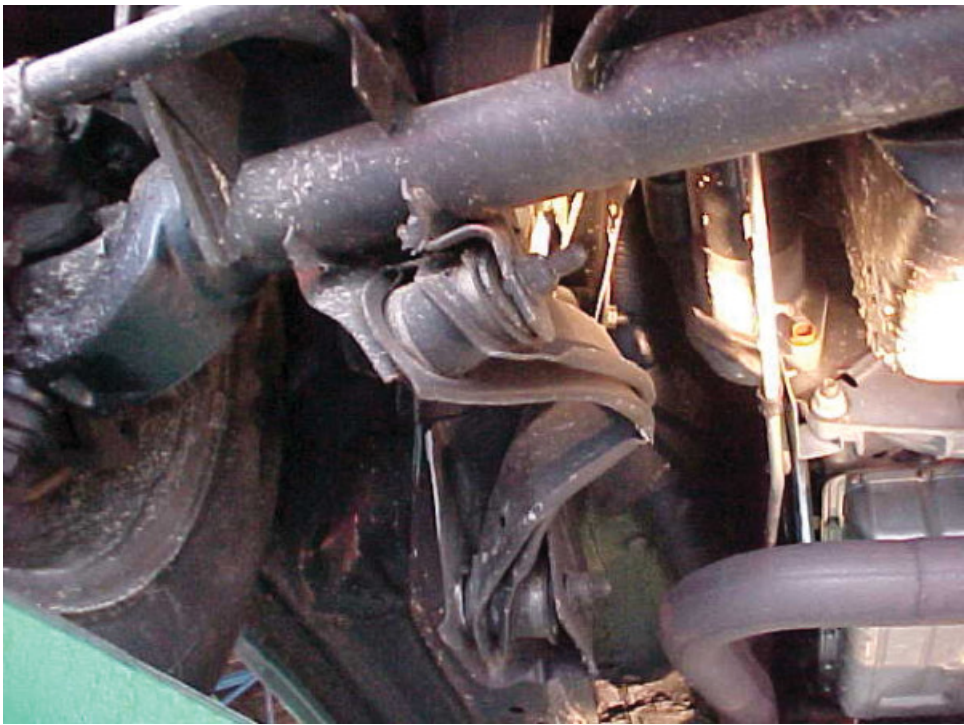
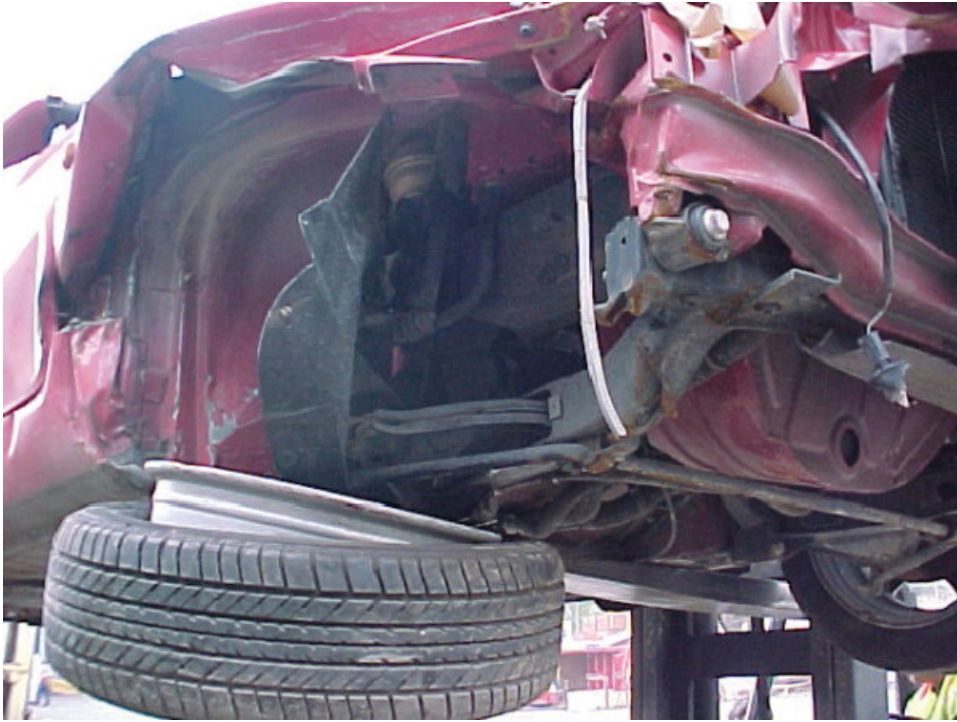
5-8 Collision damage to steering or suspension components

Collision damage to steering or suspension components

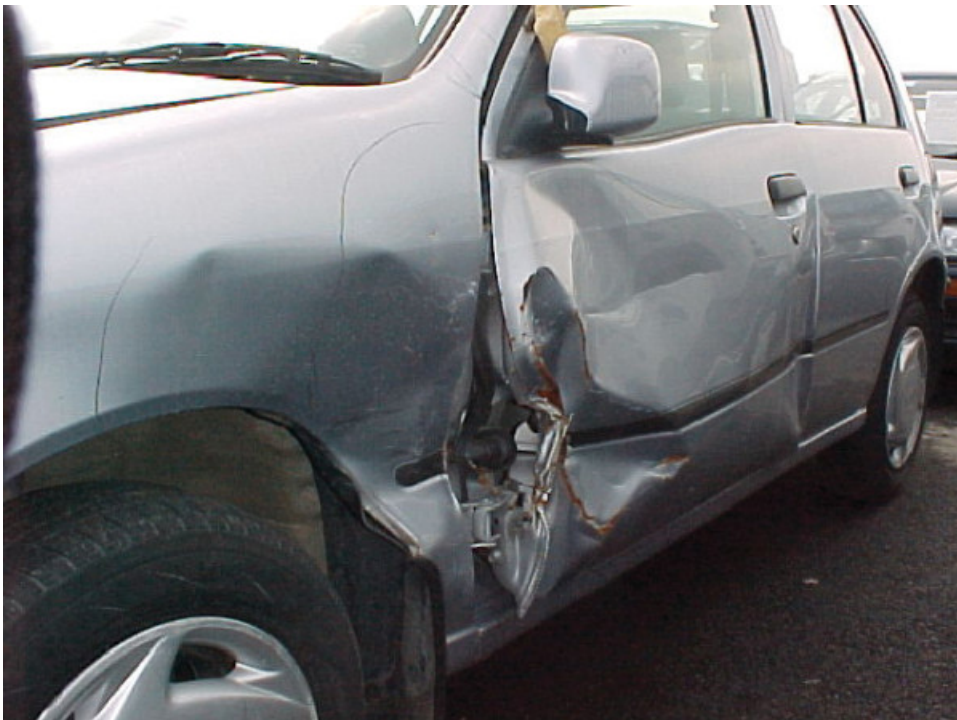
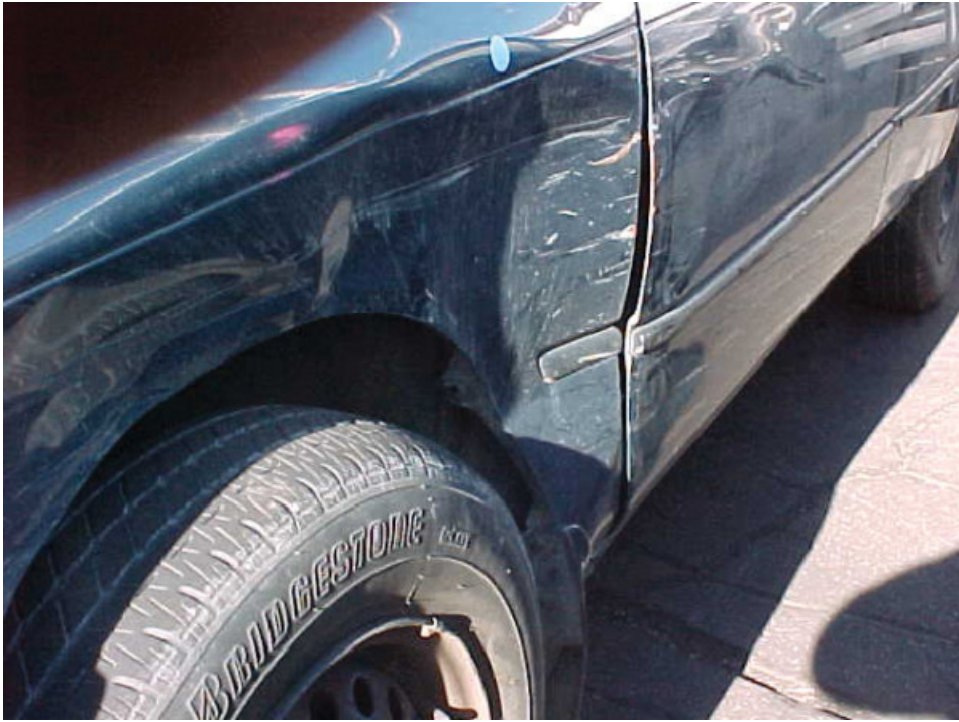
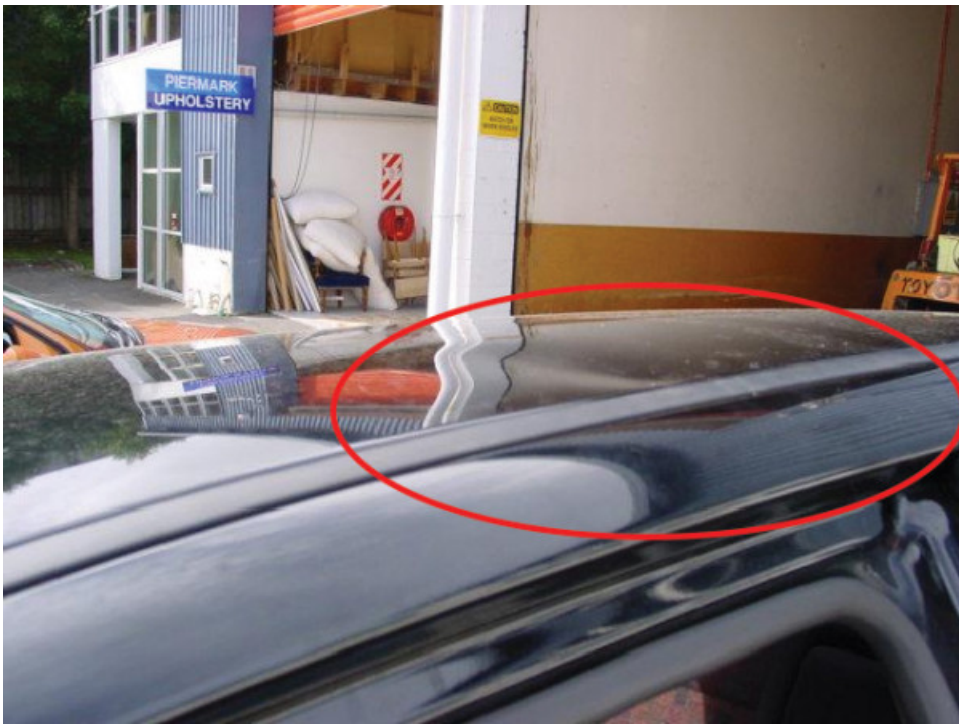
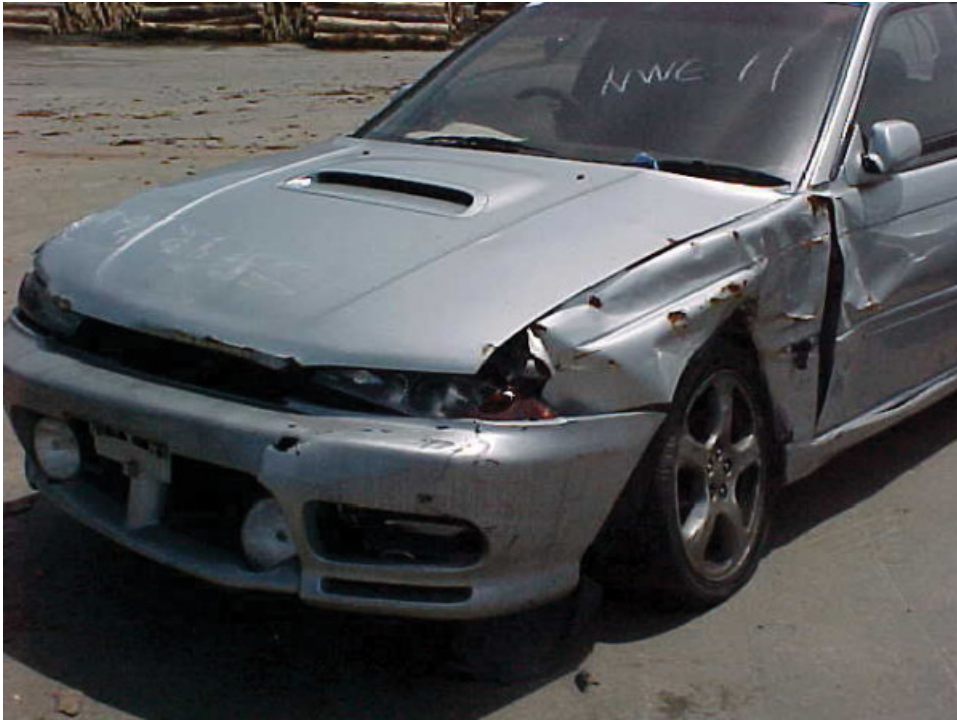
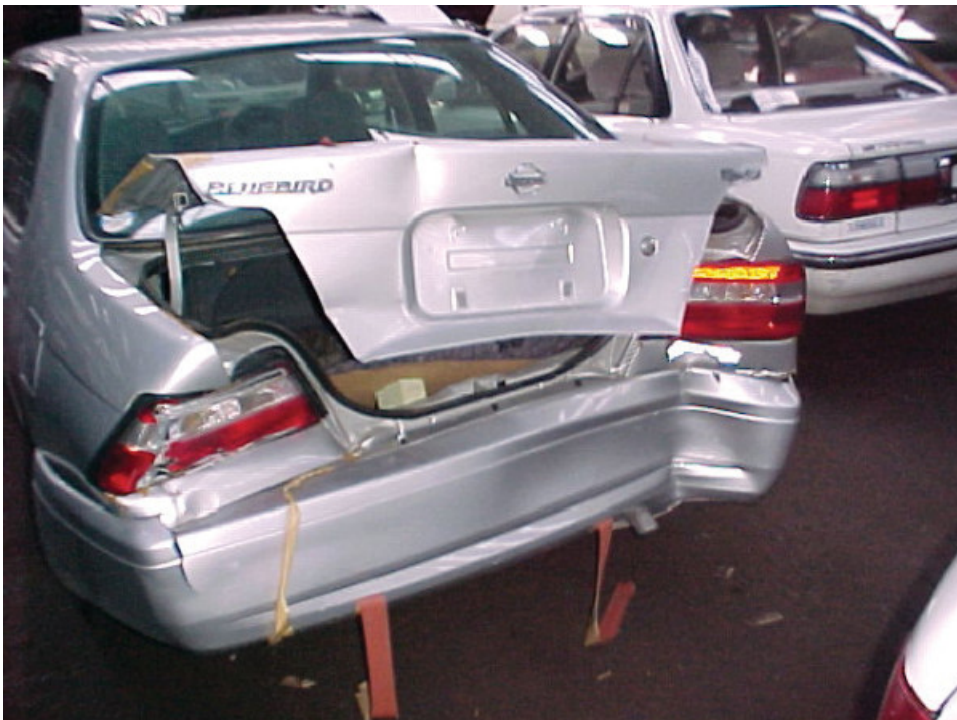
5-9 Damage to the vehicle's outer body panels: seam or joint integrity

Damage to the vehicle's outer body panels which affect the integrity of any of the seams or joints installed by the vehicle manufacturer (and may have also caused secondary damage - further inspection may be required)

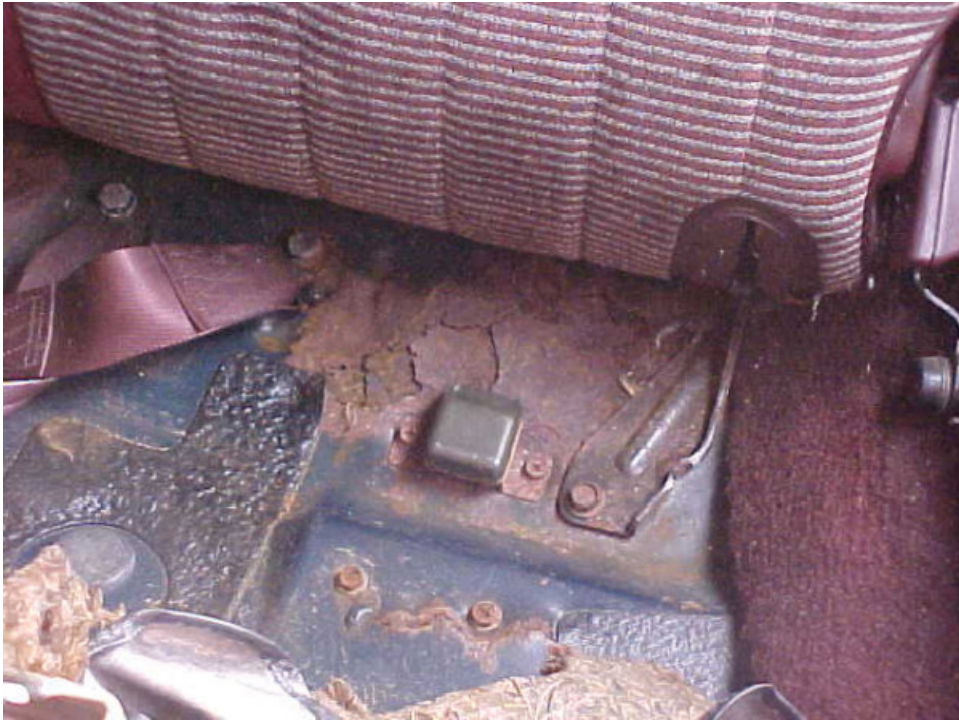
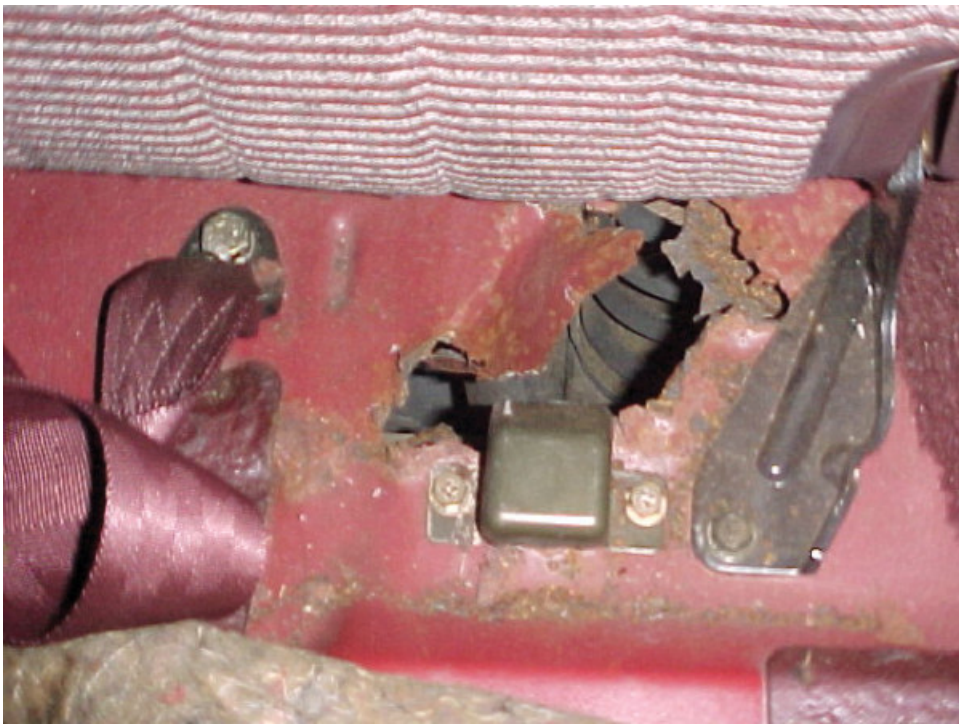
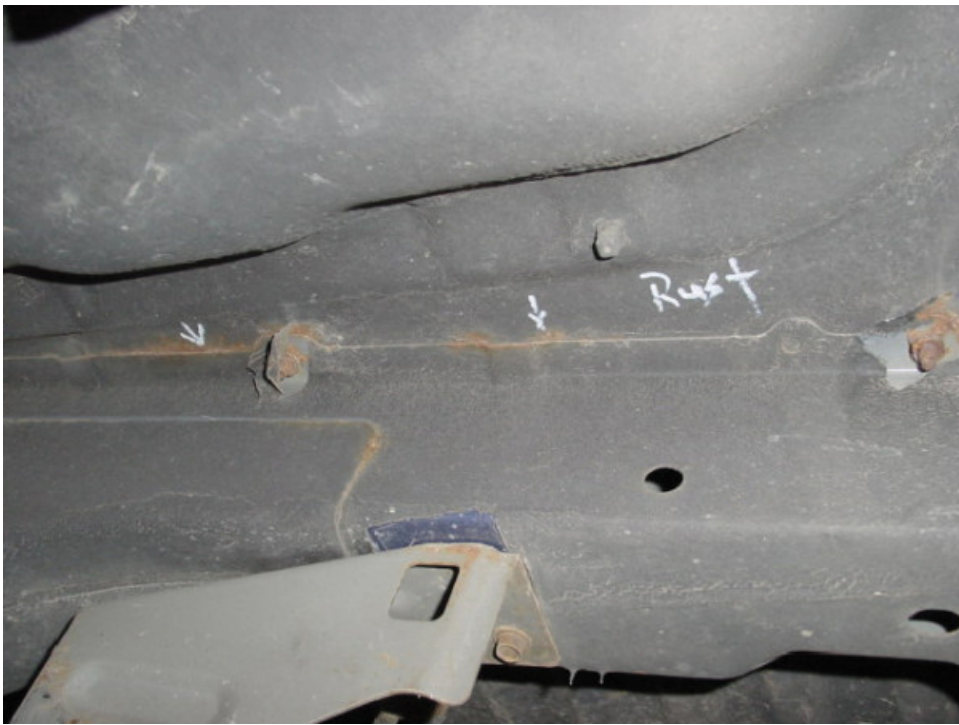
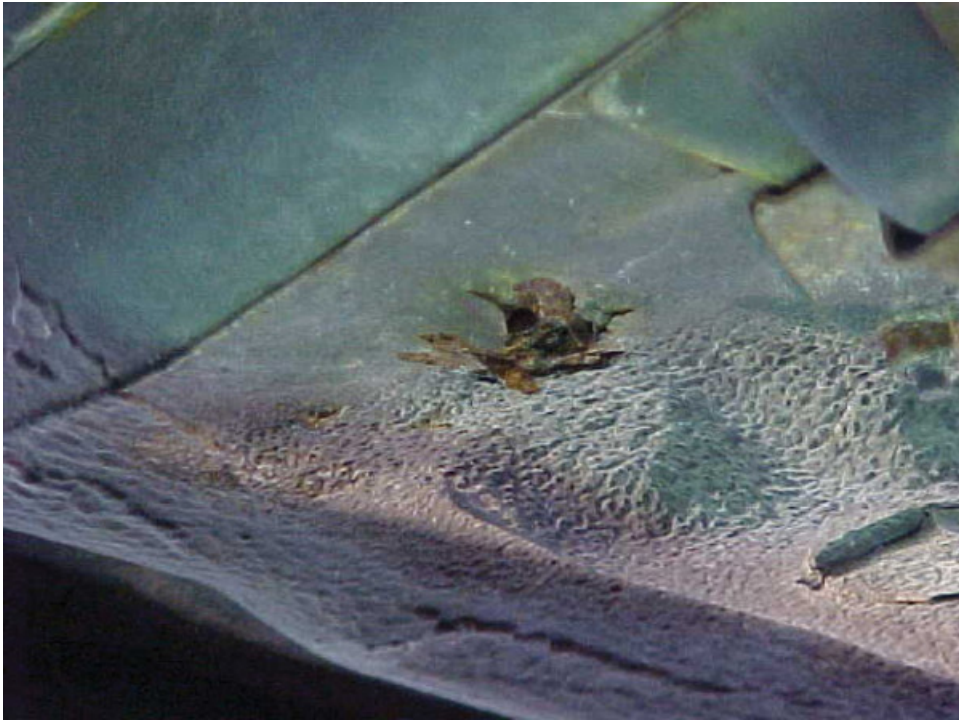
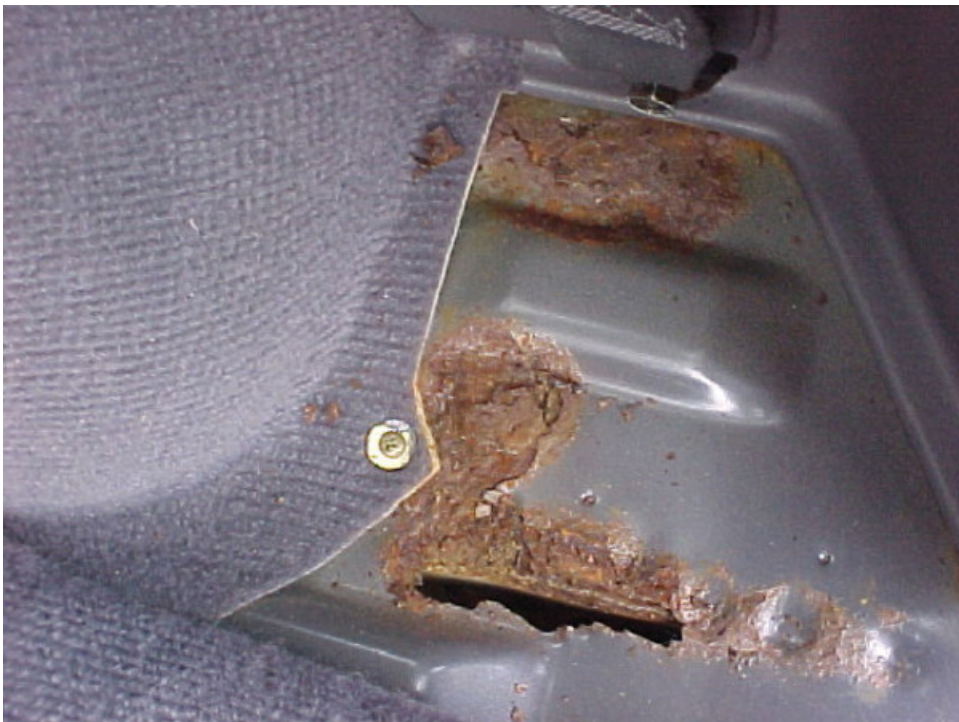
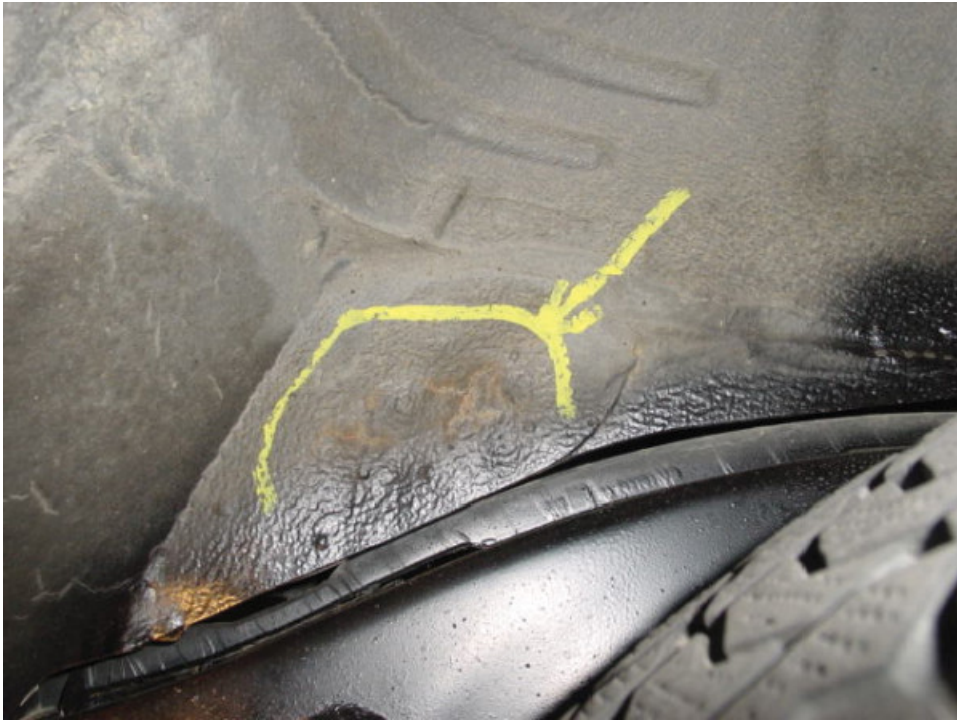
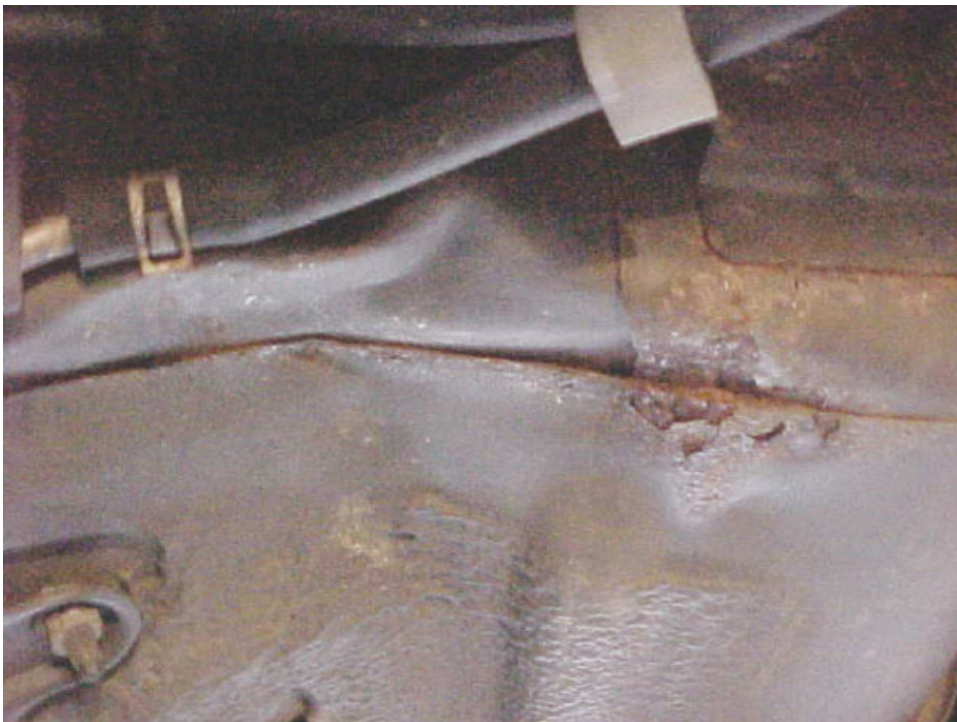
**5-10 Corrosion which has resulted in perforation or flaking of the metal:
Nissan Terrano and Mistral**

When inspecting Nissan Terranos or Mistrals always check for corrosion of the floor under the rear seat (examples are shown in the first three photos below).

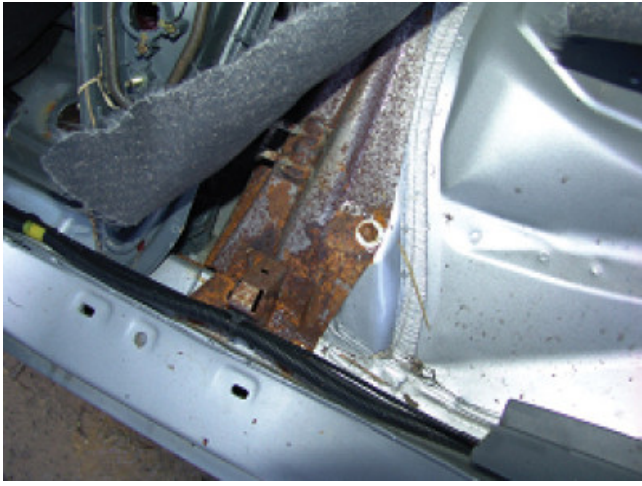
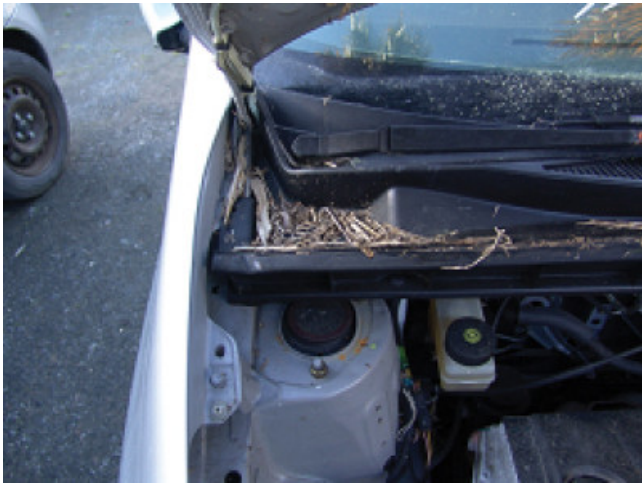
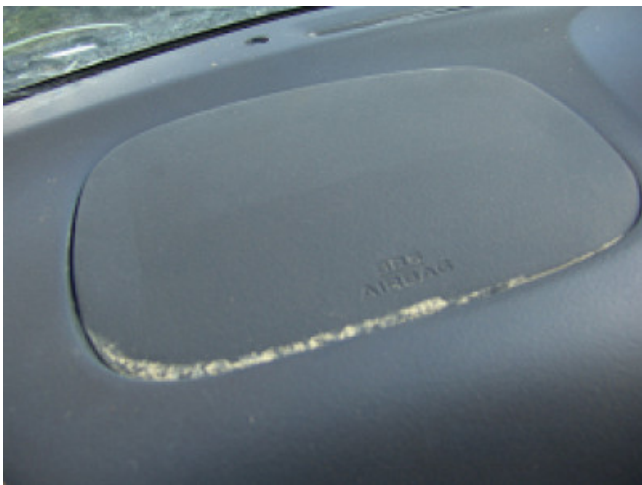
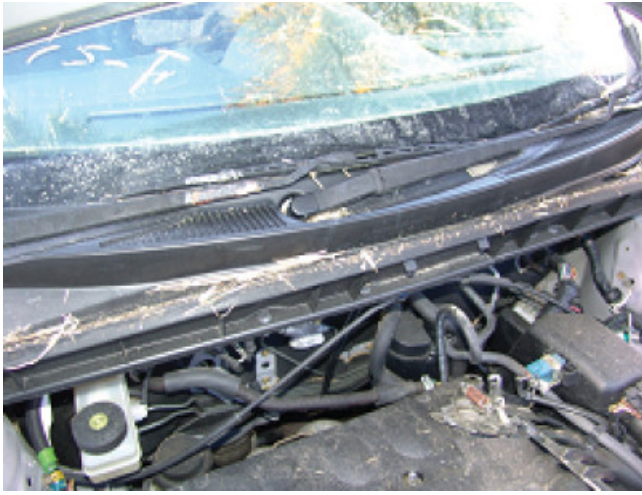
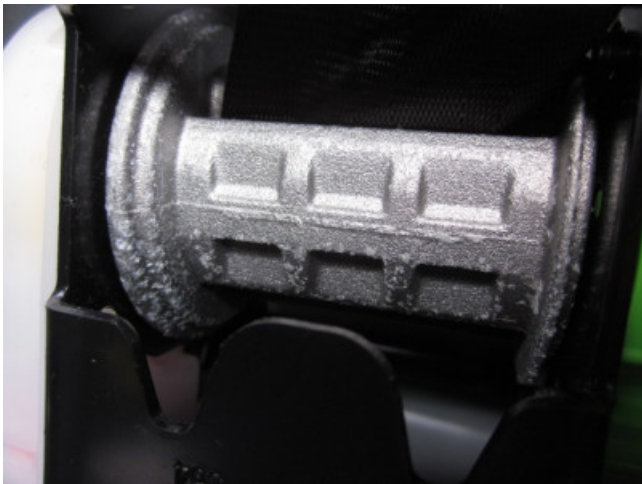
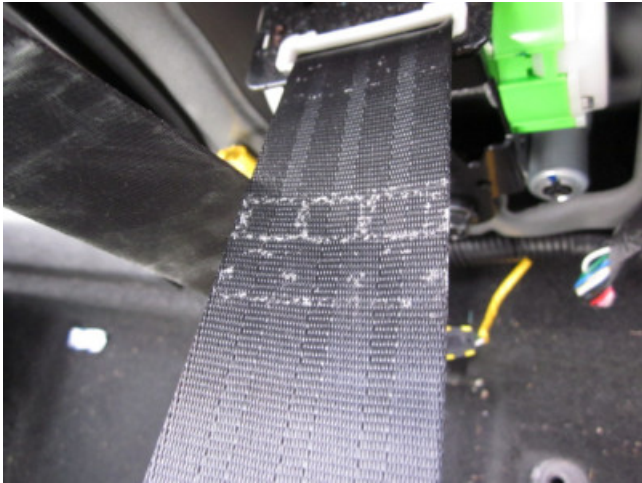
5-11 Water damaged vehicles

Water damaged vehicles

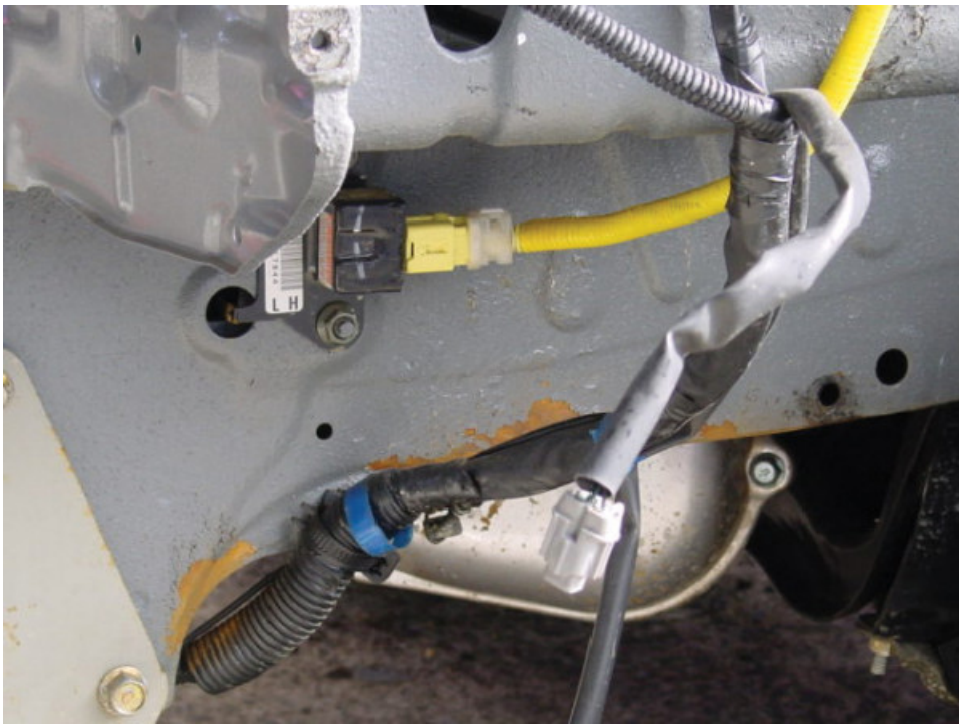
5-12 Heat and fire damaged vehicles

Heat and fire damaged vehicles

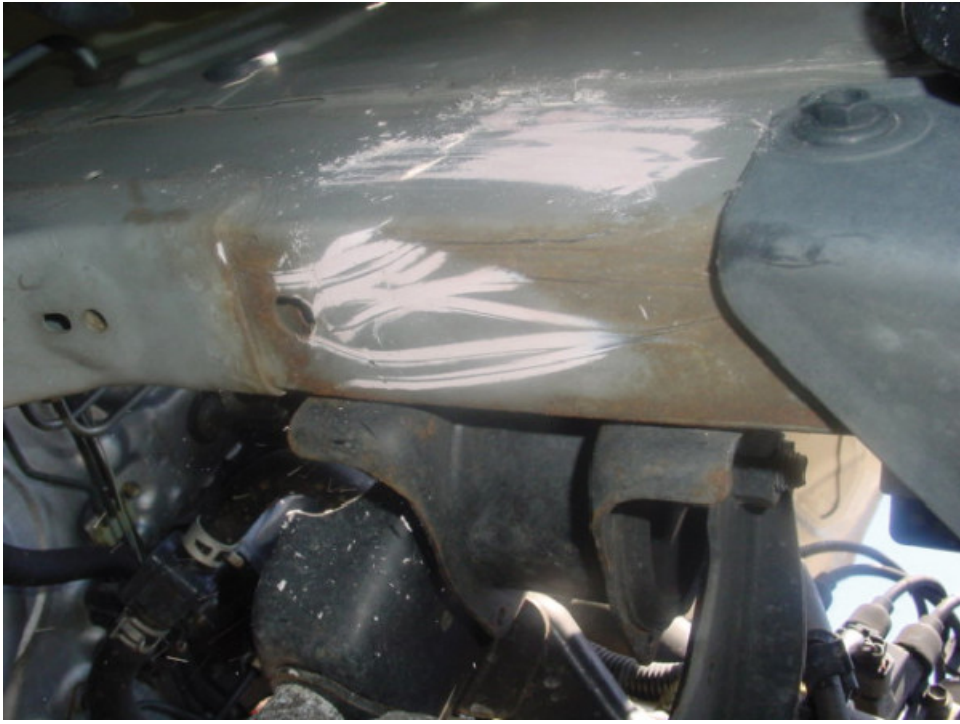
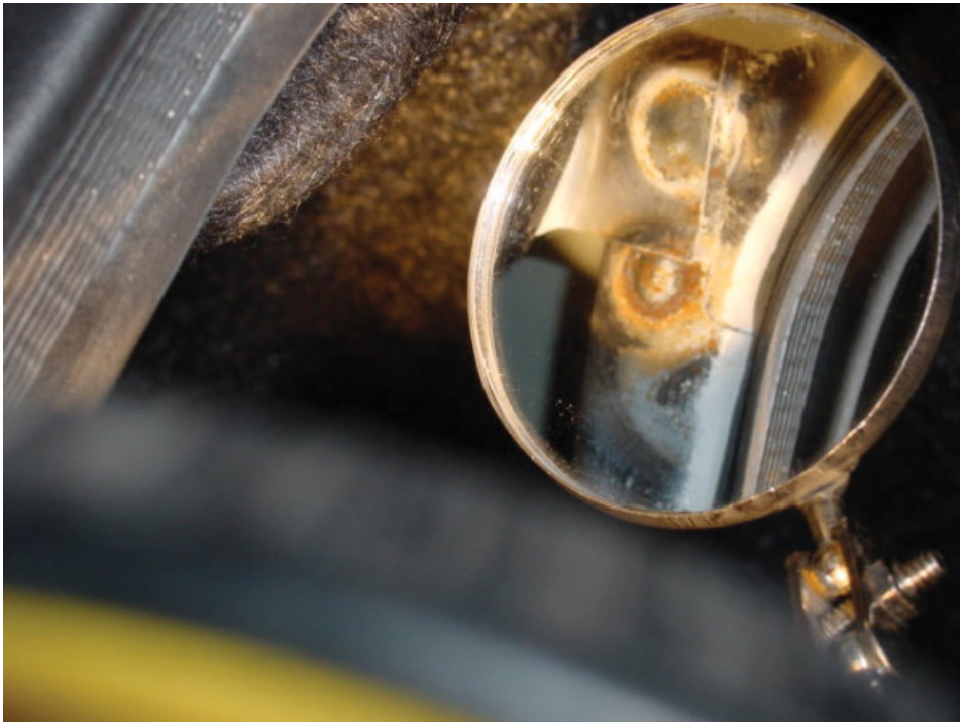
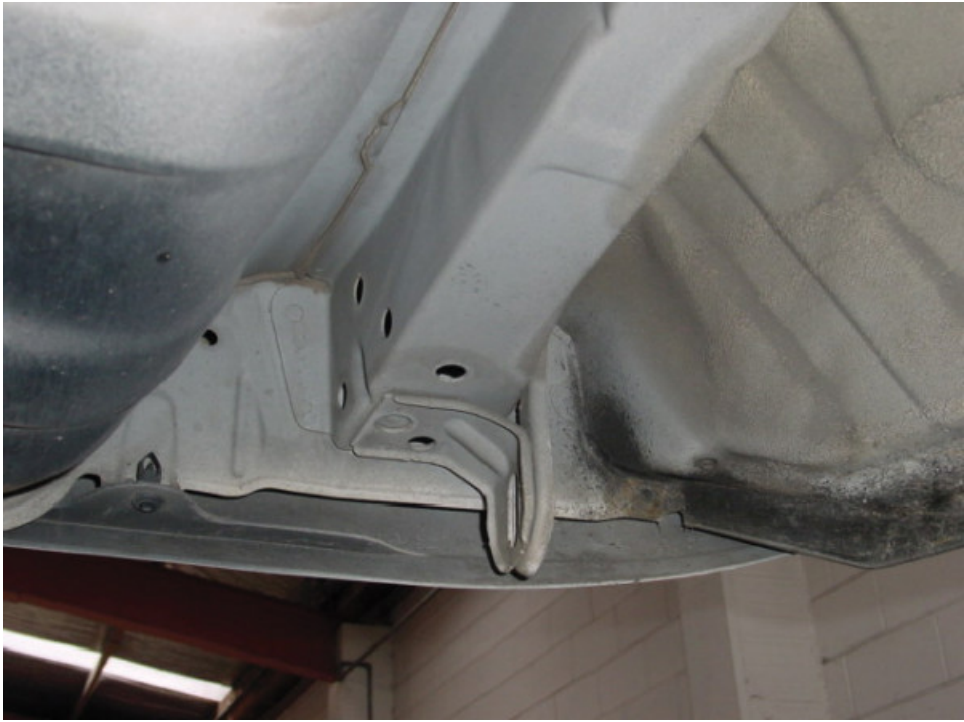
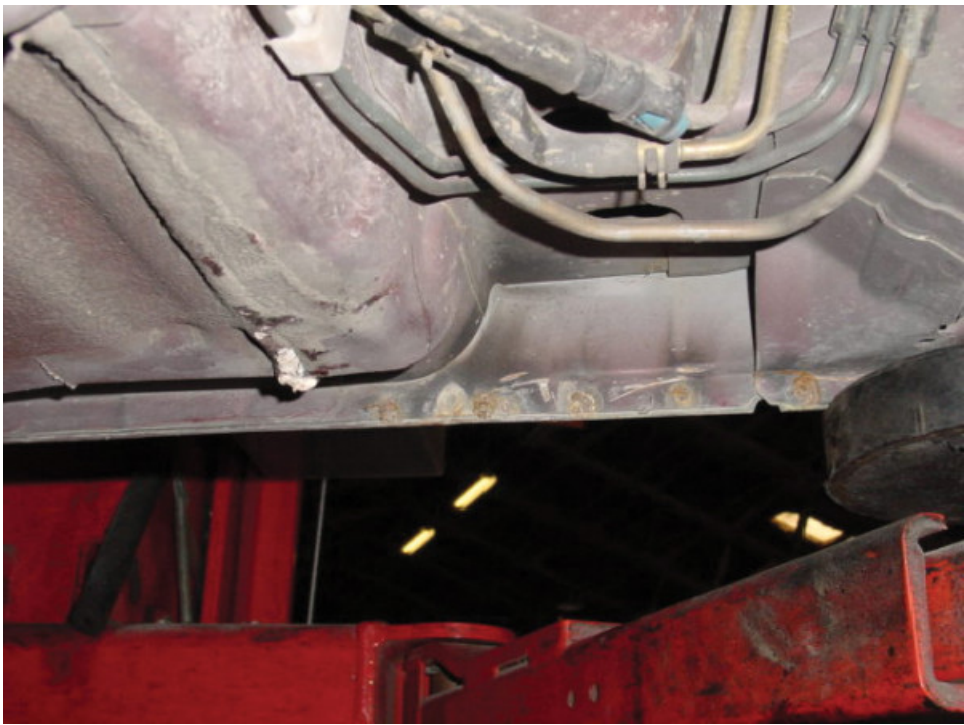
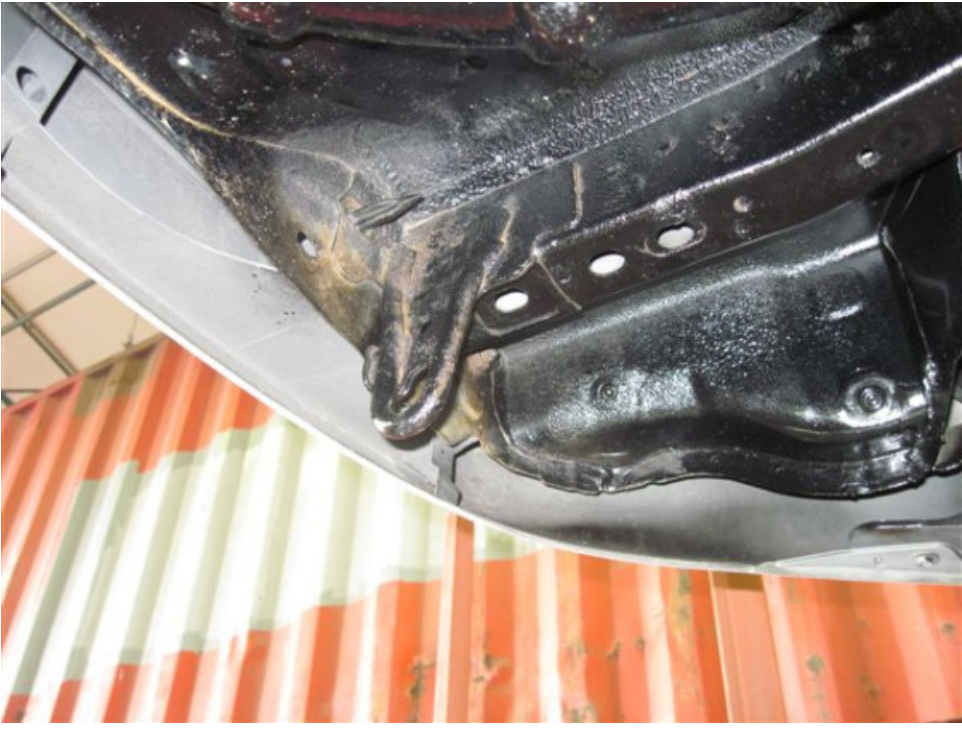
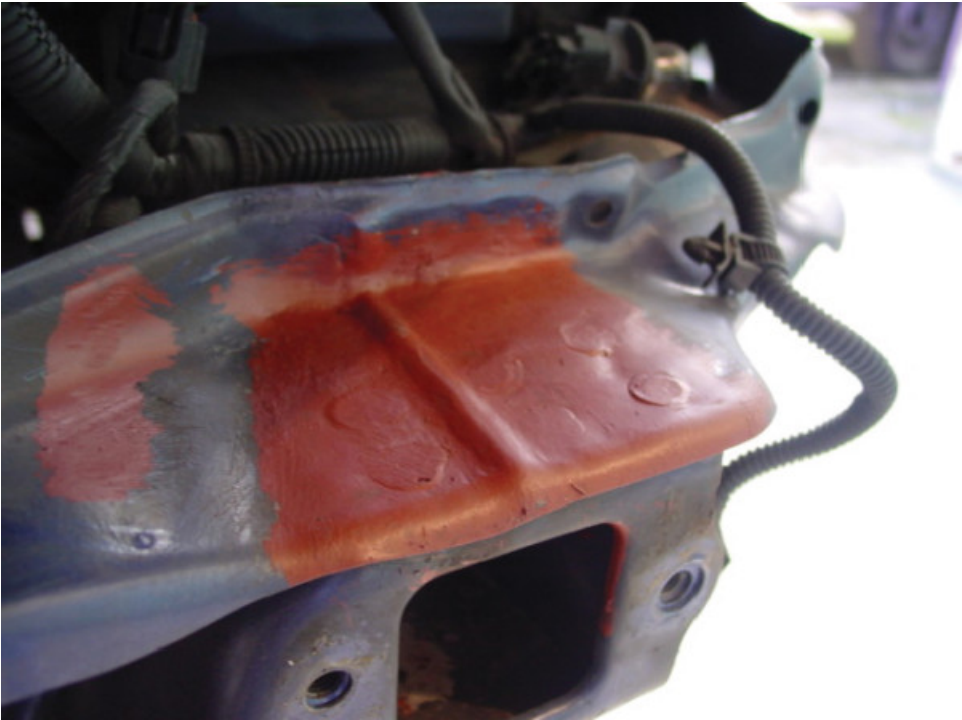
5-13 Examples of repairs

Examples of repairs

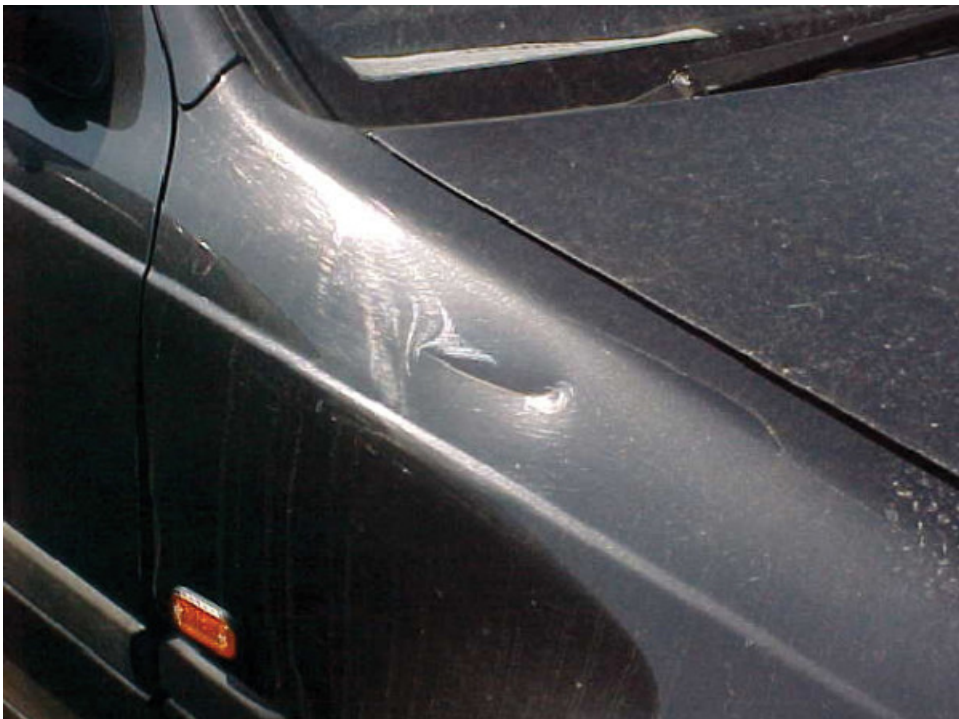
6-1 Front guards

Front guards
