Extract taken from: Border inspection of imported used vehicles > Reference materials

1 Guidelines for the detection of reportable damage on imported used vehicles (excl motorcycles)

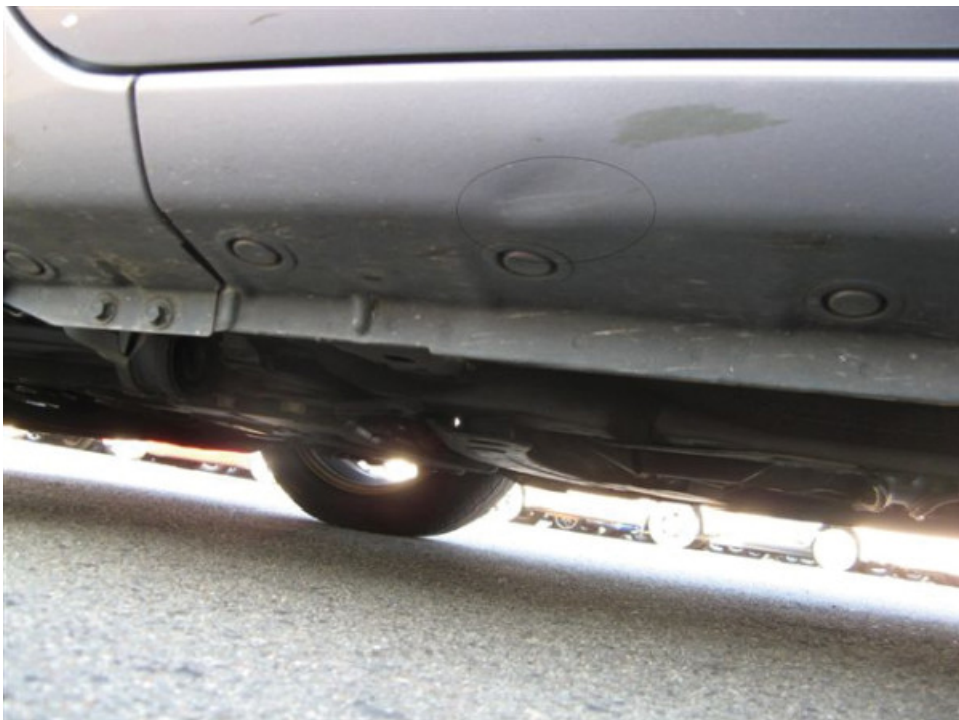
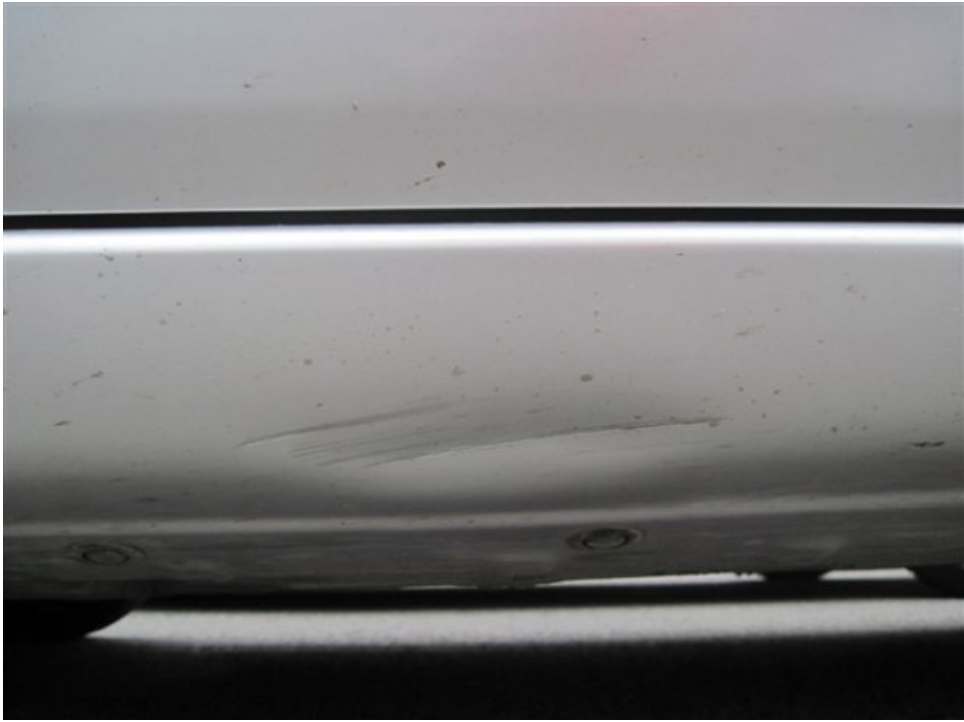
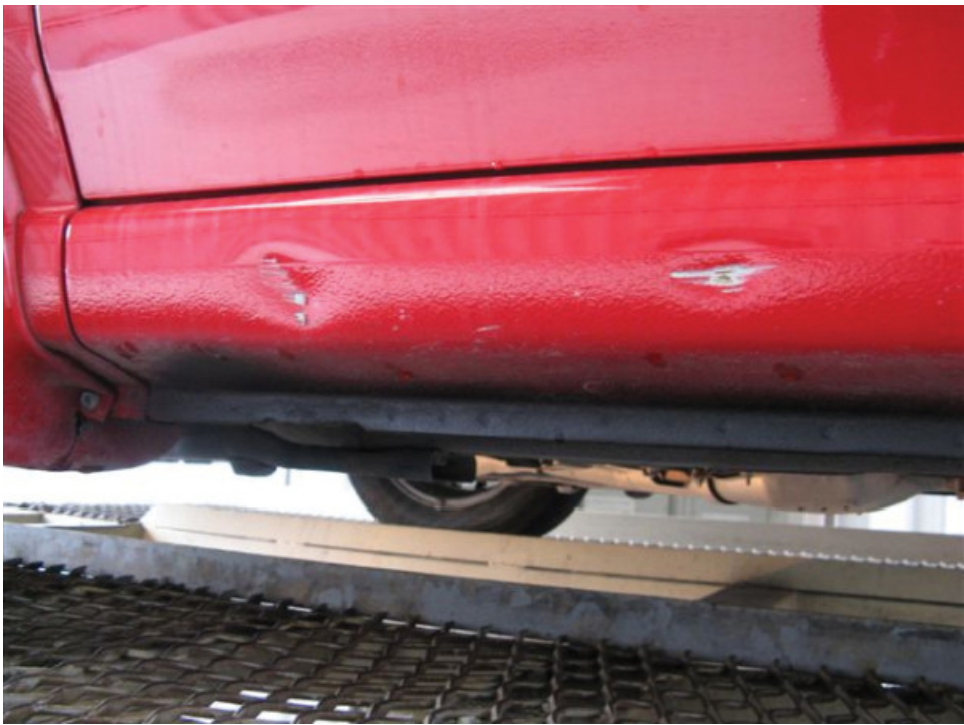
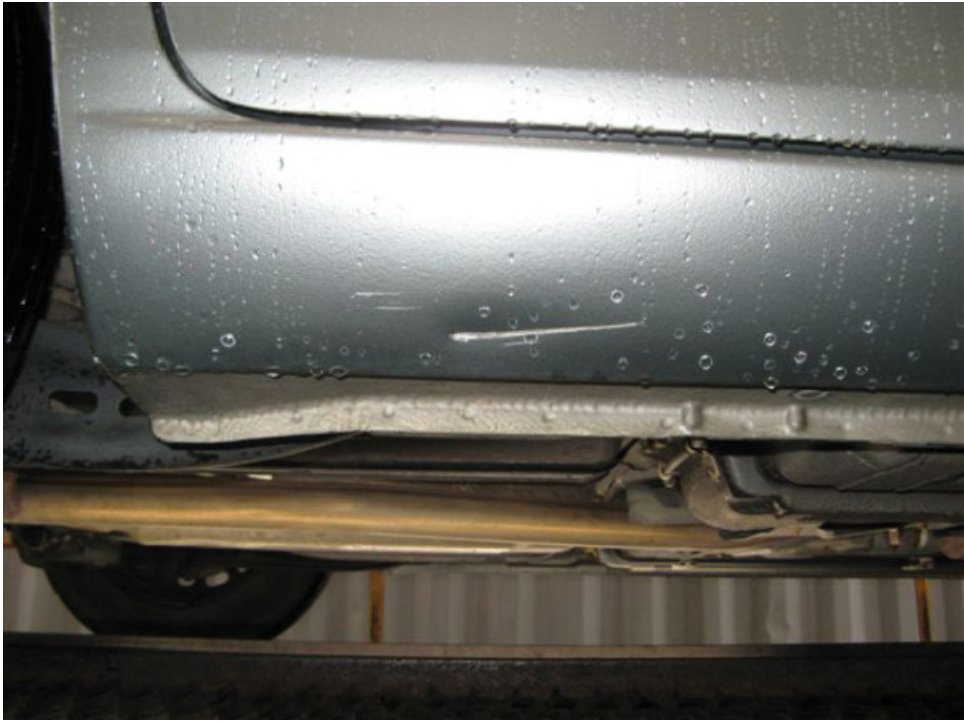
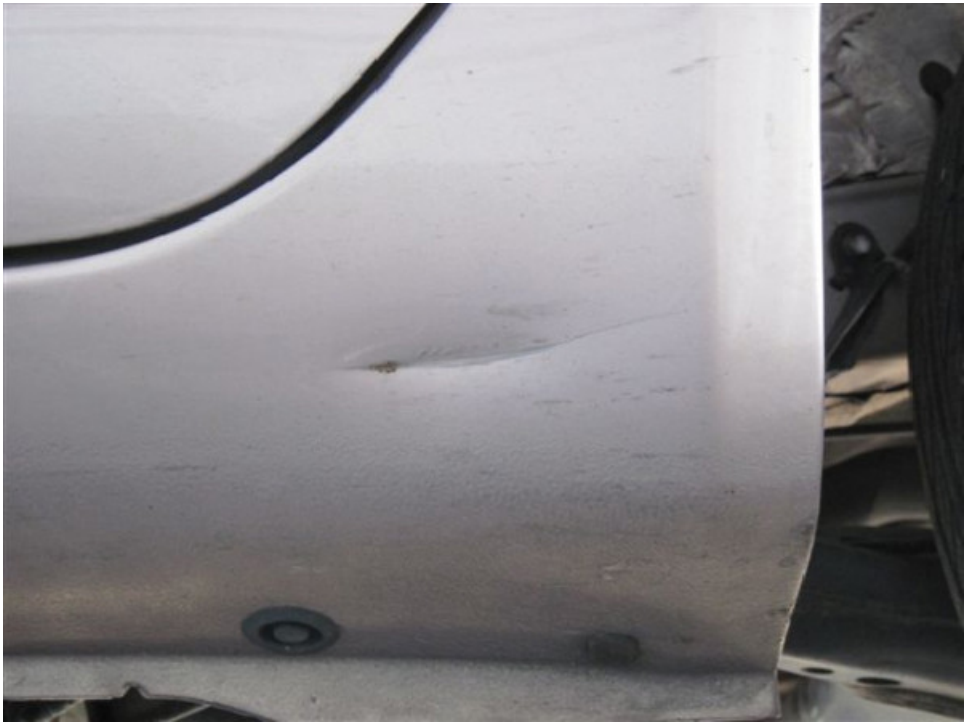
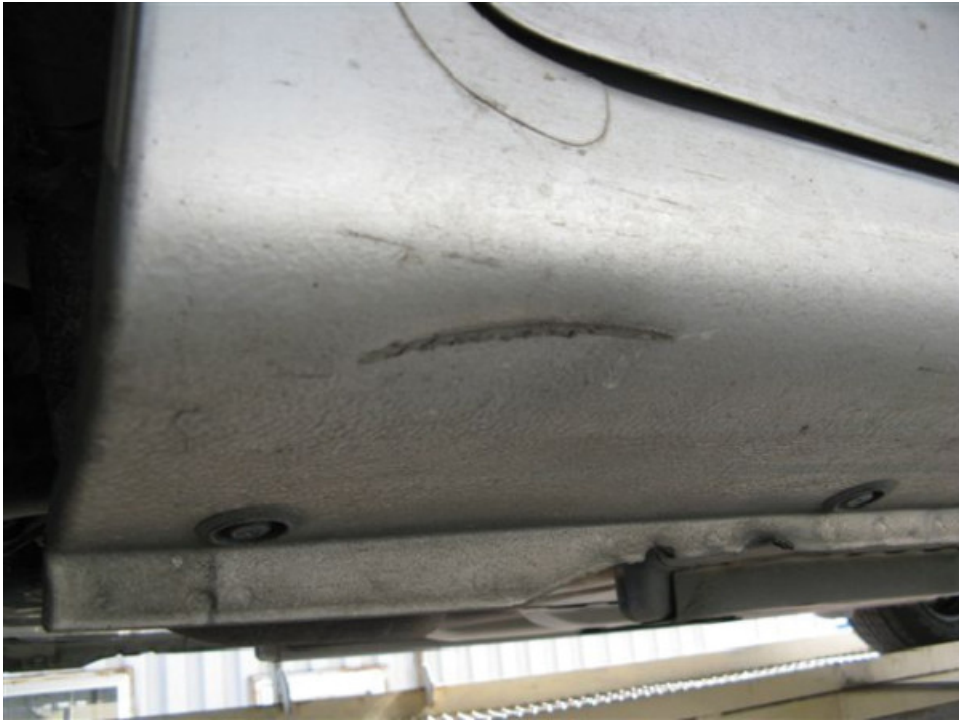
6-2 Sills/rocker panels (minor damage)

Sills/rocker panels (minor damage)

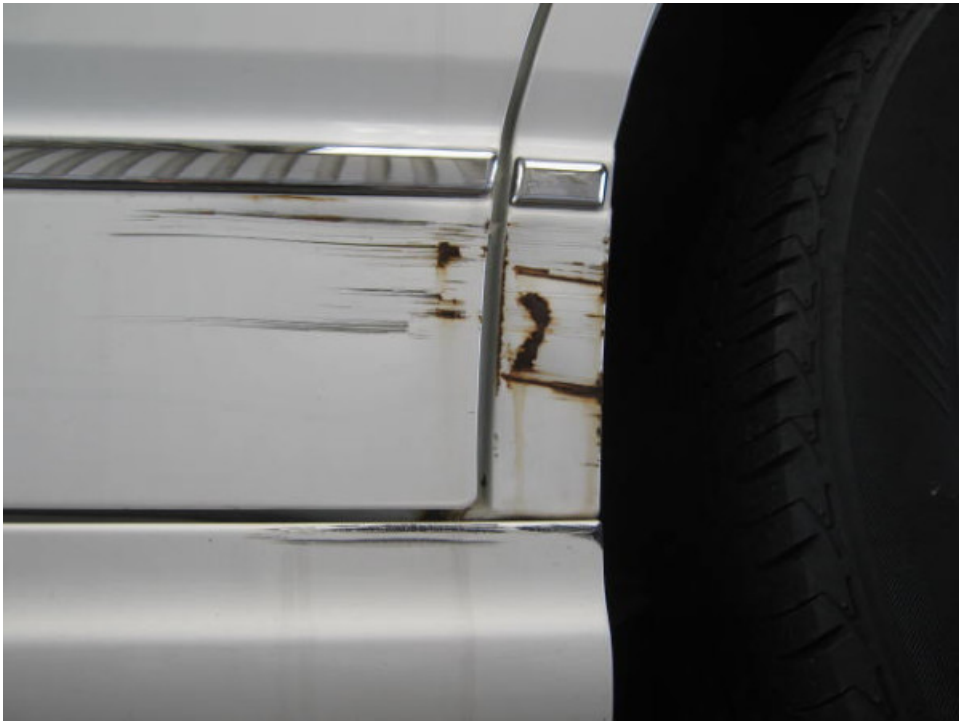
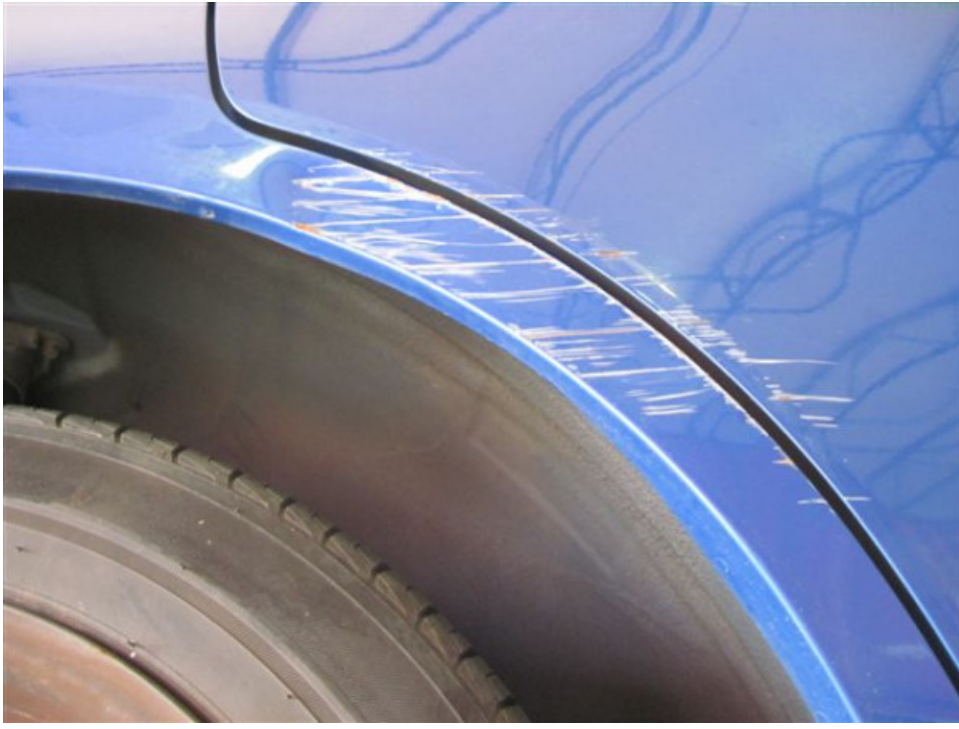
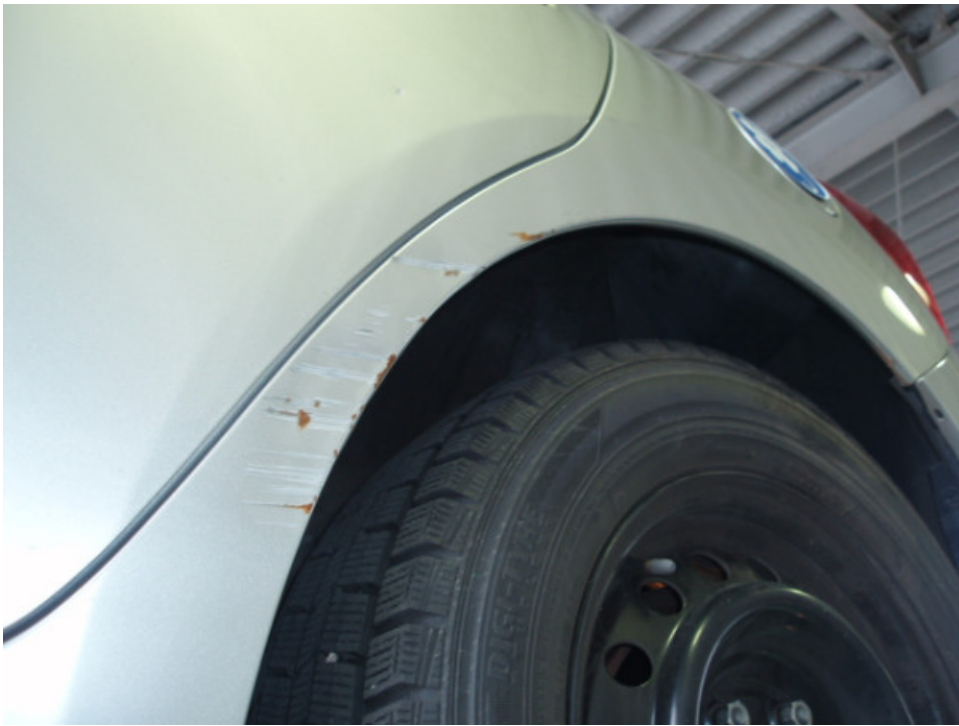
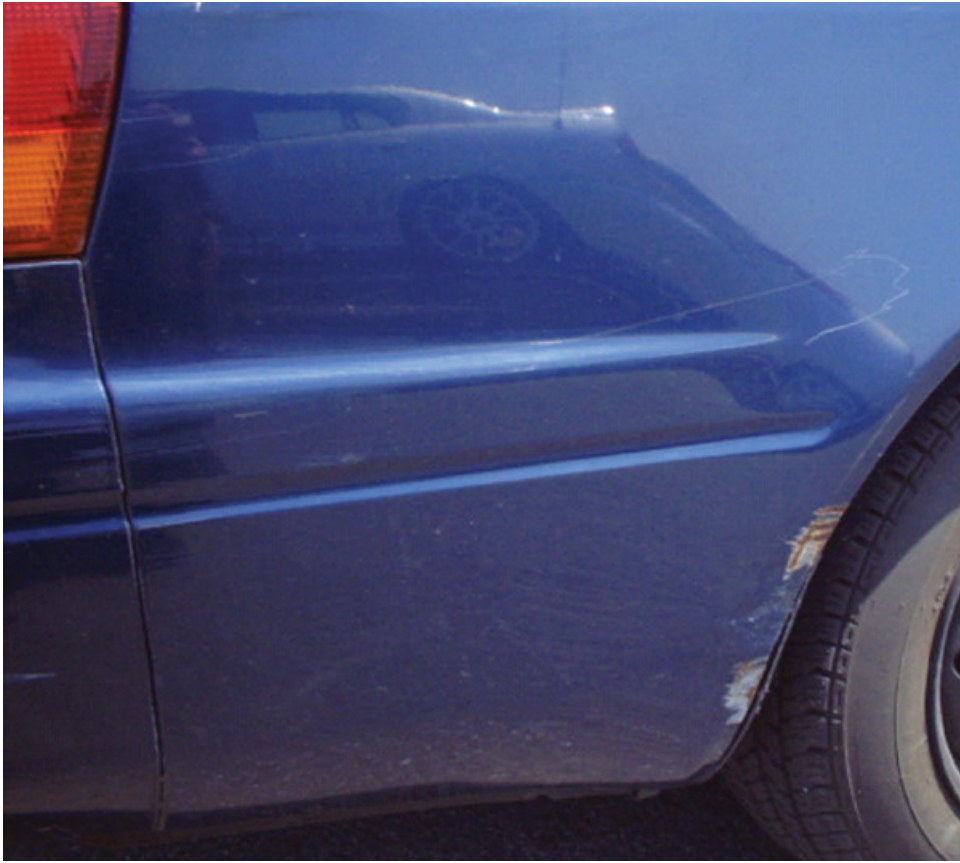
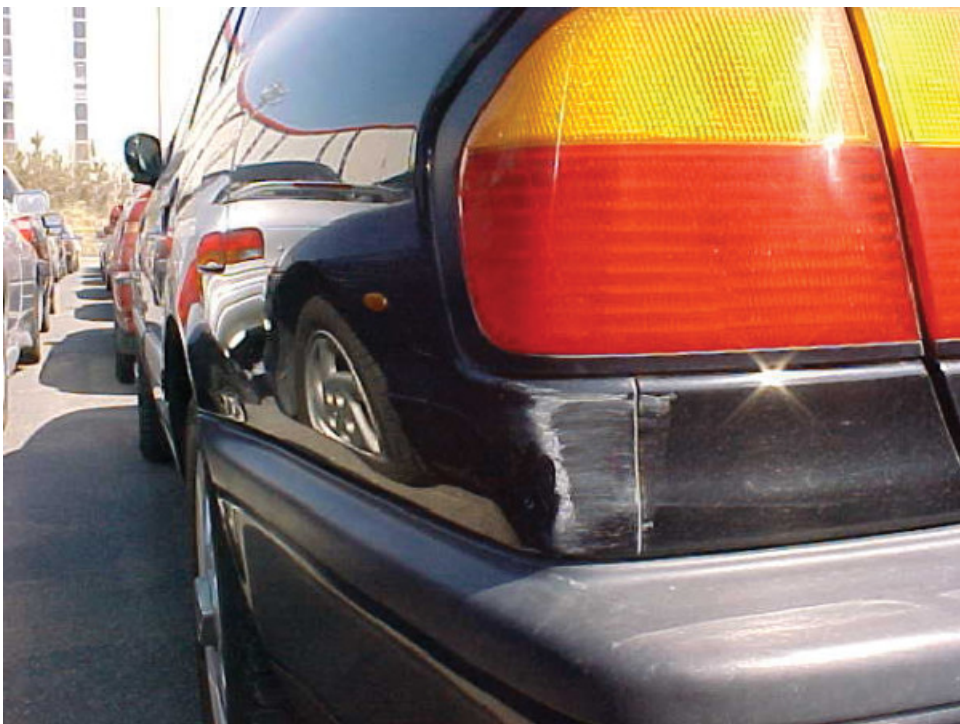
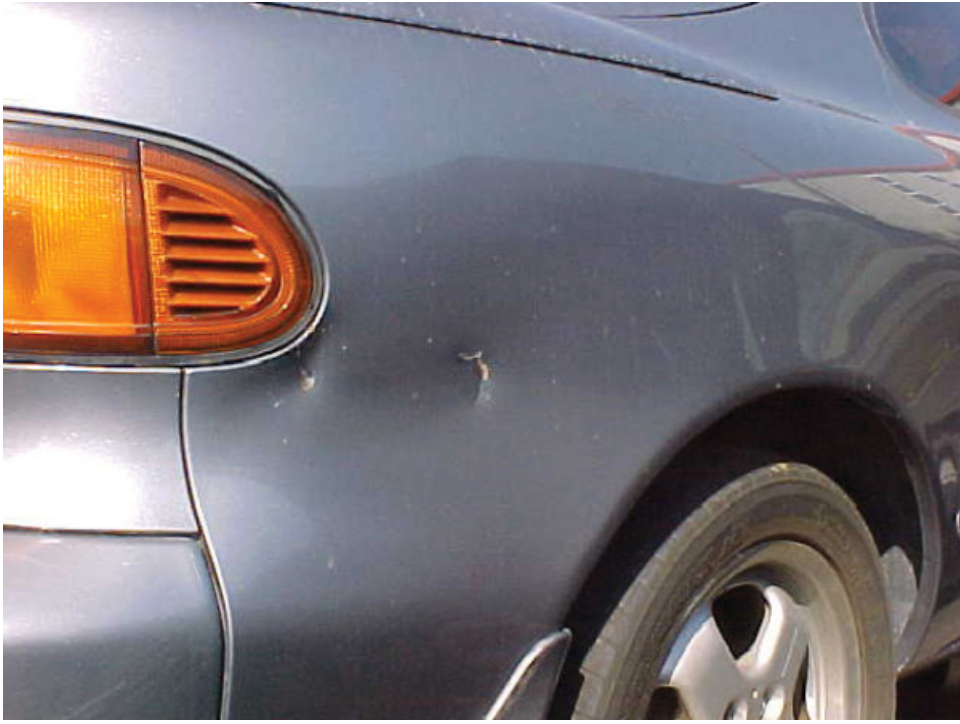
6-3 Minor/cosmetic damage: rear quarter panel and dogleg

Minor/cosmetic damage: rear quarter panel and dogleg

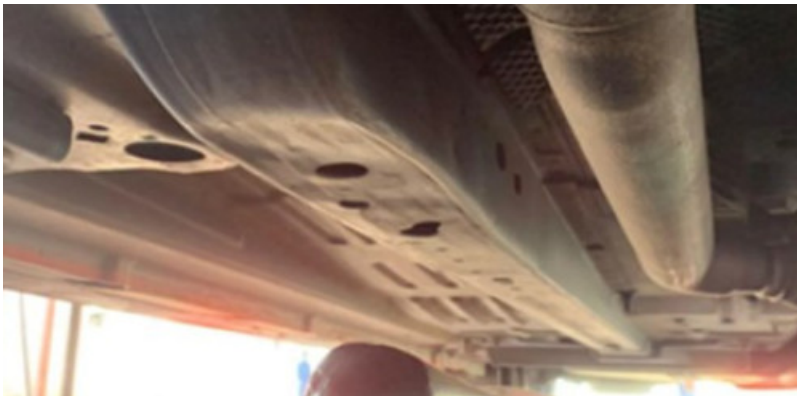
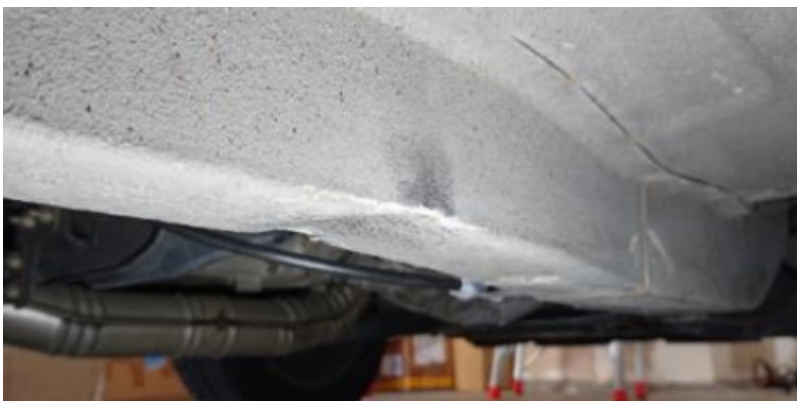
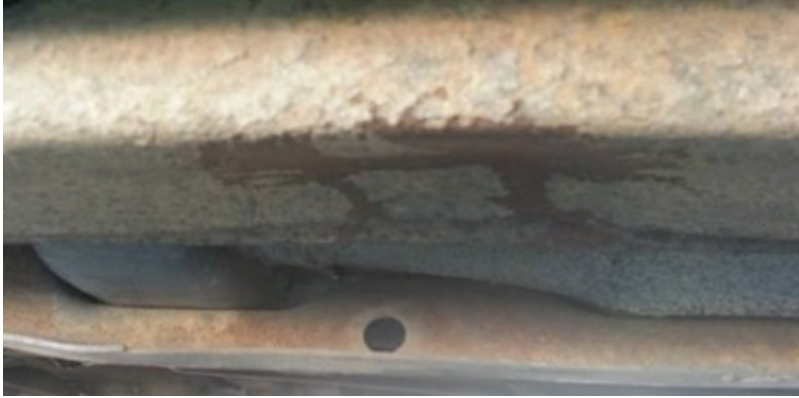
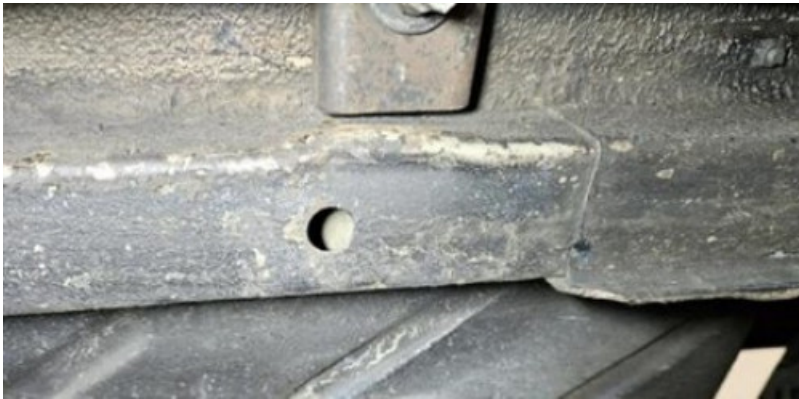
6-4 Minor/cosmetic damage: floor pan stiffening members

The minor/cosmetic damage in these images doesn't need to be referred to a repair certifier.

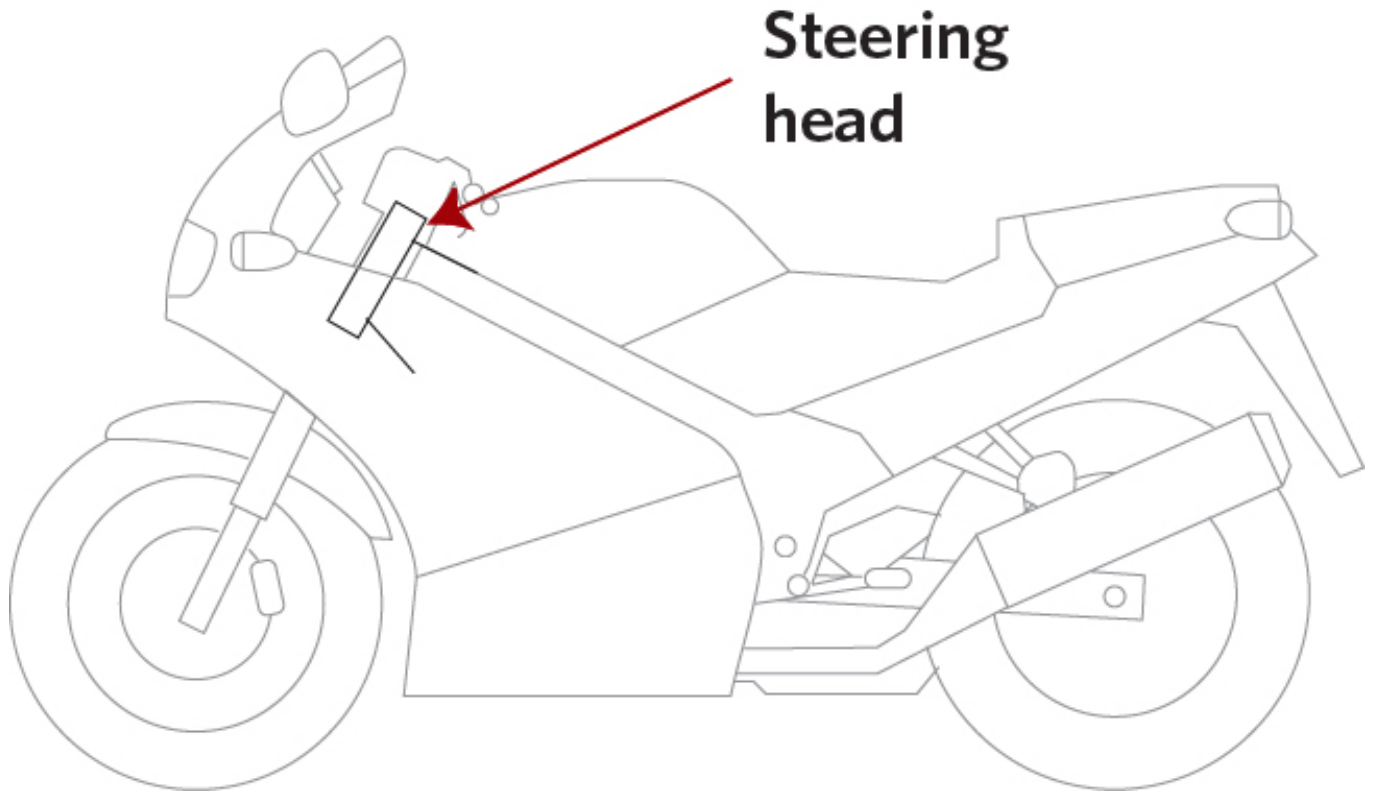
Figure 10-1-1. VIN number location

VIN number is found on the steering head, stamped into the metal.

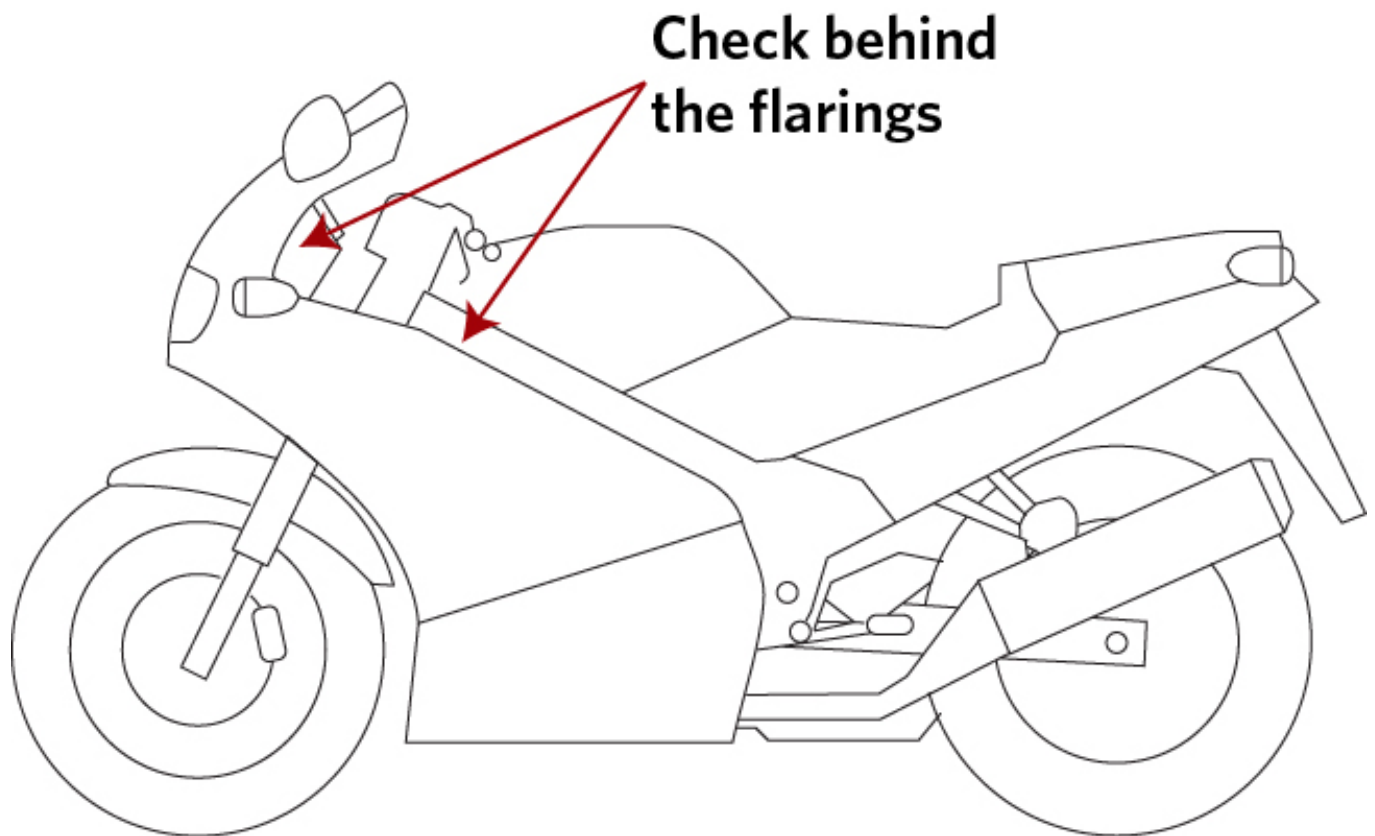
Figure 10-1-2. Plastic flarings

Modern motorbikes have a lot of plastic flarings covering the frame.
It is important that the inspector check behind these flaring's for damage.

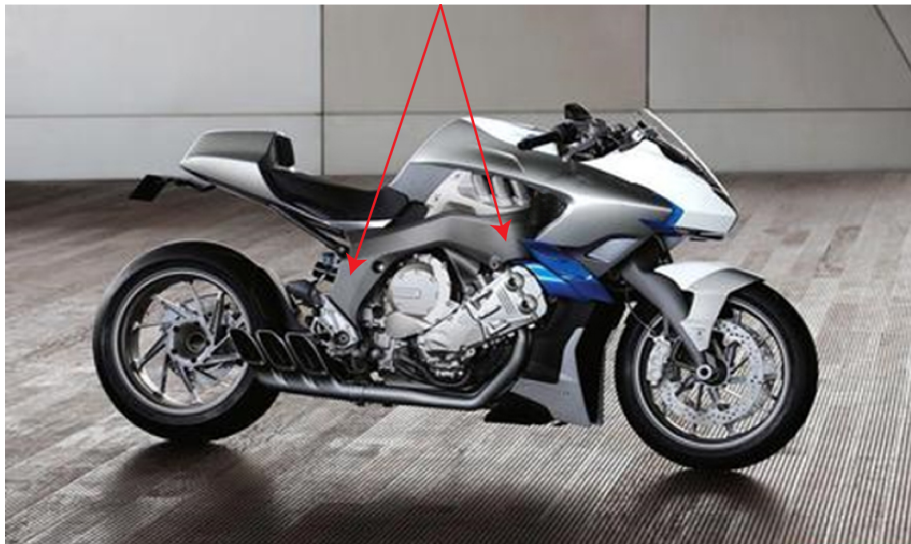
Figure 10-1-4. Check the frame

Check frame for damage

- Carry out a good inspection of this area, making sure the head angle is per factory and not bent, pushed back or fractured.

- Look for previous repairs as well as existing damage
- This is carried out by a good general inspection of the frame and factory welded joints and seams. You're looking for stress markings in the weld or seam areas and or signs of previous repairs such as file marks miss matched paint or existing damage.
