Extract taken from: In-service certification (WoF and CoF) > General trailers > Vehicle structure

3 Vehicle structure

3-1 Structure

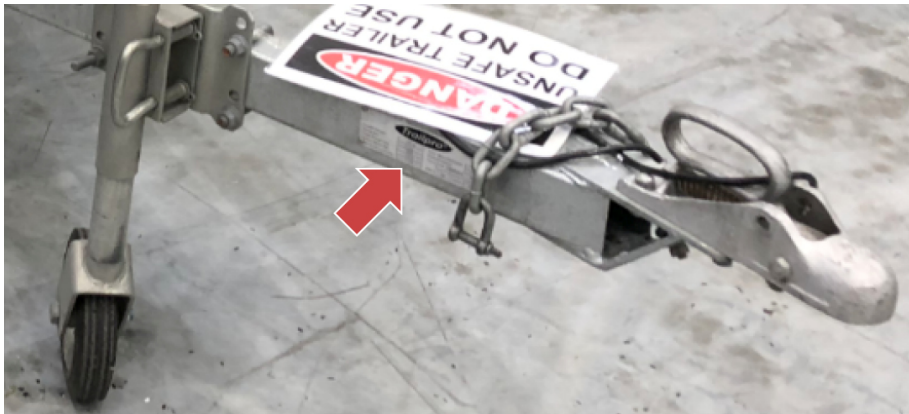
Affected trailers are fitted with an identification plate which is located on the outside of the trailer drawbar near the tow coupling.

Location of the trailer identification plate
