Extract taken from: In-service certification (WoF and CoF) > General trailers > Vehicle structure

3 Vehicle structure

3-1 Structure

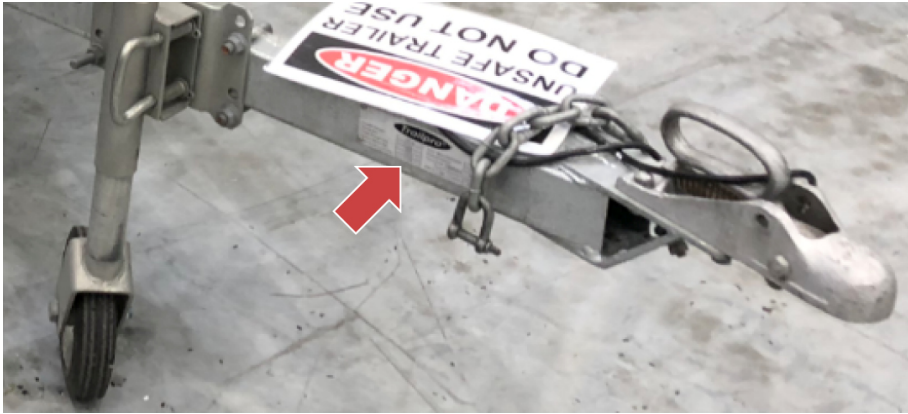
Location of the trailer identification plate

Affected trailers are fitted with an identification plate which is located on the outside of the trailer drawbar near the tow coupling.
