Extract taken from: In-service certification (WoF and CoF) > General trailers > Vehicle structure > Structure

3-1 Structure

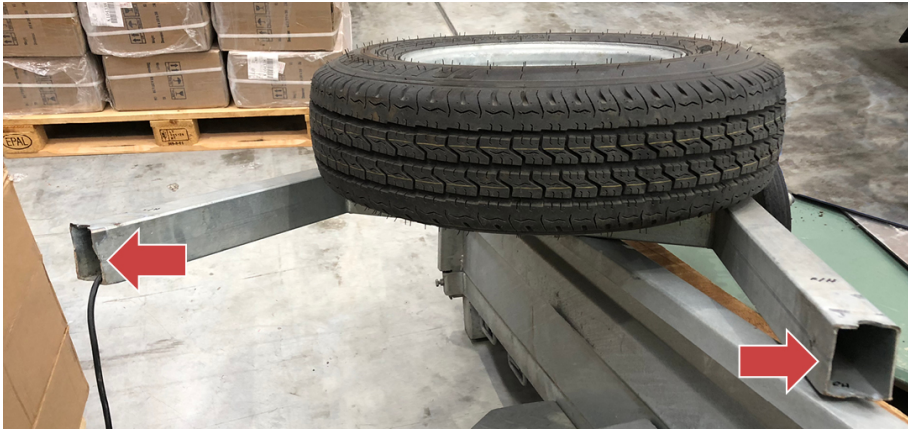
Broken drawbar (sitting on trailer)

Special attention should be given to the point or points where the drawbar attaches to the body of the trailer. This is often the first point of structural failure on trailers.
