Being part of the NZ Transport Agency team

The correct repair of outrigger locking devices

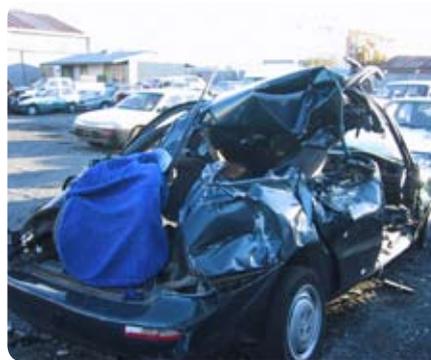
The result of an outrigger striking a car.

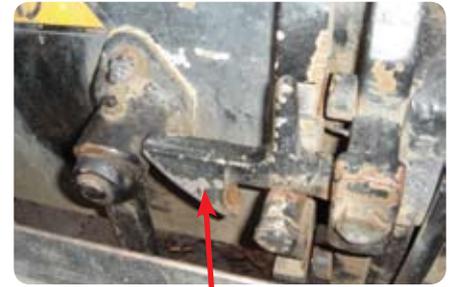
Manufacturers provided outrigger retention locking device.

Locking is apparent. No problem.

The outrigger is usually supplied with a manufacturer's designed OE locking device incorporated into the assembly. It is very common for these to be external and able to be seen in the locked position when the outrigger is retracted.

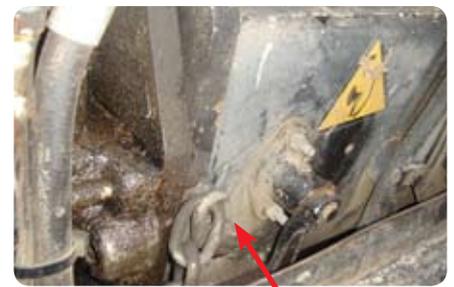
The bottom right photo shows that even though a chain was fitted it was not secured (an operational issue) and the vehicle was found to have the stabiliser leg protruding outside the dimensions of the vehicle – a potentially dangerous situation.

Manufacturers provided locking device inoperative and chain used with a 'D' link to prevent accidental extension.

Not repaired to within safe tolerance of manufacturer's original.

If an OE locking device failed due to being defective, eg it is bent, worn or otherwise damaged or deteriorated so that it is not effective, then it's recommended a request be made for it to be repaired back to within safe tolerance of its original design rather than using an alternative method such as a small chain.

In this case it would be expected that if the manufacturer's locking device was not functioning as intended it be reinstated

to provide the original locking capabilities which does not rely on the operator remembering to engage the chain.

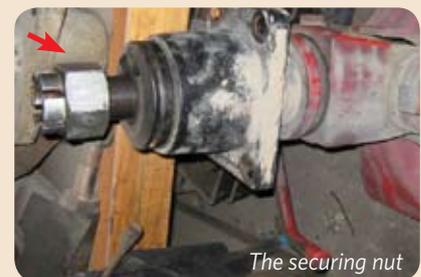
Due to the large number of stress reversal cycles thread pitches can become worn, loosening the coupling shank or nut, which in turn allows the nut to be pulled over the thread on the shank resulting in the trailer becoming detached.

The NZ Police CVIU has advised of a recent crash that was caused by a trailer becoming detached from the towing vehicle. In this instance the large nut unwound, allowing the coupling to pull through the mounting block assembly. In this incident it is not confirmed if the locking split pin was re-fitted during recent maintenance.

When inspecting either the mounting nut on the tow coupling or the bolt in tow eye, ensure full and complete security of these items. Any looseness or witness marks (nut or washer) indicating that the coupling is loose should immediately be cause for rejection and replacement. Just tightening the assembly is not adequate to provide continued safety!

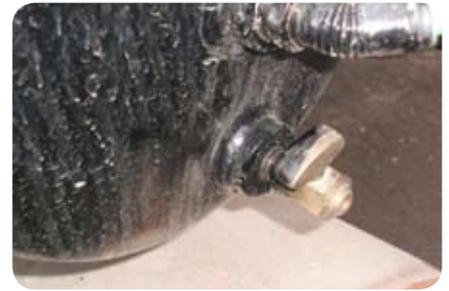
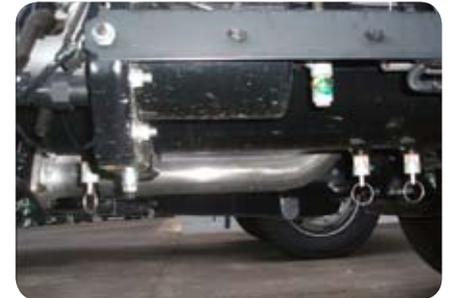
The Heavy Vehicle Brake Code and the New Zealand Heavy-vehicle Brake Specification (Schedule 5) contain similar requirements for the air brake system air reservoirs to have a drain valve fitted.

Clause 4.2.9 Each air reservoir in an air brake system must be fitted with a condensate drain valve at the lowest point. Where an automatic condensate valve is fitted, it must have a provision for manual operation.

Clause 3.5 A drain valve must be fitted to the lowest point of each brake reservoir, specifically, the reservoirs of the service brake and park brake, and including the so-called 'wet tank'.

Clause 3.6 An automatic drain valve must have a means of manual operation.

Vehicle inspectors must ensure that mandatory drain valves are fitted and operational when carrying out CoF inspections on vehicles certified to the Heavy Vehicle Brake Code and Schedule 5.
