Extract taken from: In-service certification (WoF and CoF) > Heavy vehicles > Vehicle structure > Structure

3-1 Structure

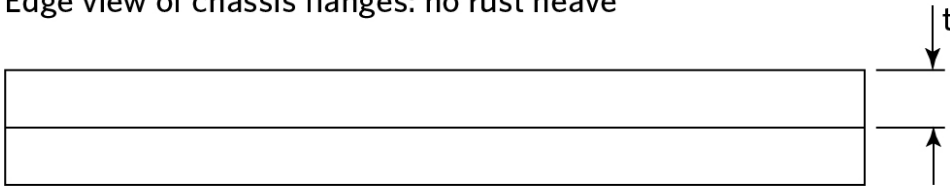
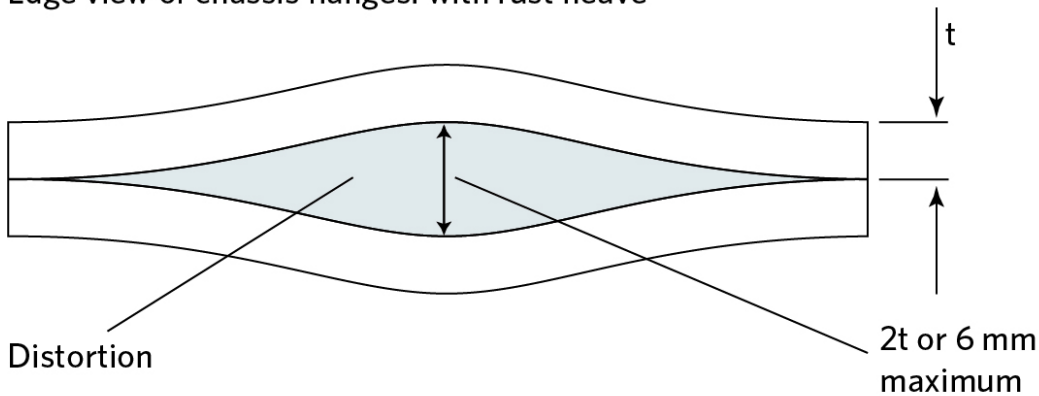
Figure 3-1-3. Rust heave limits

Edge view of chassis flanges: no rust heave

Edge view of chassis flanges: with rust heave

Apply similar criteria (twice material thickness or 6 mm maximum) for corrosion in other parts of structural members

Note: where the flanges are of different thickness, t shall be taken as the minimum of these.

- d) significant rust heave that exceeds the limits in (Figure 3-1-3), or
 - e) poor repairs that have not returned the structure to within safe tolerance of when it was manufactured, eg:

Rust heave beyond the limits described above is acceptable only if an HVS certifier with the HVEC category has confirmed in writing that at the time of inspection the identified chassis rust heave on the vehicle remains within safe tolerance of the vehicle's state of manufacture. Confirmation from the HVS certifier should be kept with the checksheet. The identity of the HVS certifier must be recorded in the Landata GNOTE page. This assessment is only valid for that specific CoF inspection.
