Extract taken from: In-service certification (WoF and CoF) > Heavy vehicles > Vehicle structure > Structure

3-1 Structure

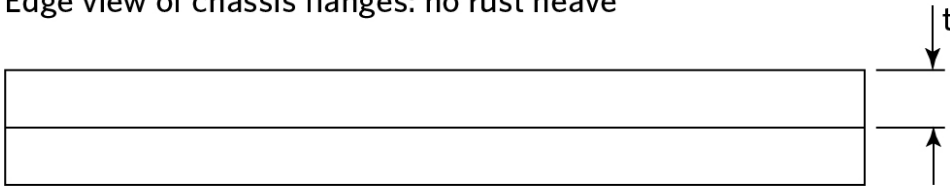
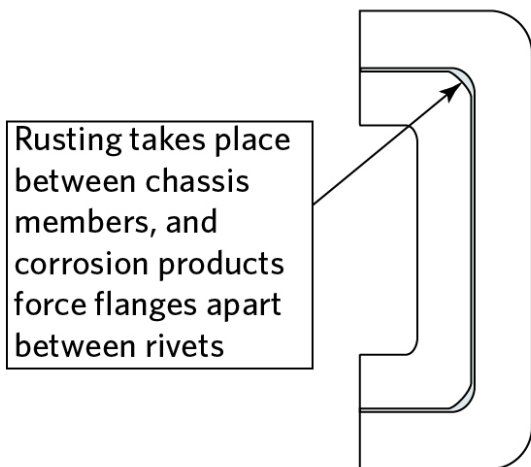
Figure 3-1-3. Rust heave limits

Edge view of chassis flanges: no rust heave

Edge view of chassis flanges: with rust heave

Apply similar criteria (twice material thickness or 6 mm maximum) for corrosion in other parts of structural members

Note: where the flanges are of different thickness, t shall be taken as the minimum of these.

- a) deformation from original shape that has affected the vehicle's structural integrity (Note 6) (Figure 3-1-4), or
- b) cracking, or
- c) significant corrosion or delamination, or
- d) significant rust heave that exceeds the limits in (Figure 3-1-3), or
- e) poor repairs that have not returned the structure to within safe tolerance of when it was manufactured, eg:
 - i. filler has been used to conceal corrosion damage or deformation of a component
 - ii. a high-strength steel component has been heated
 - iii. a component has been strengthened.

Rust heave beyond the limits described above is acceptable only if an HVS certifier with the HVEC category has confirmed in writing that at the time of inspection the identified chassis rust heave on the vehicle remains within safe tolerance of the vehicle's state of manufacture. Confirmation from the HVS certifier should be kept with the checksheet. The identity of the HVS certifier must be recorded in the Landata GNOTE page. This assessment is only valid for that specific CoF inspection.
