Extract taken from: Alternative fuel system certification > LPG inspection

LPG inspection

1-1 Alternative Fuel System Installation Certificate

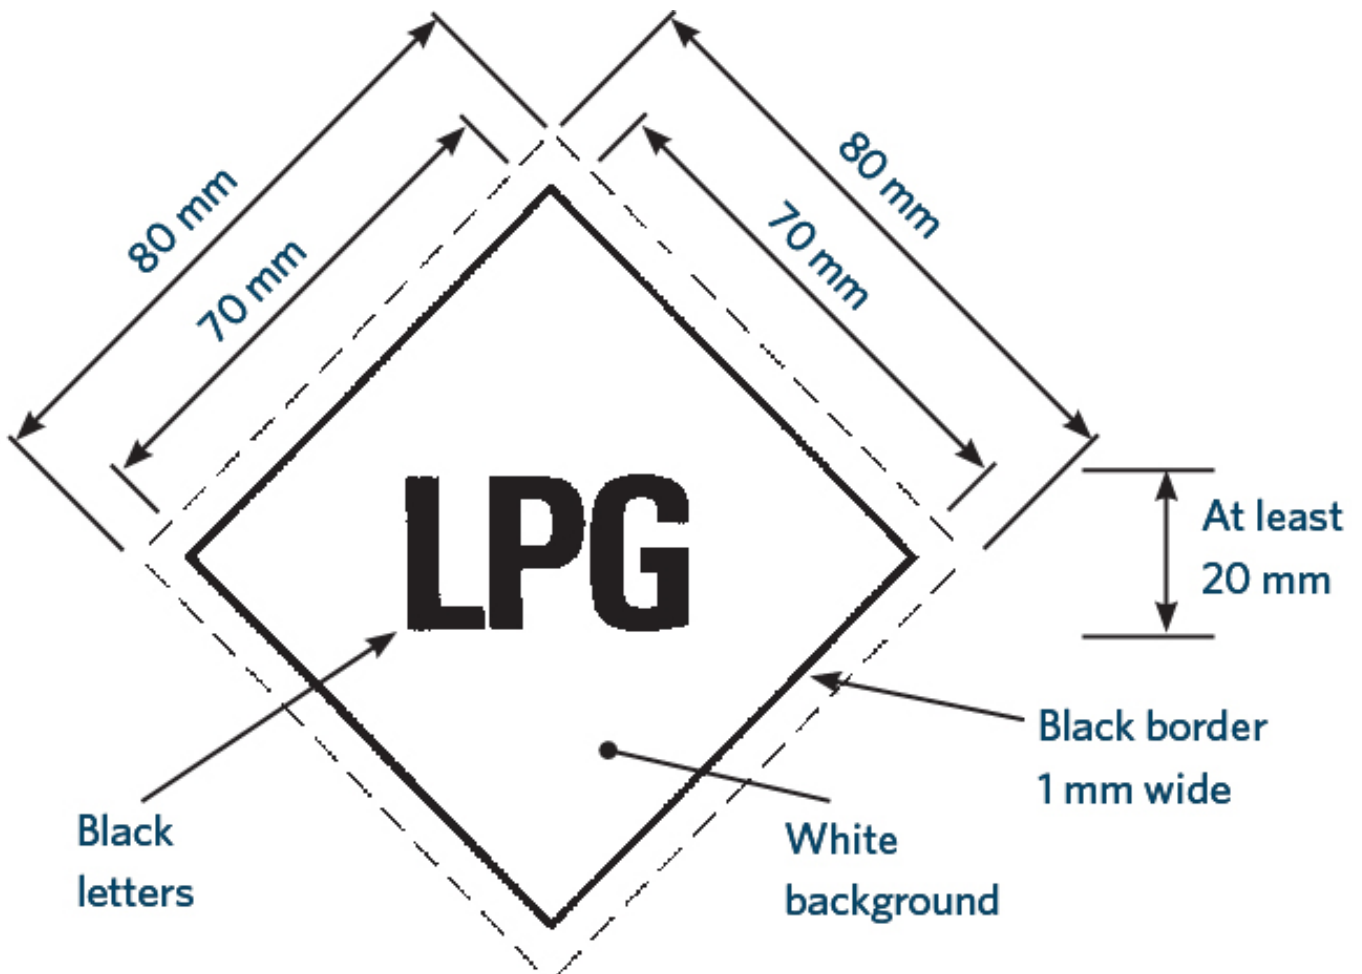
Figure 1-2-1. LPG vehicle identification label

1. A vehicle is not fitted with identification labels as shown in Figure 1-2-1 positioned in a clearly visible location as close as practical to the front and rear registration plates.

AS/NZS 1425: 2003 specifies a red diamond for Australia. Vehicles fitted with red diamonds may retain these, but must also be fitted with the white diamonds specified above.

1. A vehicle must be fitted with identification labels as shown in Figure 1-2-1 positioned in a clearly visible location as close as practicable to the front and rear registration plates.

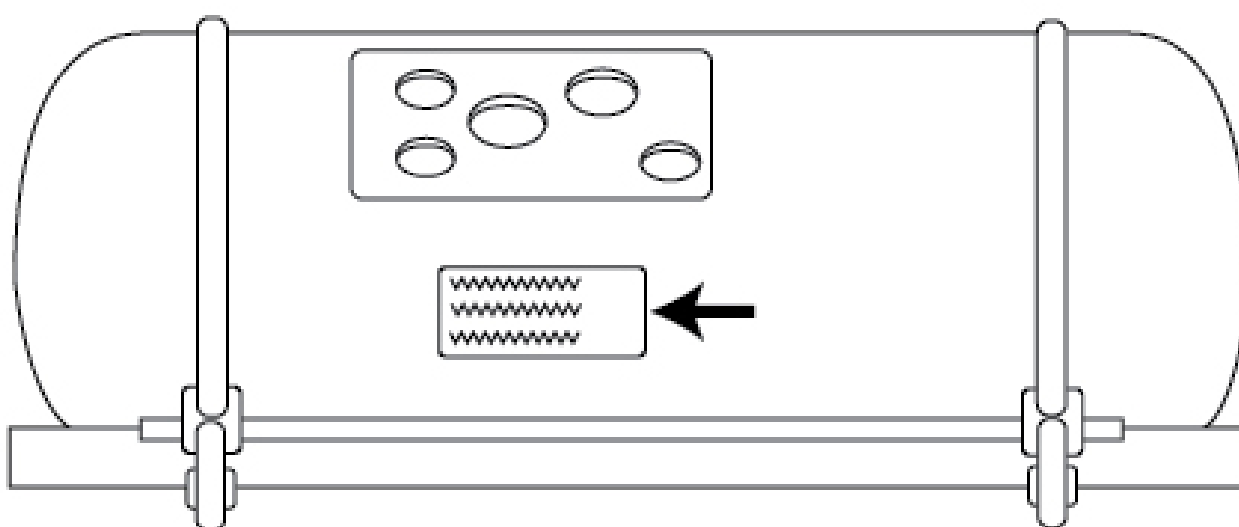
Figure 1-3-1. Container markings

1. The container's (Note 1) test date and cylinder testing station identification mark (Figure 1-3-1):

LPG container markings are located on a plate welded or glued to the container shell or to the outside of the gas proof compartment.

1. The container must be stamped with the test date and the identification mark of the cylinder testing station.
2. The date stamp on a container must be within ten years of the next alternative fuels inspection.
3. A container must not be damaged by impact to the extent described in Table 1–3–1.

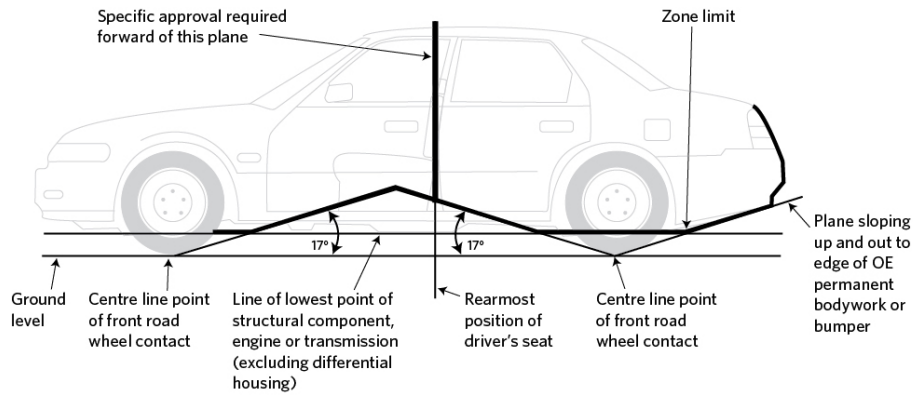
Figure 1-8-1. Zone limit for container location (requirements from NZS 5422: 1987, Part 1)

1. An installation to NZS 5422: 1987, Part 1 does not meet all the requirements in the left-hand column of Table 1-8-1.
2. An installation to AS/NZS 1425: 2003 does not meet all the requirements in either:
 - a) the right-hand column of Table 1-8-1, or
 - b) the left-hand column of Table 1-8-1 if the requirements in the right-hand column are not practicable.

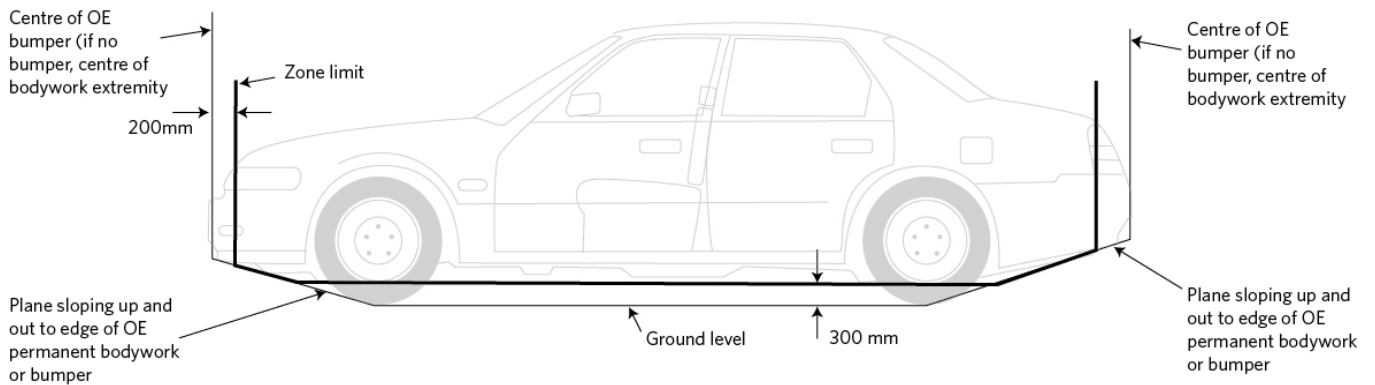
Figure 1-8-2. Ground clearance zone limits for a small vehicle (requirements from AS/NZS 1425: 2003)

Vehicle mass ¹	Chassis ground clearance at rear of vehicle	Figure that shows ground clearance zone limits
Less than 4500kg	600mm or less	Figure 1-8-2
Less than 4500kg	More than 600mm	Figure 1-8-3
4500kg or more	600mm or less	Figure 1-8-2
4500kg or more	More than 600mm	Figure 1-8-3
