Extract taken from: Alternative fuel system certification > LPG inspection

LPG inspection

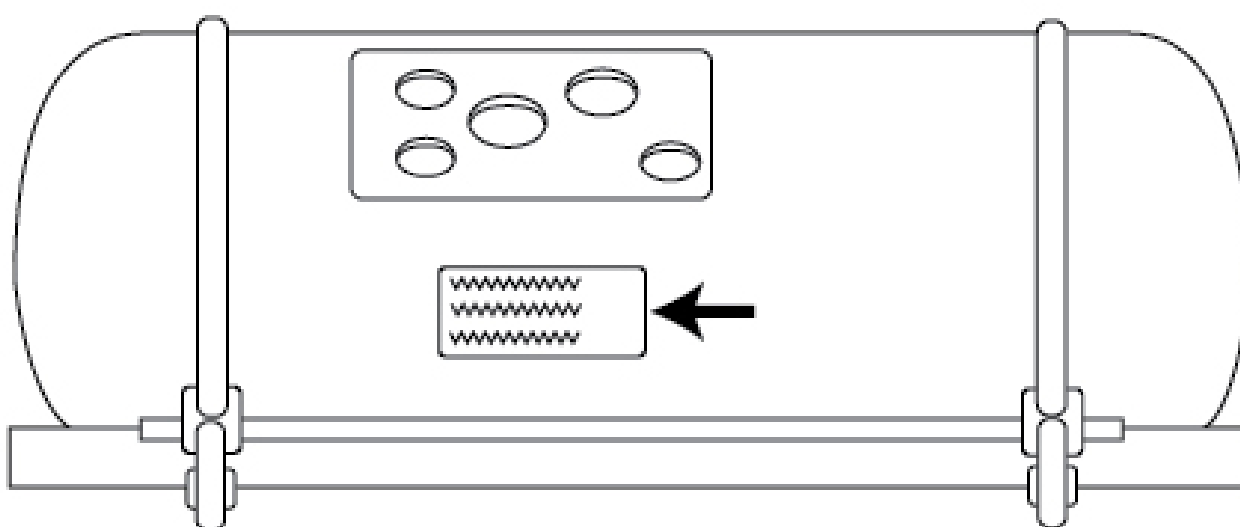
Figure 1-3-1. Container markings

1. The container's (Note 1) test date and cylinder testing station identification mark (Figure 1-3-1):

LPG container markings are located on a plate welded or glued to the container shell or to the outside of the gas proof compartment.

1. The container must be stamped with the test date and the identification mark of the cylinder testing station.
2. The date stamp on a container must be within ten years of the next alternative fuels inspection.
3. A container must not be damaged by impact to the extent described in Table 1–3–1.
