Extract taken from: Alternative fuel system certification > CNG inspection

CNG inspection

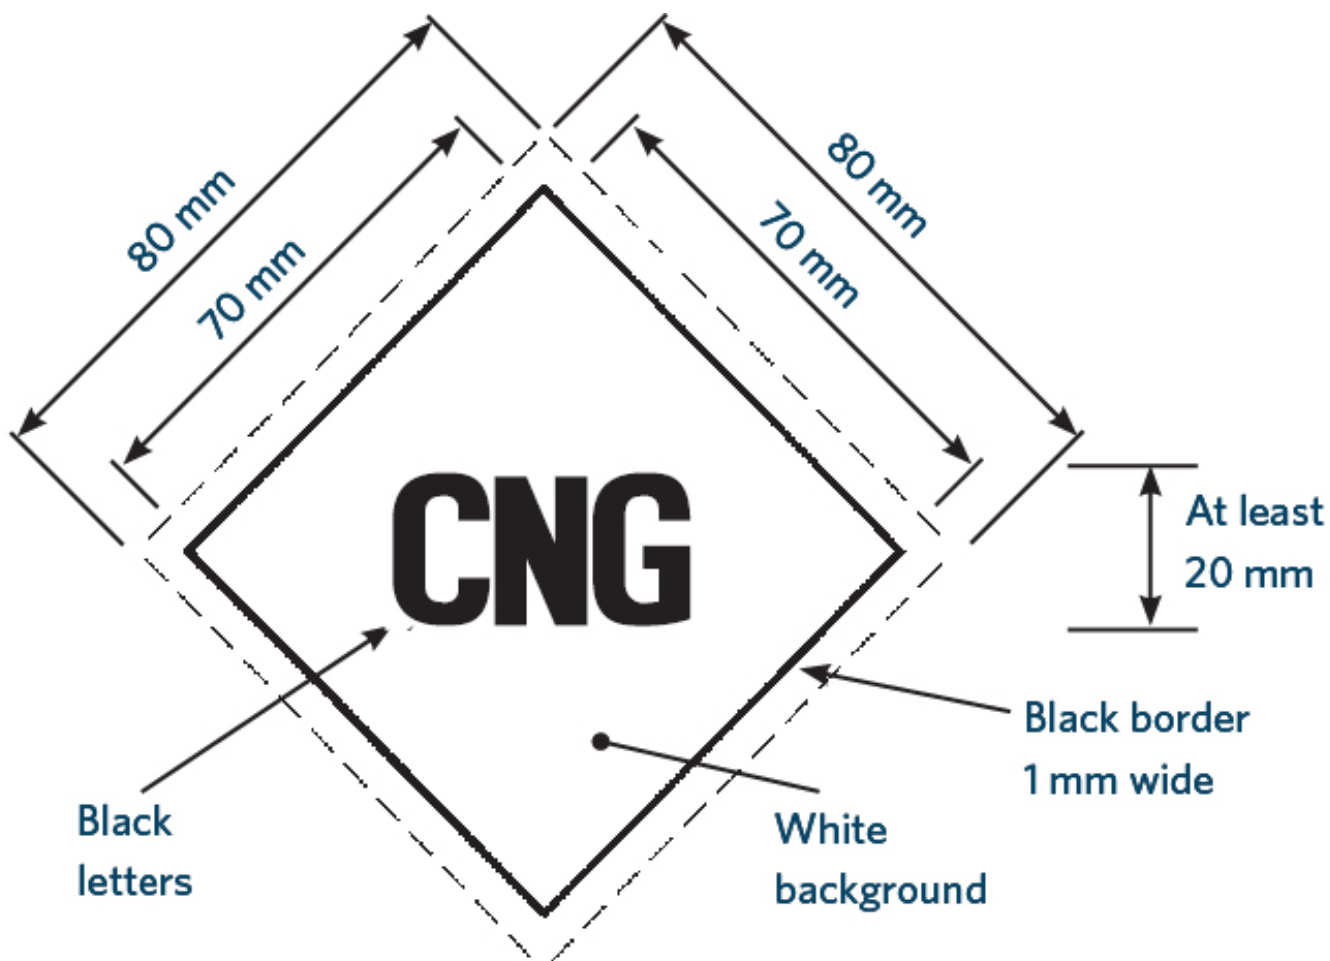
Figure 2-2-1. CNG vehicle identification label

1. An identification label as shown in Figure 2-2-1 is not affixed as close as practicable to each of the vehicle's registration plates.

AS/NZS 2739: 2003 specifies a red circle for Australia. Vehicles fitted with red circles may retain these, but must also be fitted with the white diamonds specified above.

1. An identification label as shown in Figure 2-2-1 must be affixed as close as practicable to each of the vehicle's registration plates.

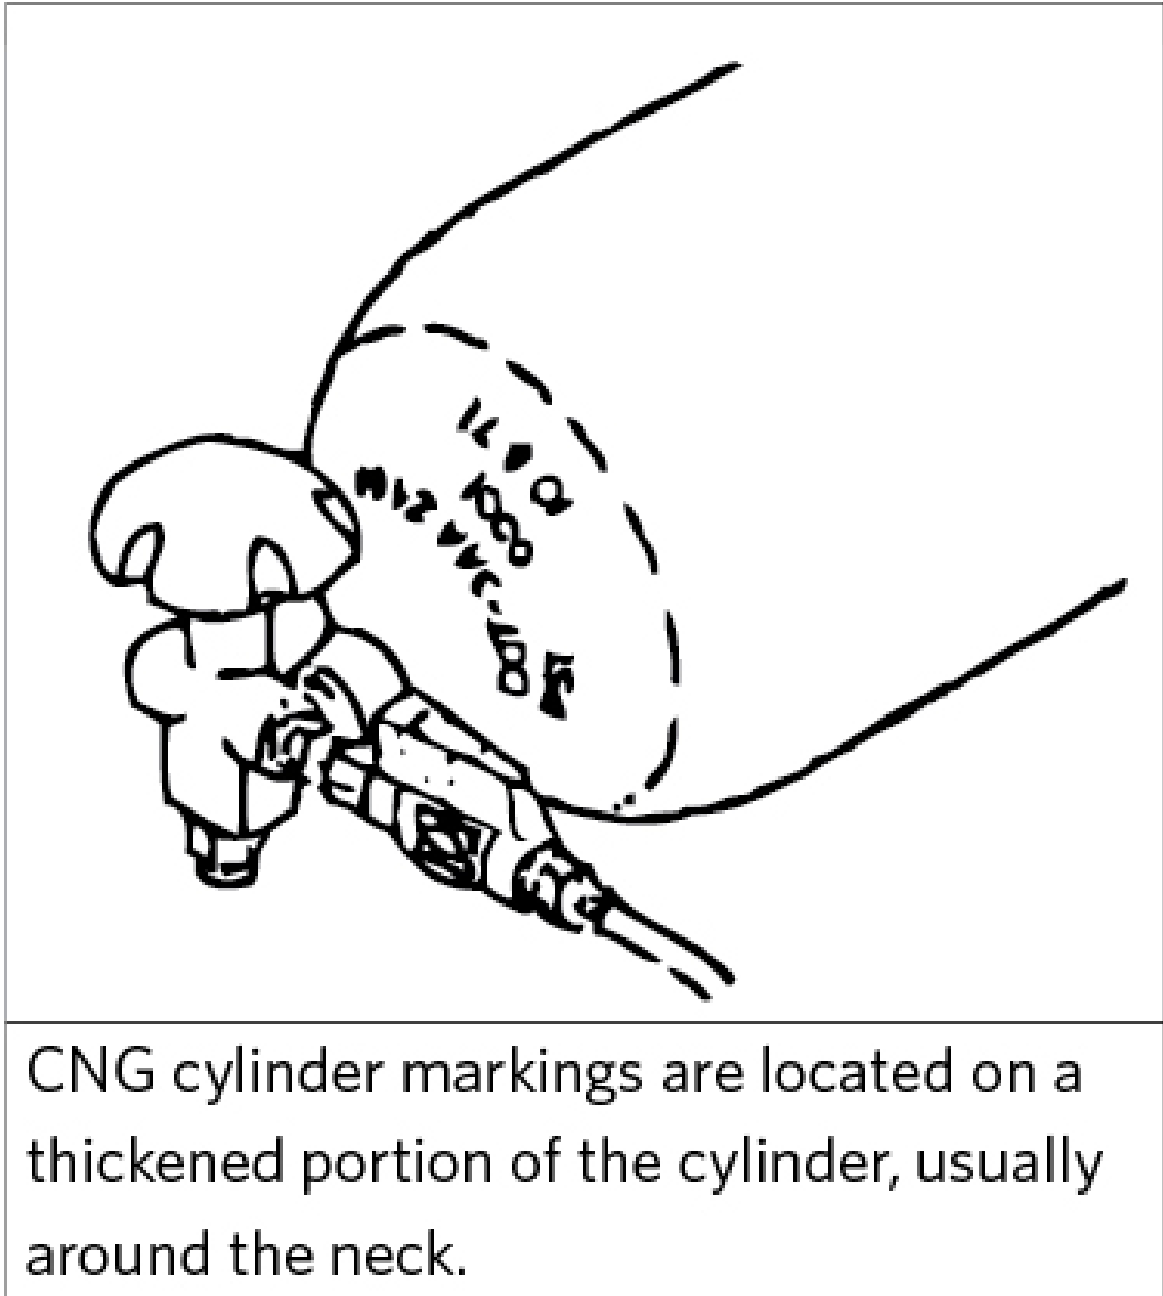
Figure 2-3-1. Cylinder markings

1. The cylinder's test date and cylinder testing station identification mark:
 - a) are missing, or
 - b) are not legible, or
 - c) have been altered, or
 - d) have not been stamped on the container.
2. There are more than five years between the test date stamped on a cylinder and the date of the next alternative fuels inspection.
3. A cylinder shows evidence of impact damage, corrosion, or heating by fire.

Cylinder means a pressure vessel, or gas cylinder for the storage of CNG to be used as fuel for an engine.

1. The cylinder must be stamped with the test date and the identification mark of the cylinder testing station.
2. The date stamp on a cylinder must be within five years of the next alternative fuels inspection.
3. A cylinder must not show evidence of impact damage, corrosion, or heating by fire.

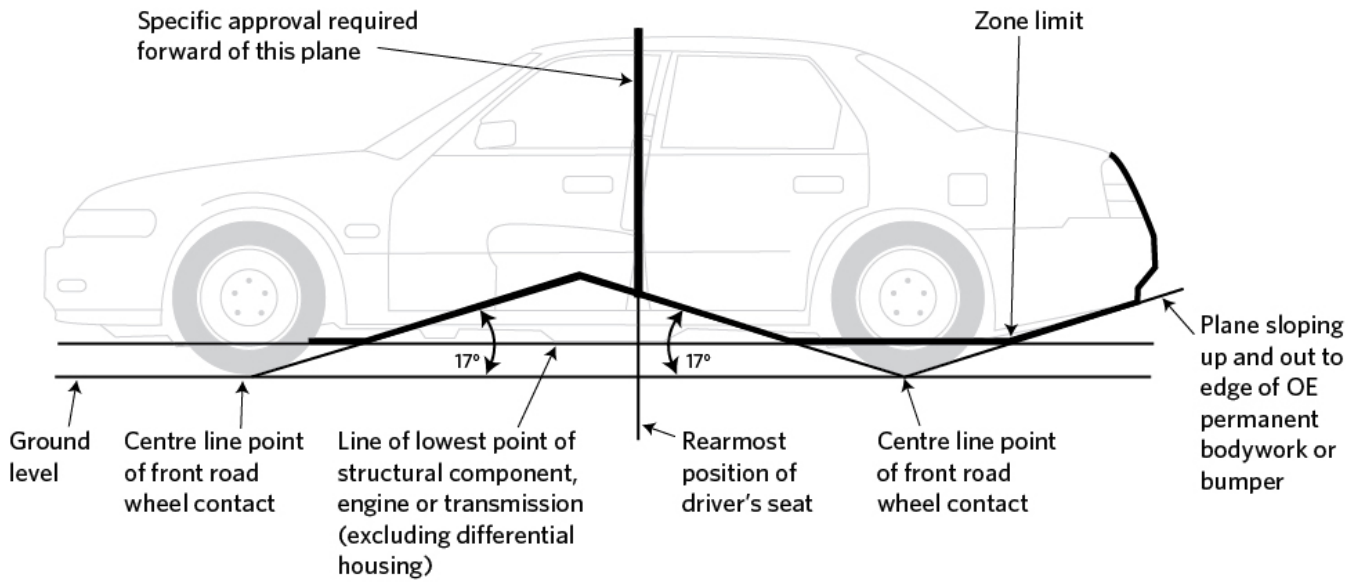
Figure 2-7-1. Zone limit for container location (requirements from NZS 5422: 1987, Part 2)

1. An installation to NZS 5422: 1987, Part 2 does not meet all the requirements in the left-hand column of Table 2-7-1.
2. An installation to AS/NZS 2739: 2003 does not meet all the requirements in either:
 - a) the right-hand column of Table 2-7-1, or
 - b) the left-hand column of Table 2-7-1 of the requirements

Requirements from NZS 5422: 1987: Part 2	Requirements from AS/NZS 2739: 2003
<p>1. Cylinders, fittings and pipework must be mounted inside the perimeter of the vehicle.</p> <p>2. Cylinder valves on externally mounted containers must be positioned no less than 200mm from the vehicle extremities.</p> <p>3. A cylinder must not be fitted:</p> <ul style="list-style-type: none"> a) on the roof or above a passenger compartment b) forward of the rear of the driver's seat in its rearmost position without specific approval c) in a position beneath the vehicle that decreases the effective ground clearance. <p>4. A cylinder located between or behind the axles must be within the zone limit shown in Figure 2-7-1.</p>	<p>1. A cylinder must lie within the ground clearance zone limits indicated by Table 2-7-2 and Figure 2-7-2 and Figure 2-7-3.</p> <p>2. A cylinder must not be mounted outside the body contour to the front or sides of the vehicle.</p> <p>3. A cylinder must not be mounted outside the body contour to the rear or top of the vehicle without specific approval.</p> <p>4. A cylinder must be located such that its fittings are at least 100mm inside the outer body skin or tray of the vehicle.</p>

1. Installations to NZS 5422: 1987, Part 2 must meet the requirements in the left-hand column of Table 2-7-1.
2. Installations to AS/NZS 2739: 2003 must meet the requirements in the right-hand column of Table 2-7-1, or if this is not practicable, the requirements in the left-hand column.

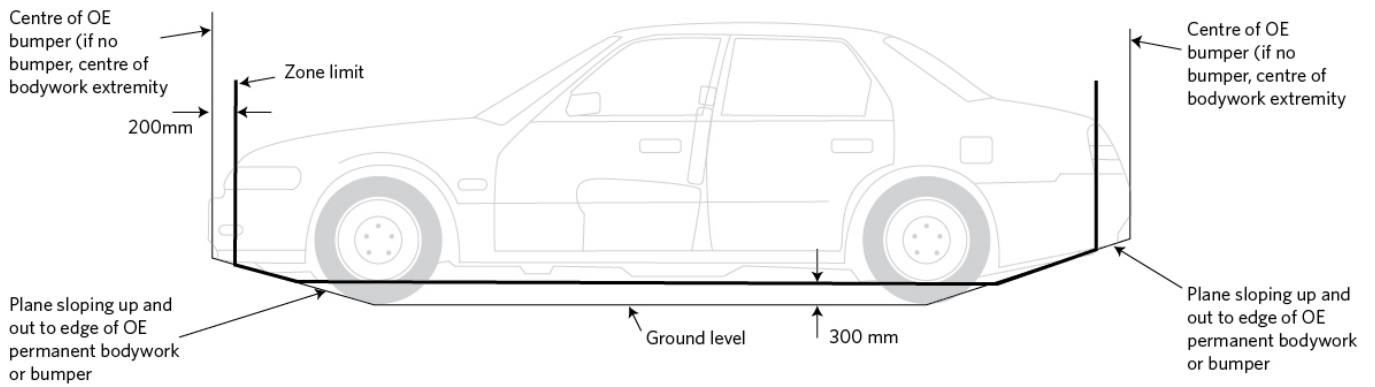
Figure 2-7-2. Ground clearance zone limits for a small vehicle (requirements from AS/NZS 2739: 2003)

Vehicle mass ¹	Chassis ground clearance at rear of vehicle	Figure that shows ground clearance zone limits
Less than 3500kg	610mm or less	Figure 2-7-2
Less than 3500kg	More than 610mm	Figure 2-7-3
3500kg or more	610mm or less	Figure 2-7-2
3500kg or more	More than 610mm	Figure 2-7-3

¹ Unladen mass with fuel, coolant and oil containers full.

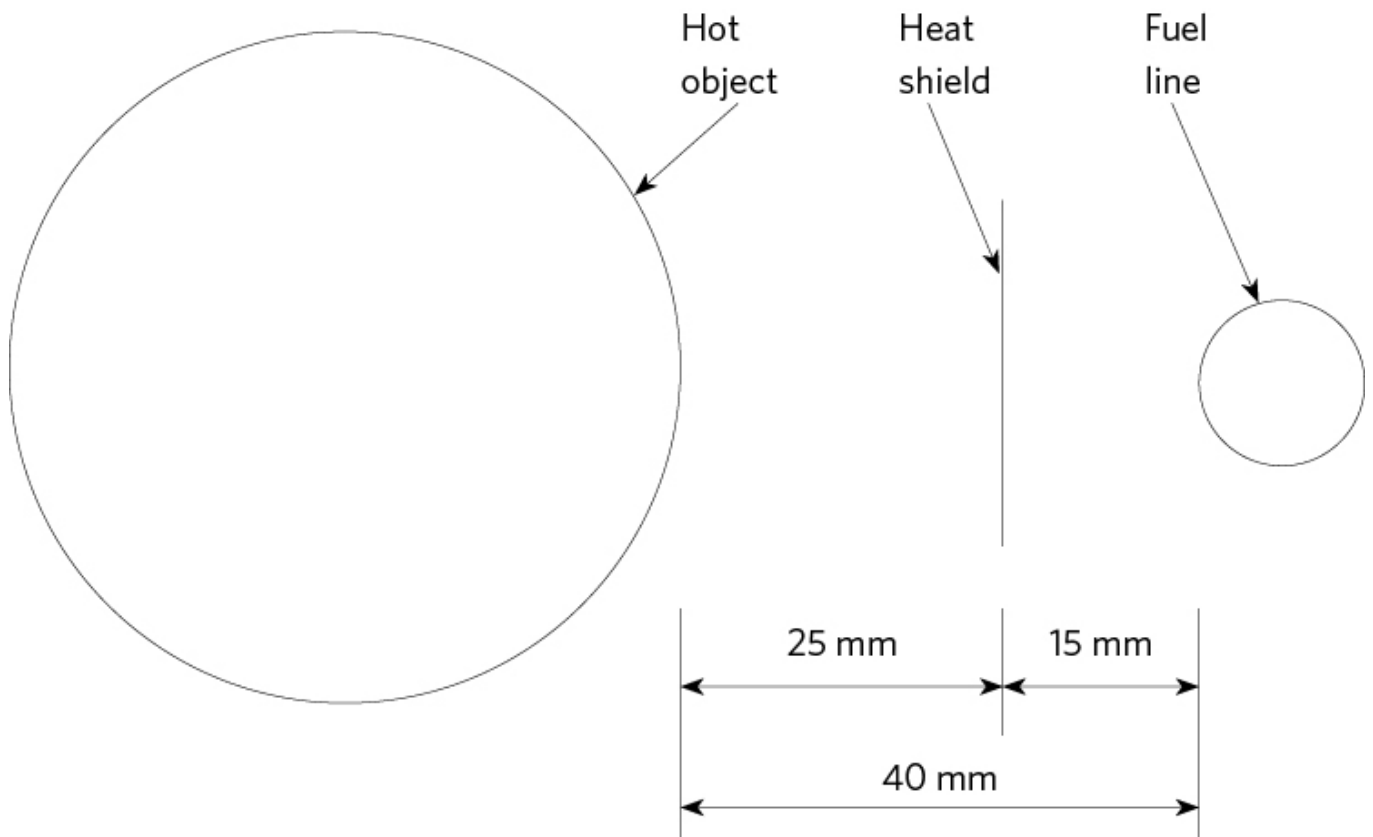
Figure 2-8-1. Minimum fuel line distance to hot object with heat shield

1. A fuel service line enters an enclosed driver, passenger or luggage compartment (Note 1).
2. A fuel service line in a drive shaft tunnel is within 40mm of the drive shaft under some operating conditions.
3. The underside of a fuel service line in a drive shaft tunnel is more than 15mm of the intersection of the drive shaft tunnel and the floor pan.
4. Required fuel line protection is missing.
5. A required clip or grommet is missing.
6. A pipe, component or fitting that is not fully protected by a radiation shield at least 15mm away is within 150mm of a hot object at a temperature above the normal water jacket temperature.
7. A pipe, component or fitting that is fully protected by a radiation shield at least 15mm away is within 40mm of a hot object at a temperature above the normal water jacket temperature (Figure 2-8-1).

3. The underside of a fuel service line must be within 15mm of the intersection of the drive shaft tunnel and the floor pan.
4. A fuel service line below the body shell must be protected from impact or abrasion.
5. Piping subject to corrosion must be protected throughout its exposed length.
6. Piping must be secured to the chassis frame or body with cushioned clips not more than 600mm apart.
7. A pipe must be protected with a grommet where it passes through a body panel.
8. A pipe, component or fitting that is not fully protected by a radiation shield at least 15mm away, must not be within 150mm of a hot object at a temperature above the normal water jacket temperature.
9. A pipe, component or fitting that is fully protected by a radiation shield at least 15mm away, must not be within 40mm of a hot object at a temperature above the normal water jacket temperature (Figure 2-8-1).
