Extract taken from: Alternative fuel system certification > CNG inspection

## CNG inspection

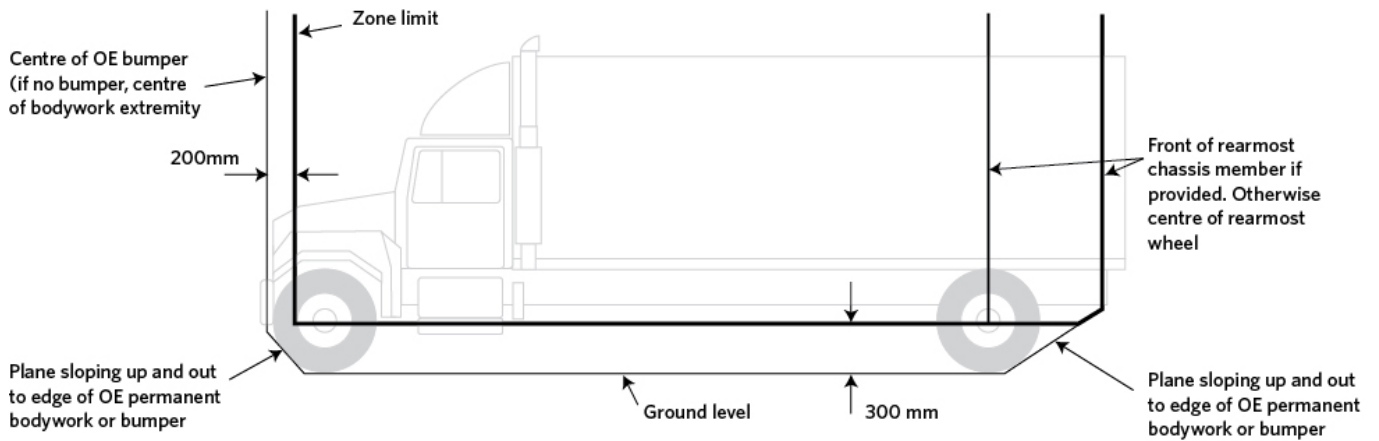
**Figure 2-7-3. Ground clearance zone limits for a large vehicle (requirements from AS/NZS 2739: 2003)**

Vehicle mass <sup>1</sup>	Chassis ground clearance at rear of vehicle	Figure that shows ground clearance zone limits
Less than 3500kg	610mm or less	Figure 2-7-2
Less than 3500kg	More than 610mm	Figure 2-7-3
3500kg or more	610mm or less	Figure 2-7-2
3500kg or more	More than 610mm	Figure 2-7-3

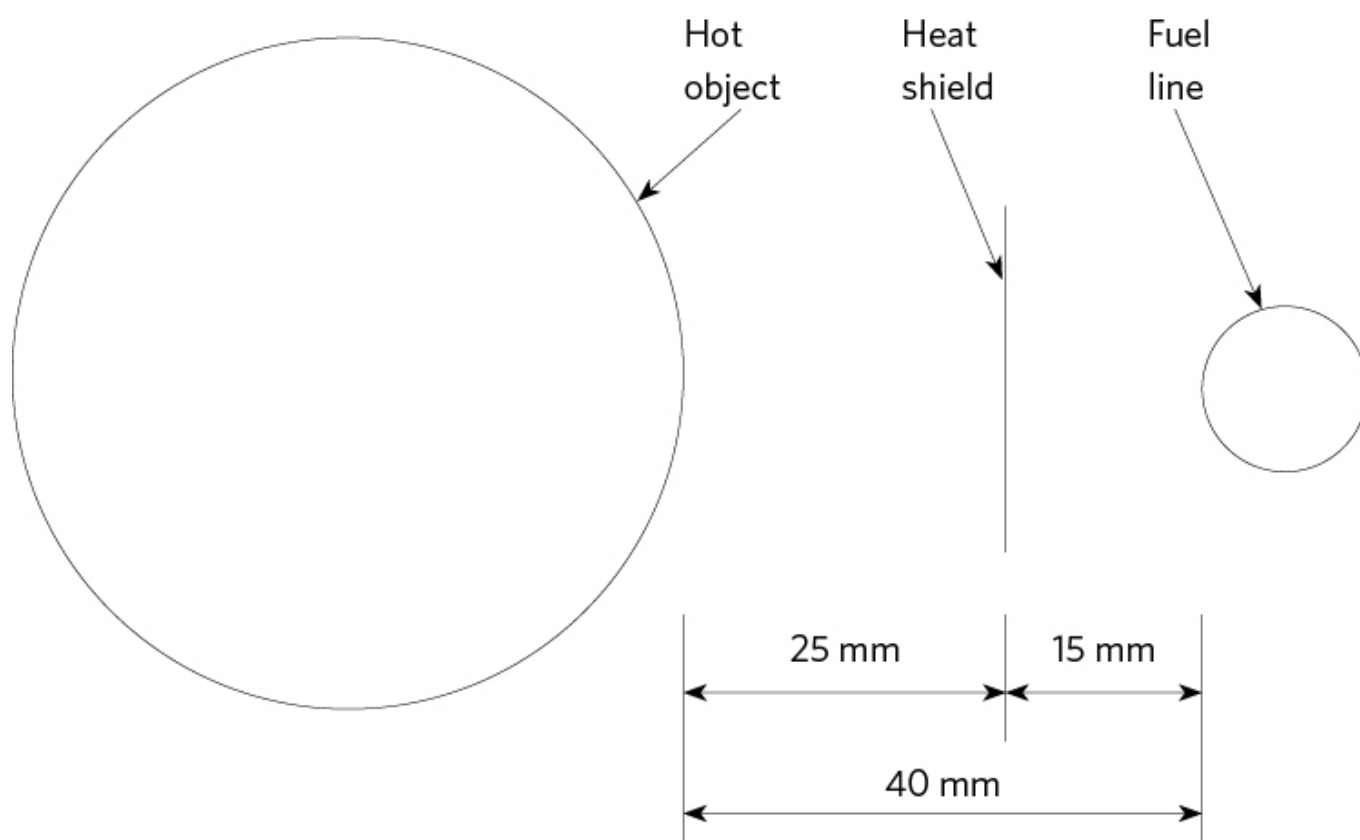
Figure 2-8-1. Minimum fuel line distance to hot object with heat shield

1. A fuel service line enters an enclosed driver, passenger or luggage compartment (Note 1).
2. A fuel service line in a drive shaft tunnel is within 40mm of the drive shaft under some operating conditions.
3. The underside of a fuel service line in a drive shaft tunnel is more than 15mm of the intersection of the drive shaft tunnel and the floor pan.
4. Required fuel line protection is missing.
5. A required clip or grommet is missing.
6. A pipe, component or fitting that is not fully protected by a radiation shield at least 15mm away is within 150mm of a hot object at a temperature above the normal water jacket temperature.
7. A pipe, component or fitting that is fully protected by a radiation shield at least 15mm away is within 40mm of a hot object at a temperature above the normal water jacket temperature (Figure 2-8-1).

3. The underside of a fuel service line must be within 15mm of the intersection of the drive shaft tunnel and the floor pan.
4. A fuel service line below the body shell must be protected from impact or abrasion.
5. Piping subject to corrosion must be protected throughout its exposed length.
6. Piping must be secured to the chassis frame or body with cushioned clips not more than 600mm apart.
7. A pipe must be protected with a grommet where it passes through a body panel.
8. A pipe, component or fitting that is not fully protected by a radiation shield at least 15mm away, must not be within 150mm of a hot object at a temperature above the normal water jacket temperature.
9. A pipe, component or fitting that is fully protected by a radiation shield at least 15mm away, must not be within 40mm of a hot object at a temperature above the normal water jacket temperature (Figure 2-8-1).
