Extract taken from: Border inspection of imported used vehicles > Reference materials > Examples of major structural damage and corrosion > Dogleg flag

5-6 Dogleg flag

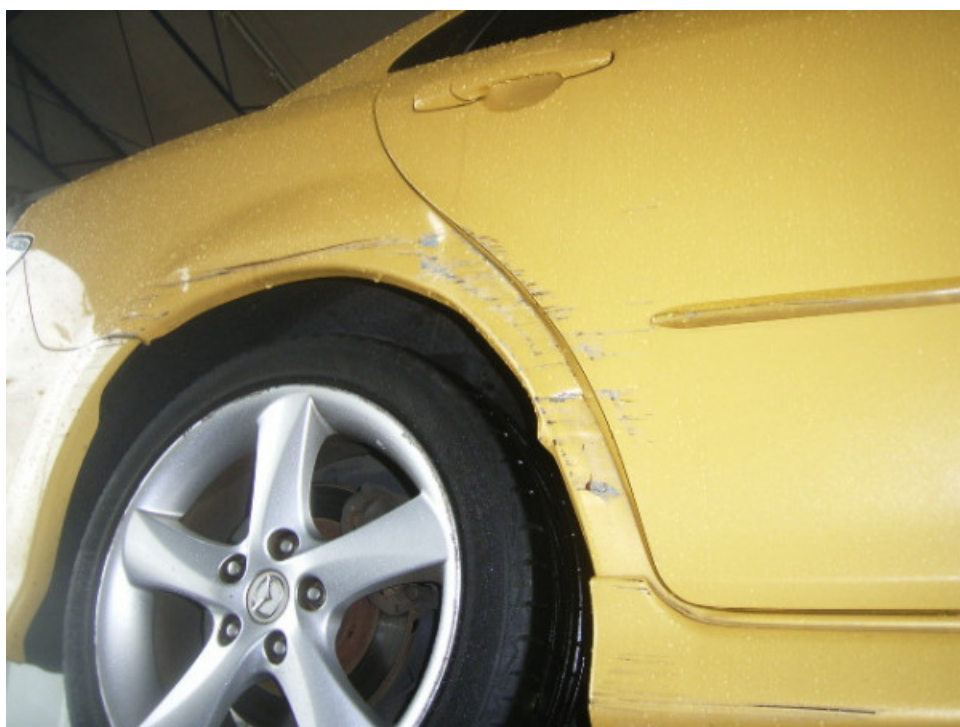
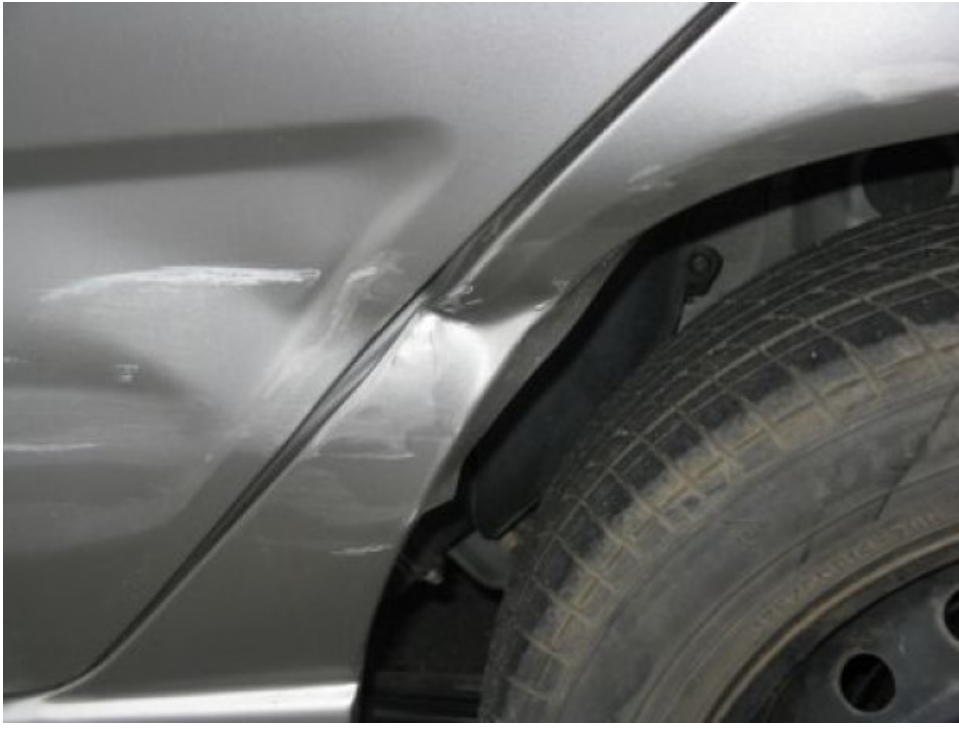
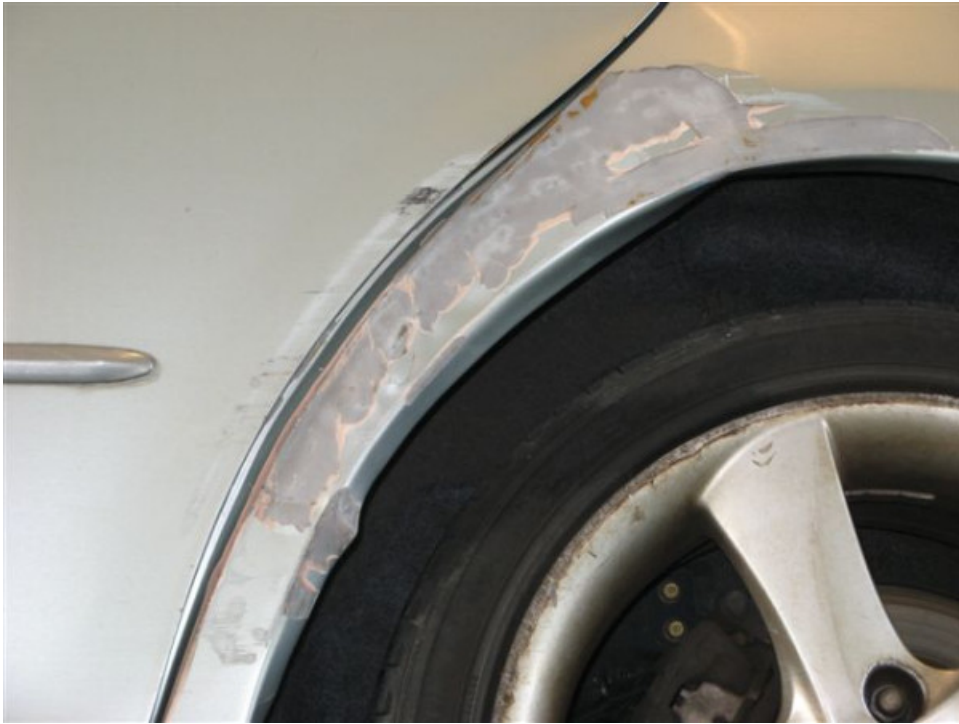
Look for discrepancies in the door gap.
