Extract taken from: Border inspection of imported used vehicles > Reference materials > Examples of major structural damage and corrosion > Dogleg flag

5-6 Dogleg flag

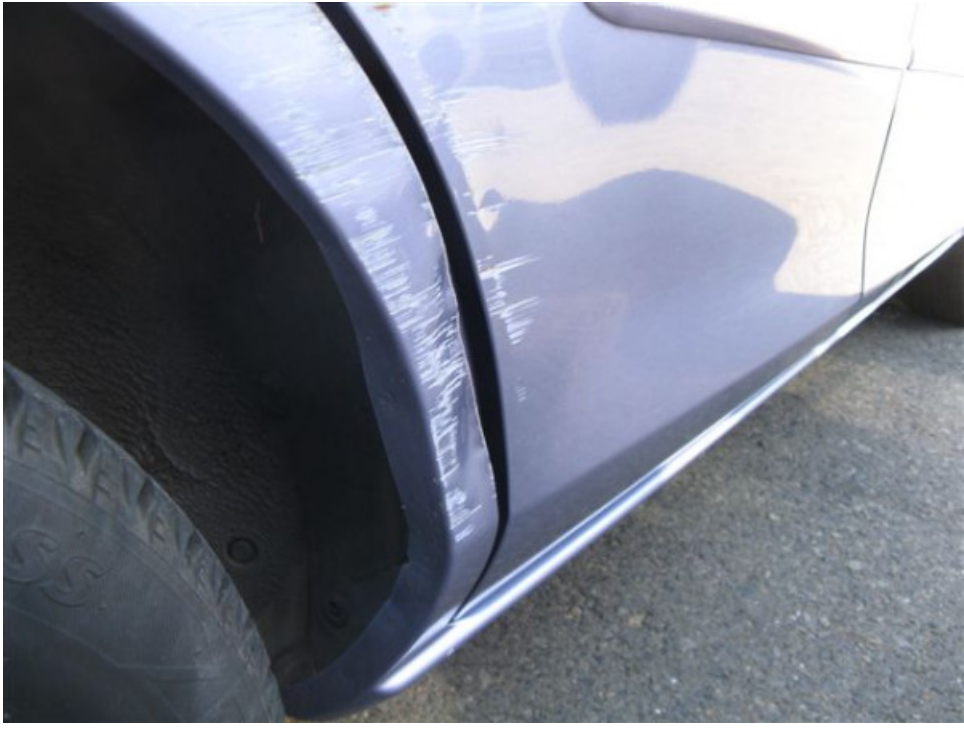
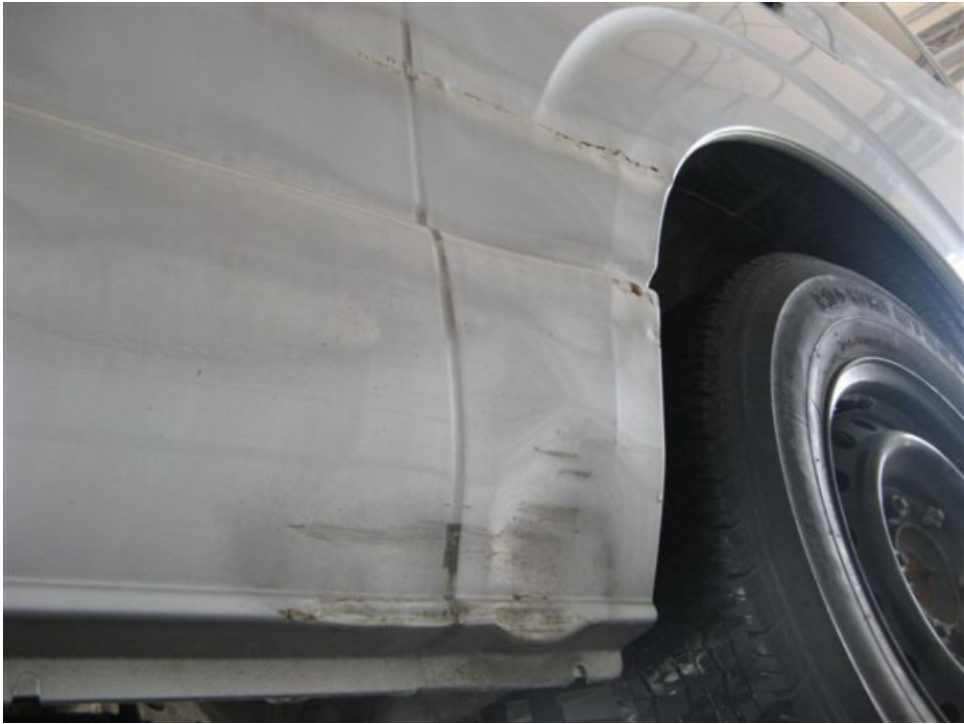
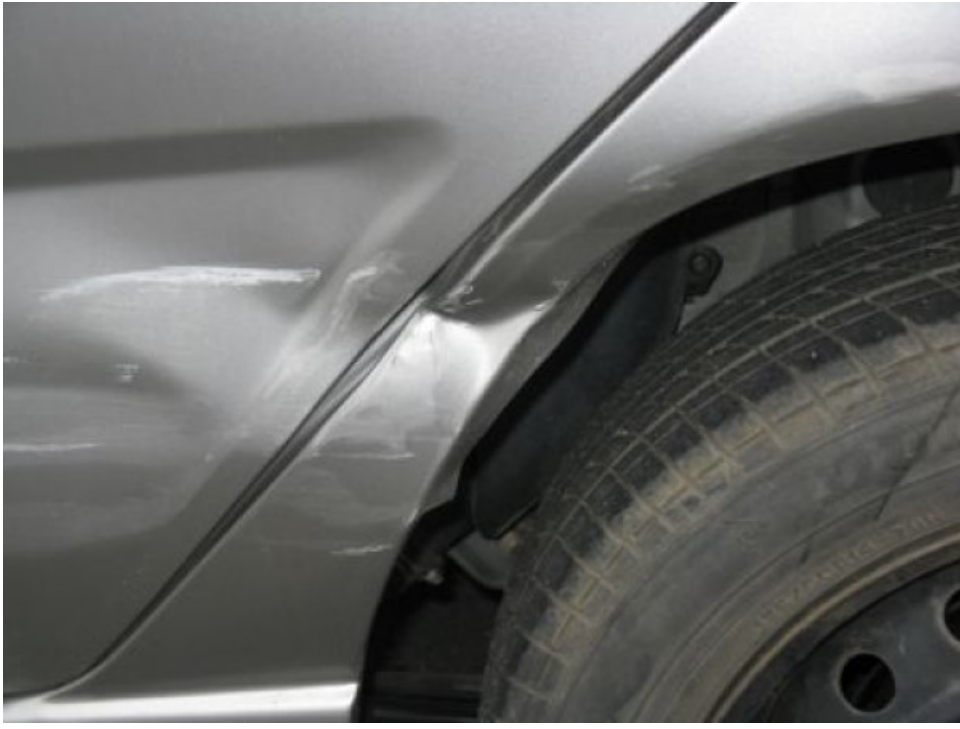
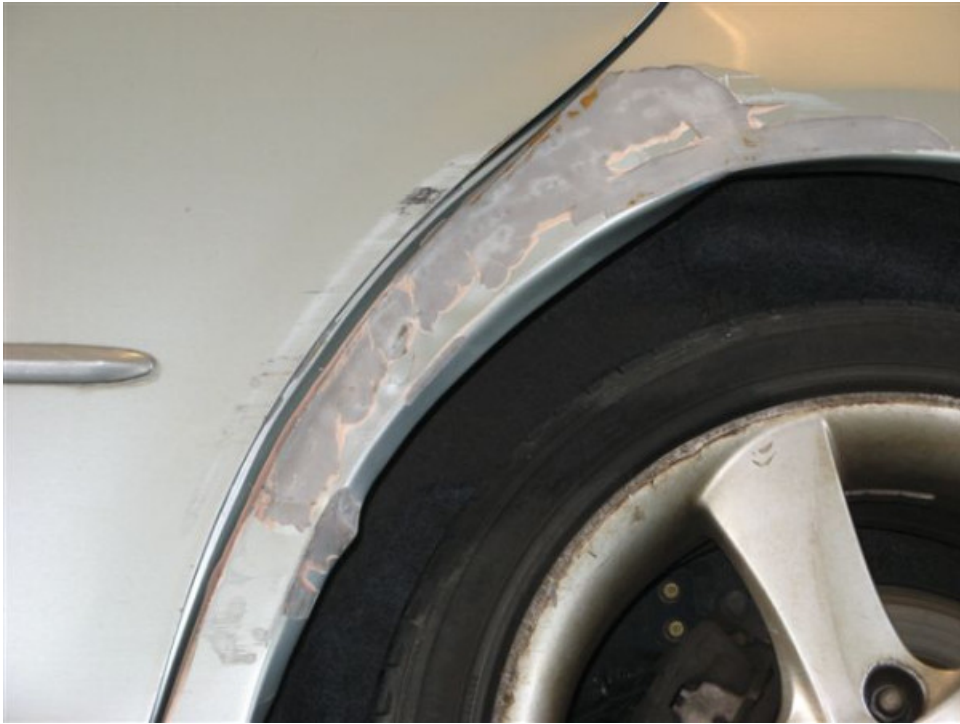
Look for discrepancies in the door gap.
