Extract taken from: Entry certification > Reference materials > Examples of major structural damage and corrosion > Dogleg flag

71-6 Dogleg flag

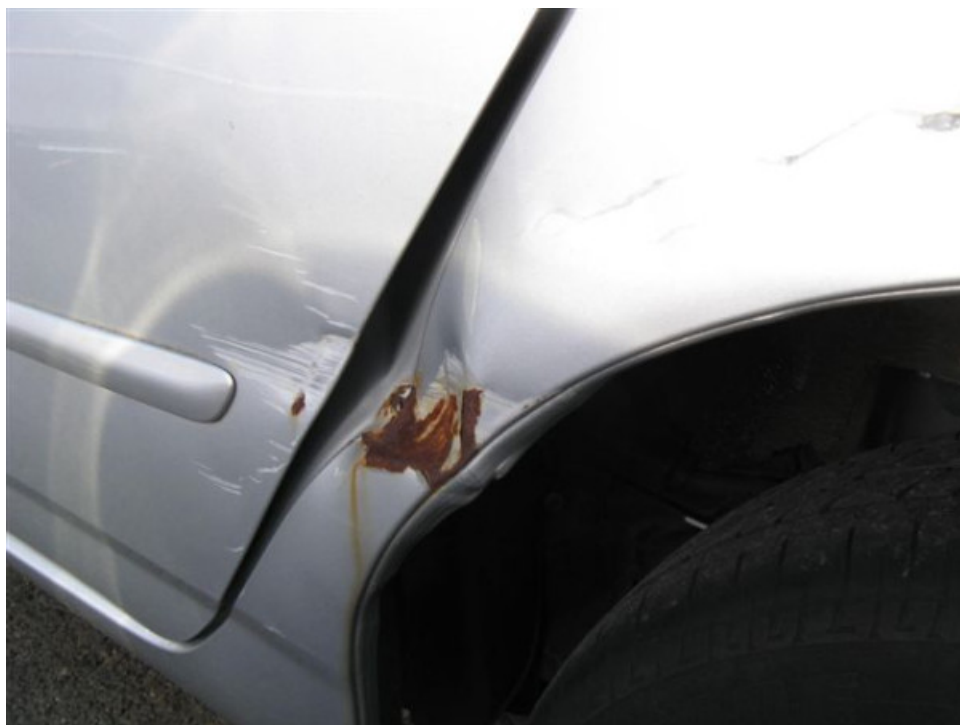
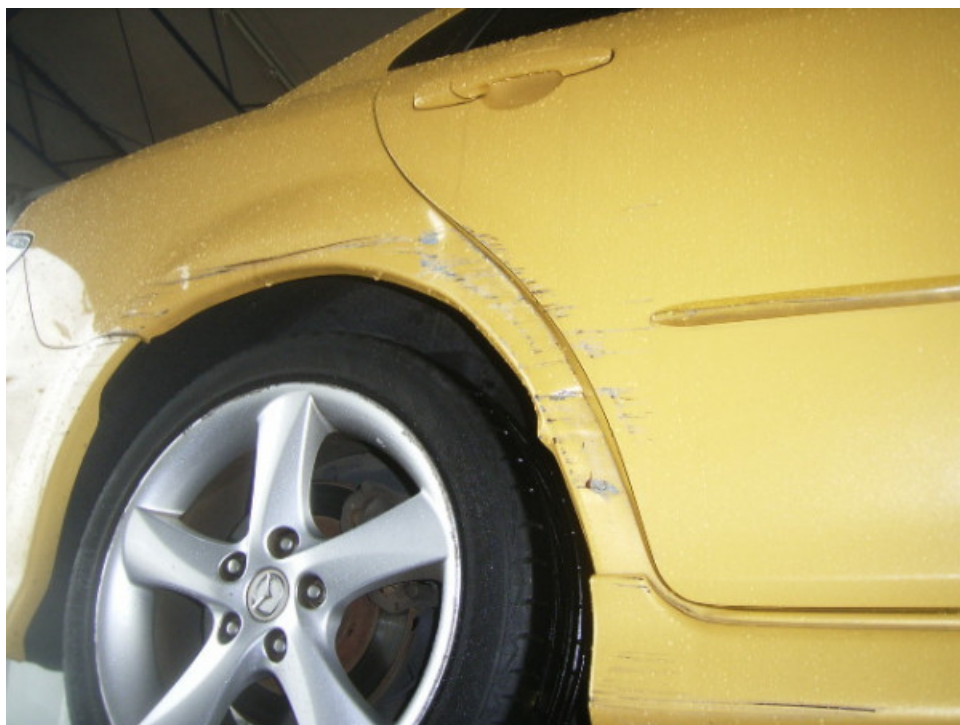
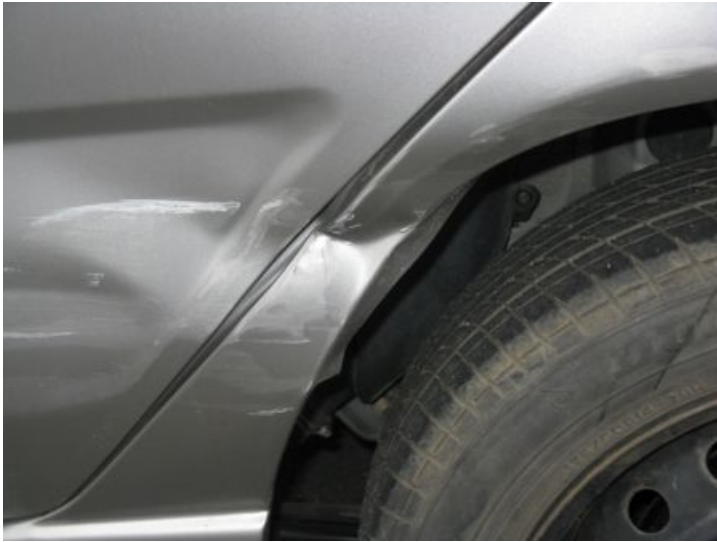
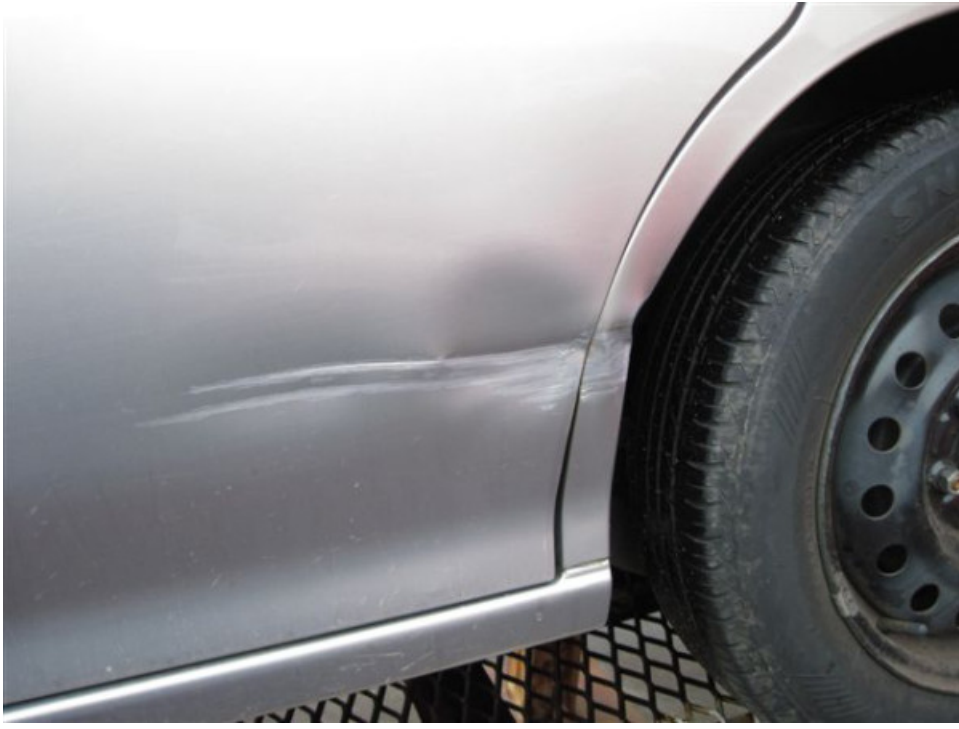
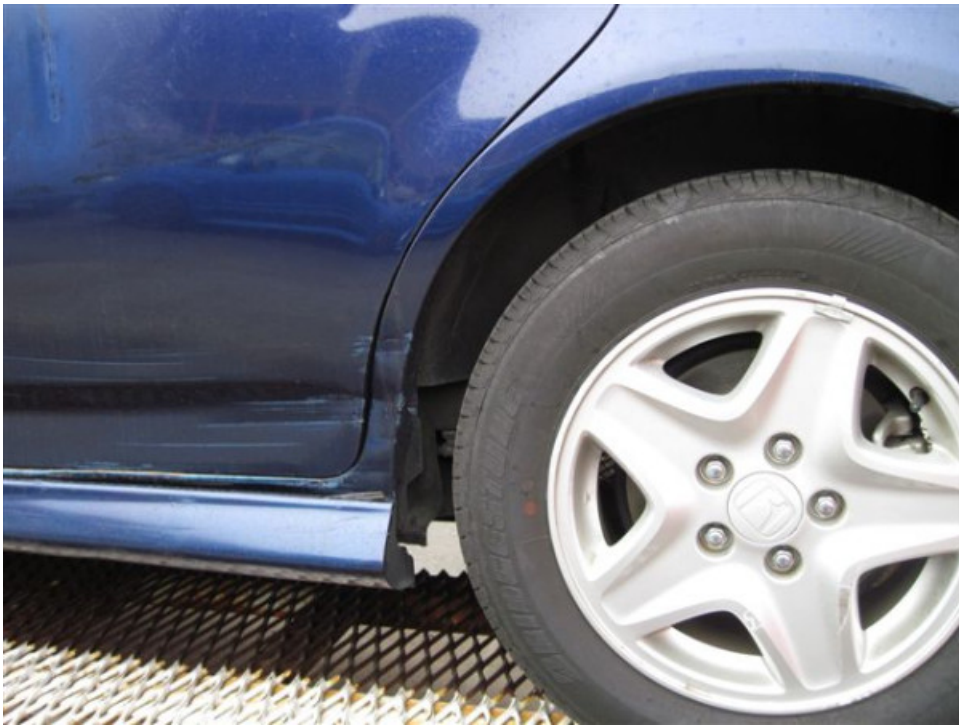
Look for discrepancies in the door gap.
