Extract taken from: Entry certification > Reference materials > Examples of major structural damage and corrosion > Damage to the vehicle's outer body panels: seam or joint integrity

71-9 Damage to the vehicle's outer body panels: seam or joint integrity

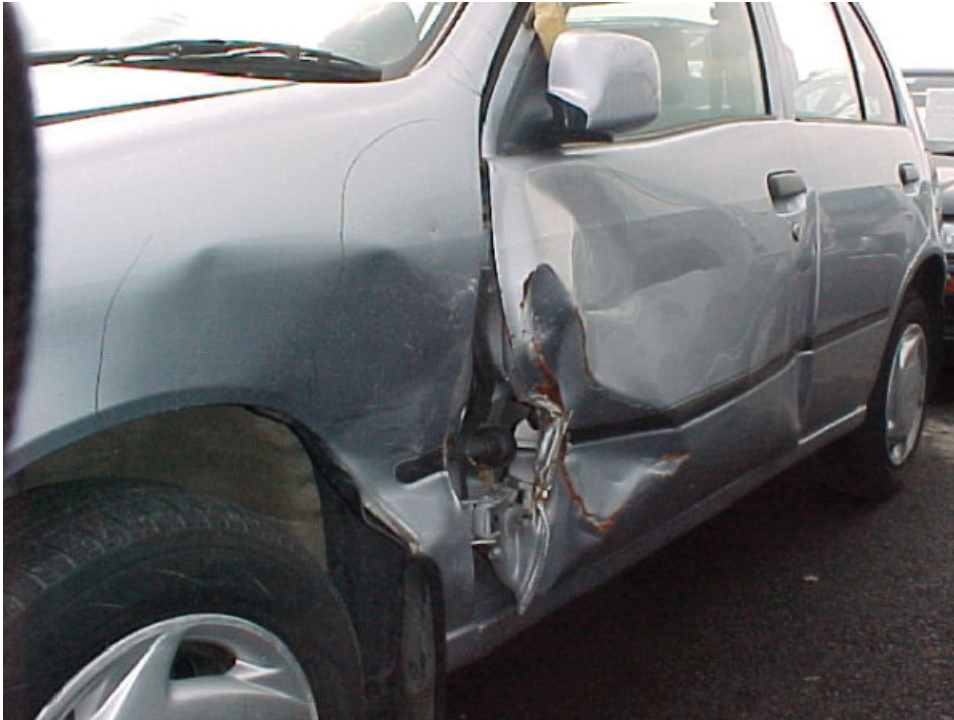
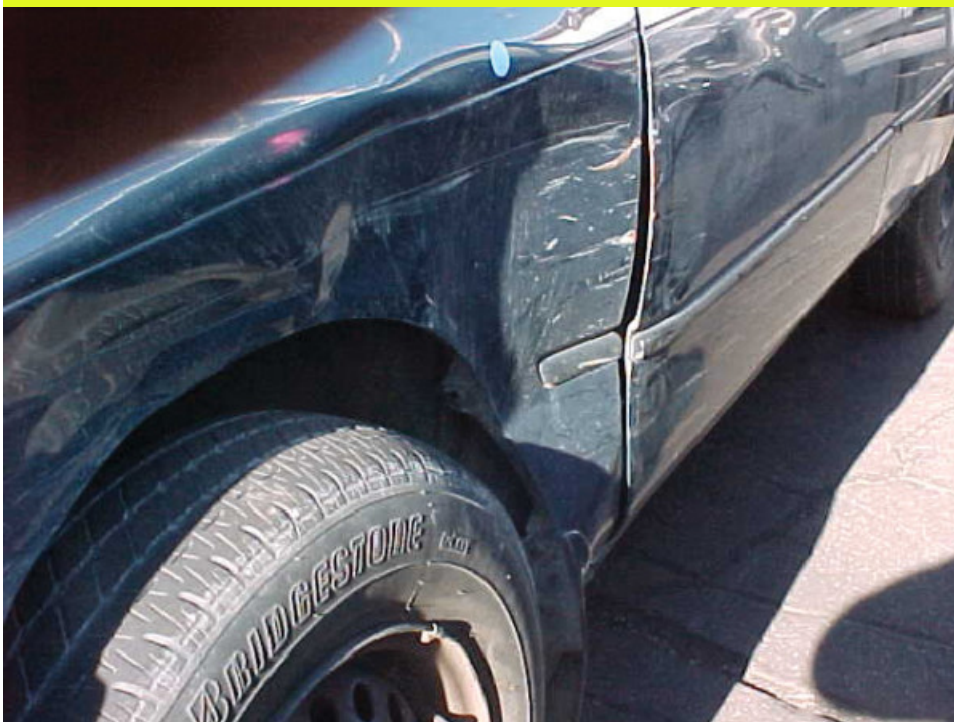
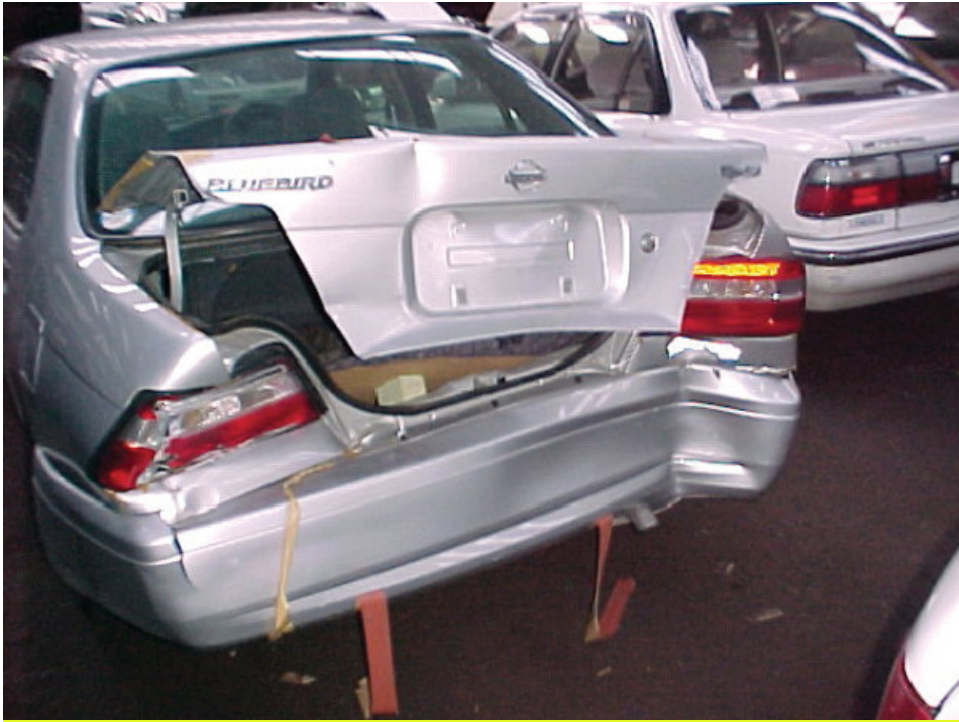
Damage to the vehicle's outer body panels which affect the integrity of any of the seams or joints installed by the vehicle manufacturer (and may have also caused secondary damage - further inspection may be required)
